**NSW  
Resources  
Regulator**

# **INVESTIGATION REPORT**

**Bulga Open Cut dump truck collision**

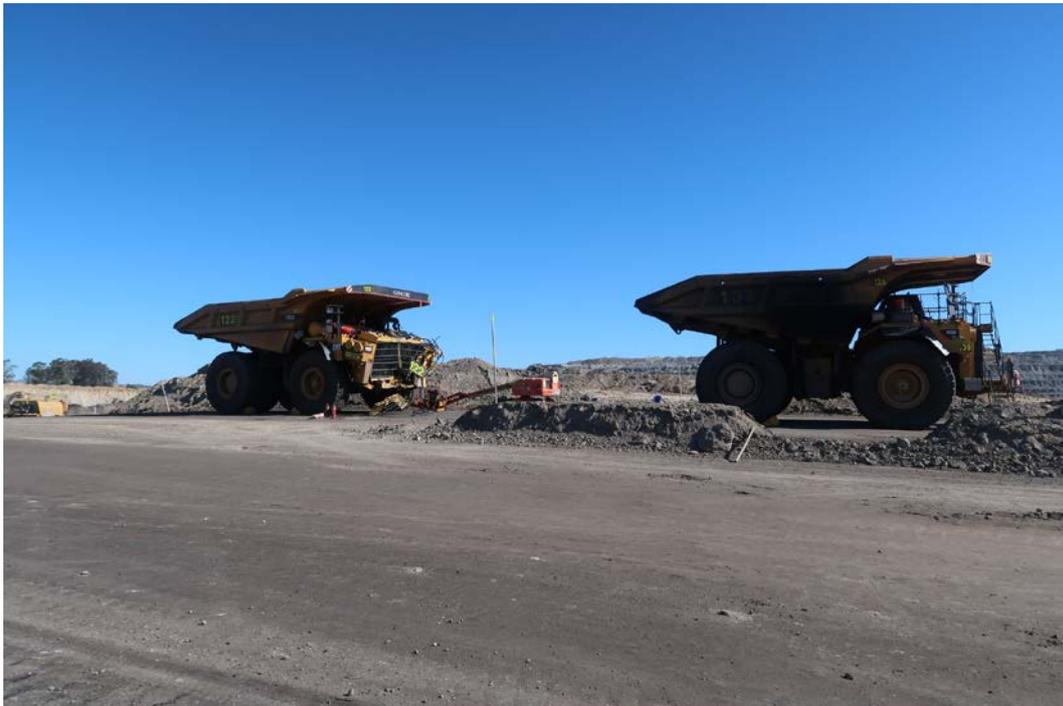
The front of DT122 hit the rear of DT139. Vehicle data records show that DT122 was travelling at 41 km/h in sixth (top) gear at the time of the collision. There is no evidence on the plant data records to support any action on steering, emergency braking or application of retarder by the driver.

The cabin of DT122 collided with the rear edge of the tray body of DT139. This resulted in the two pillars of the operator's cabin being pushed inward toward the driver. The force of the collision shunted DT139 forward about 20 metres.

*Figure 1: Final resting position of DT122 and DT139*

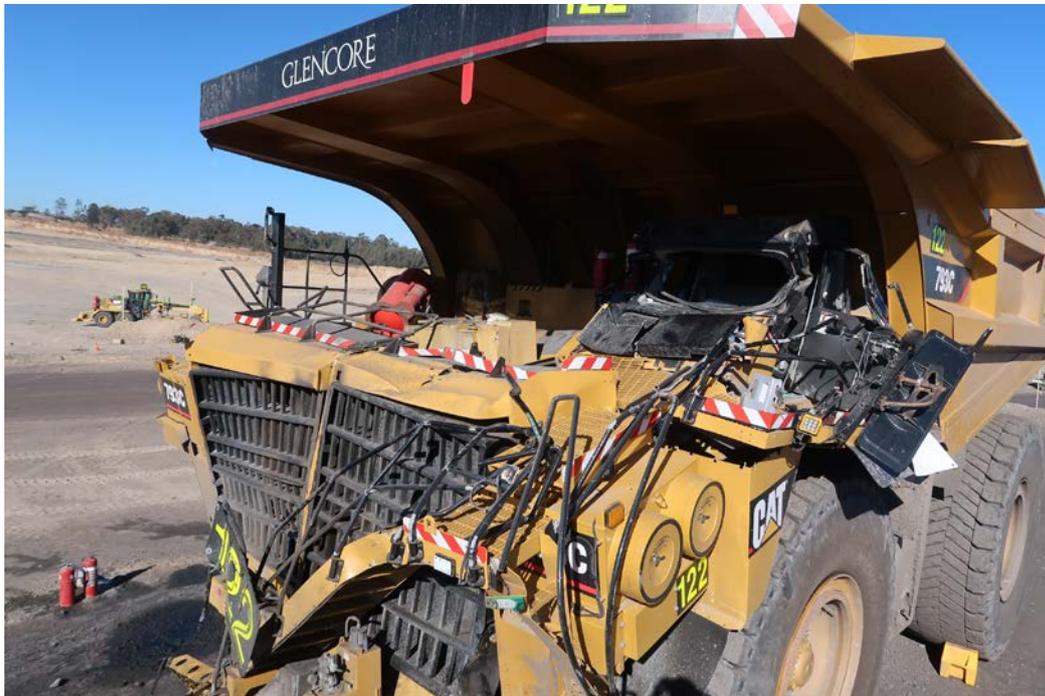
An emergency response was activated. The driver of DT122 was trapped in the cabin with his right foot twisted between the brake and accelerator pedals. Onsite rescue personnel freed the driver from the cabin and transported him to hospital by road ambulance. The driver suffered a fractured tibia, laceration to right eye and minor cuts and bruises.

Figure 2: Damage to front and cabin of DT122

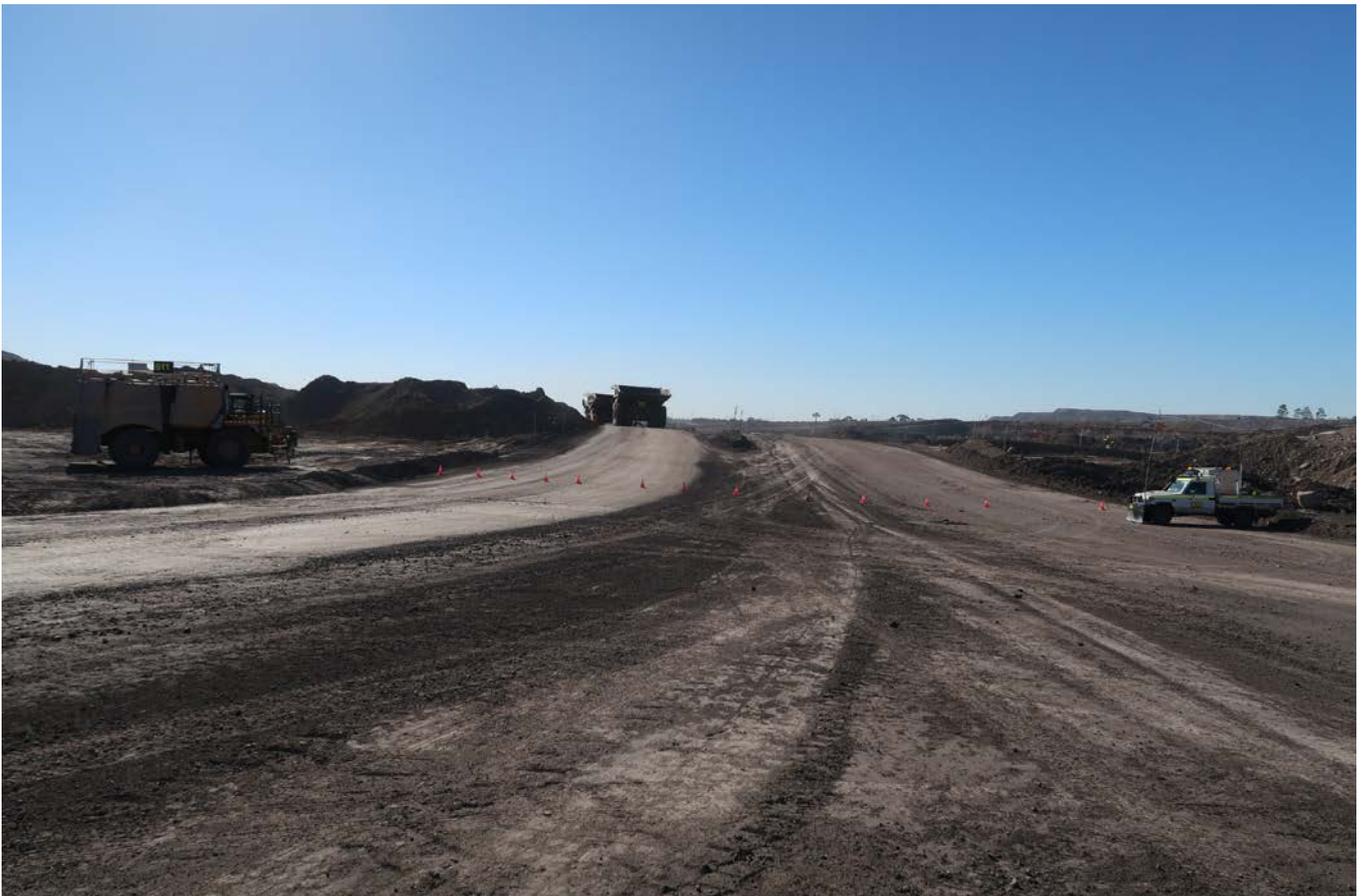
The incident occurred on a main haul road, known as Swan Lake Road. The surface roadway is of hard, compacted clay. The grade of the roadway at the point of impact was +3.5% with a cross grade of 2.0%. The photograph below is of the roadway leading to where the collision took place. The two dump trucks involved in the incident can be seen in the centre of the photograph.

*Figure 1: Roadway where collision occurred*
