# WEEKLY INCIDENT SUMMARY

**Week ending Friday 19 June 2020**

<b>CM9 reference</b>	DOC20/494261
<b>Mine safety reference</b>	ISR20-25
<b>Date published</b>	26 June 2020
<b>Approved by</b>	Chief Inspector Office of the Chief Inspector

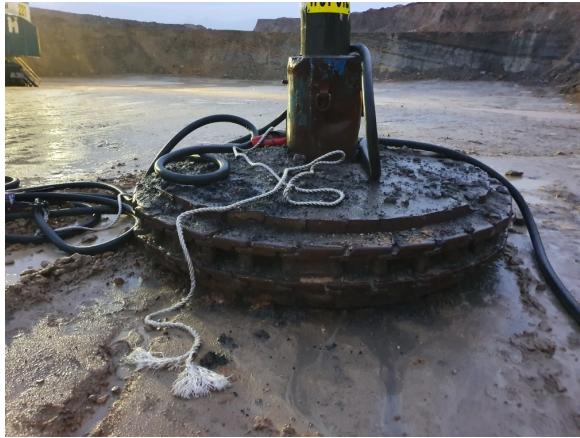
Open cut coal mine

INCIDENT TYPE	SUMMARY	COMMENTS TO INDUSTRY
Dangerous incident  IncNot0037567	Workers were lowering a shovel cable from a cable tower in an open cut mine when the shovel tower rope broke and the cable fell to the ground. The cable tower rope was attached to the ripper of a grader to lower the cable and the cable was being pulled at an angle. It was dark and wet at the time of the incident. The shovel tower brake mechanism was thrown about 60 metres and hit a supervisor on the hand.  The supervisor, who was standing about 3 metres from the tower, suffered hand fractures.	Operators are reminded of the need to follow documented procedures for tasks - to conduct a thorough risk assessment and to implement controls for identified risks, such as using fit-for-purpose equipment and establishing no-go zones.  The identification and use of fit-for-purpose equipment must be completed and documented for every task.  Safe standing zones, with a focus on remaining outside the line of fire for all foreseeable failures, must be established.

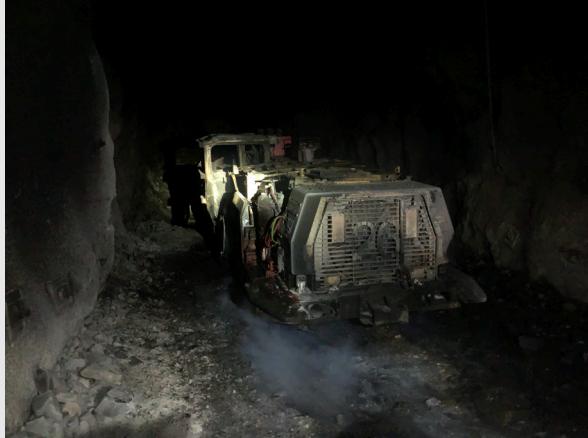
IncNot0037608

A loader, operating in remote mode, caught fire in the ventilation incline (exhaust side) while bogging at the bottom of a new ventilation shaft.

The loader's fire suppression system was activated, and three fire extinguishers were used but were unsuccessful in extinguishing the flames. All workers proceeded to refuge chambers and safely exited the mine.

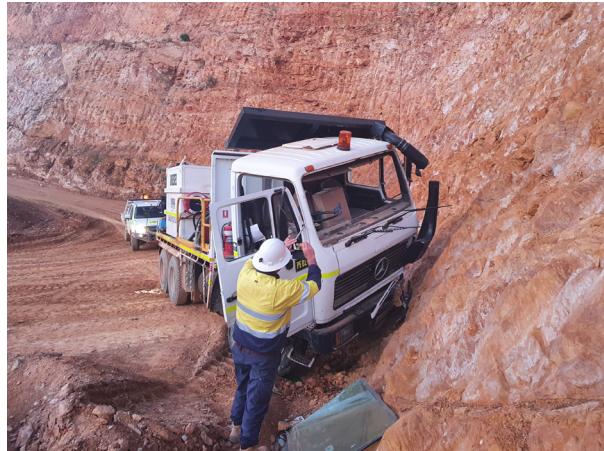
IncNot0037586

A service truck was driving down the main ramp of an open cut mine when the brakes failed. In order to bring the truck to a halt, the driver turned the truck into the wall.

The driver received lacerations to his forehead and bruising to his face. The service truck is a modified flatbed diesel on-road truck.

This incident is under investigation and the cause of the fire is not yet confirmed. A preliminary investigation suggests there was a fault in the brake solenoid circuit that caused the brakes to overheat.

Preliminary assessment indicates that the service truck was fit for purpose, however the driver, while assessed as competent on other vehicles, had not been assessed as competent for the service truck.

The service truck driver did not apply the park brake or the suppression brake during the incident.

Mine operators must ensure that vehicle operators are competent

for the vehicles they operate and that they follow daily pre-start checks on vehicles.

A drive-through park brake test should be carried out daily as part of the pre-start check.
