# WEEKLY INCIDENT SUMMARY

Week ending Friday 10 July 2020

This incident summary provides information on reportable incidents and safety advice for the NSW mining industry. To report an incident to the NSW Resources Regulator: phone 1300 814 609 24 hours a day, 7 days a week.

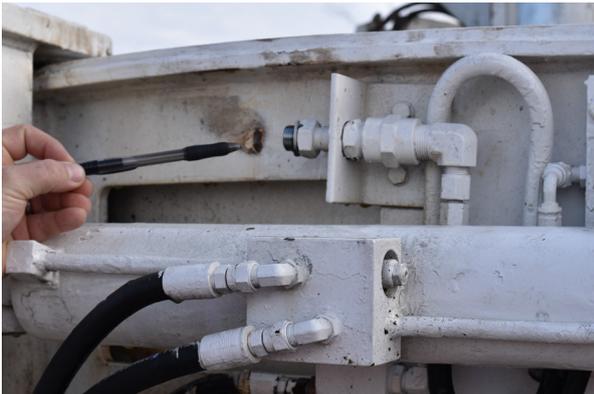
INCIDENT TYPE	SUMMARY	COMMENTS TO INDUSTRY
Dangerous incident IncNot0037725 Underground metalliferous mine	<p>A worker was removing an accumulator from a raise boring rig on the surface laydown area. During this activity, he suffered a fluid injection injury to his left-hand ring finger. The worker was admitted to hospital and underwent surgery.</p>

<p>Mine operators are reminded that effective isolation and energy dissipation are critical risk controls when working on high pressure fluid systems.</p> <p>Methods for dissipation of energy must be established and communicated for work on each part of a high pressure system.</p> <p>Refer to:</p> <p><a href="#">SB13-01 Fluid injections result in surgery</a></p> <p><a href="#">SB12-03 Fluid power isolation failures</a></p>

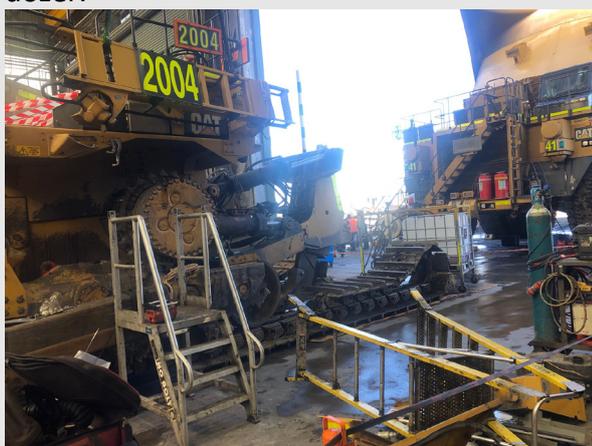
A 5T overhead crane was being used to remove an access ladder from a dozer. The operator was using the smaller hook on the crane. While taking up the slack on the slings and chains being used, the ladder was pulled free of its mountings and swung around, knocking over a stepladder which a worker was standing on. The worker jumped off the ladder and landed safely on the ground.

The crane operator was unfamiliar with the 5T crane and the speed of movement of the smaller crane hook. The crane hook moved faster than anticipated when load was applied to the ladder which was still bolted to the dozer.

Workers must be trained and competent in the use of equipment that is under their control.

All potential failures must be identified when determining safe standing zones, including unplanned movement. The risks of unplanned movements should be communicated to all workers during no-go zone identification.

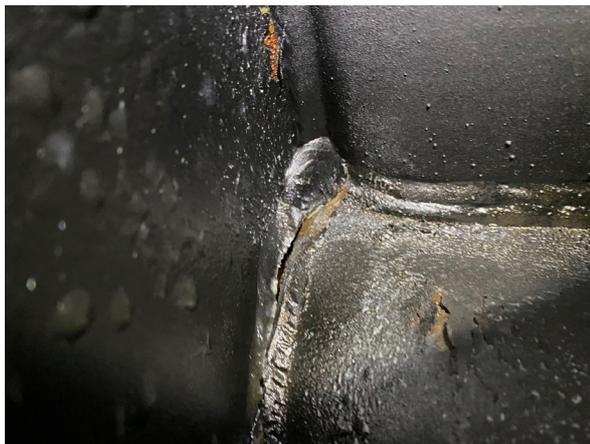
The operator of a loader in an extraction drive observed a flame coming from the muffler box on the loader. The operator stopped the machine and used a fire extinguisher to suppress the flame. The flame reignited and was extinguished again. The automatic fire suppression system was manually activated to cool the machine.

The apparent cause was fuel leaking from a crack in the internal fuel tank into the diesel particulate filter (DPF) box. The loader had previously contacted a wall, but the damage to the fuel tank was not identified at that time.

Following damage to any piece of equipment, thorough inspection and recommissioning must be undertaken to ensure all defects have been identified and repaired.
