INVESTIGATION REPORT

# DANGEROUS BLASTING INCIDENT

Albury Quarry – 10 April 2018

Title: Investigation Report: Dangerous blasting incident – Albury Quarry – 10 April 2018

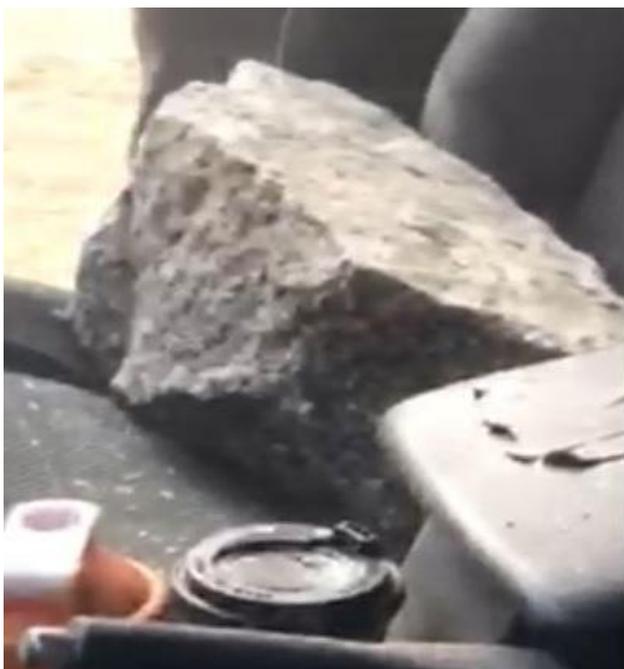
*Figure 1 Flyrock on driver's seat of shotfirer's utility*

Multiple rocks were launched into the air by the blast. Most of those present were forced to take evasive action to avoid being struck. Three light vehicles and two excavators in the immediate vicinity of these people were struck by flyrock. A piece of rock measuring approximately 400 x 200 x 200 millimetres struck the shotfirer's utility, knocked the vehicle's raised bonnet off its mounts, smashed through the front windscreen and landed on the driver's seat.

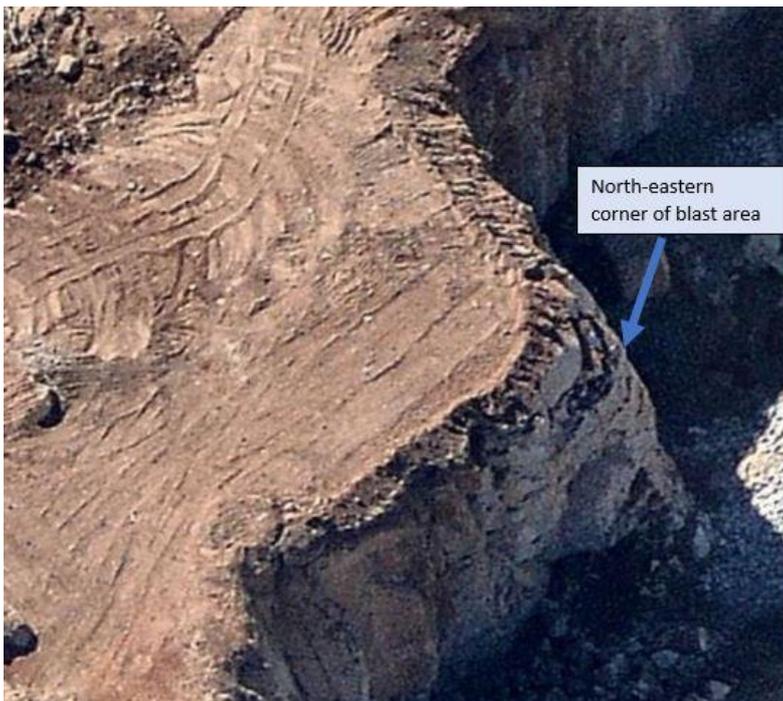
Figure 5 - Aerial image of blast area showing conditions on 11 March 2018

The shotfirer observed some cracks midway up the face of the blast area in the north-eastern corner (refer to figure 5). He estimated the depth of the cracks to be a couple of millimetres but was unable to measure them as it was unsafe to do so.

The shotfirer stated that he was aware of the potential for the north-eastern corner of the blast area to fire towards a shed at the quarry. The shed was located 235 metres north-east of the blast area and about 110 metres north-west of the firing location (refer to figure 6). The shotfirer stated that this was part of the reason that he increased the amount of burden and used a lower emulsion explosive in this part of the blast area.

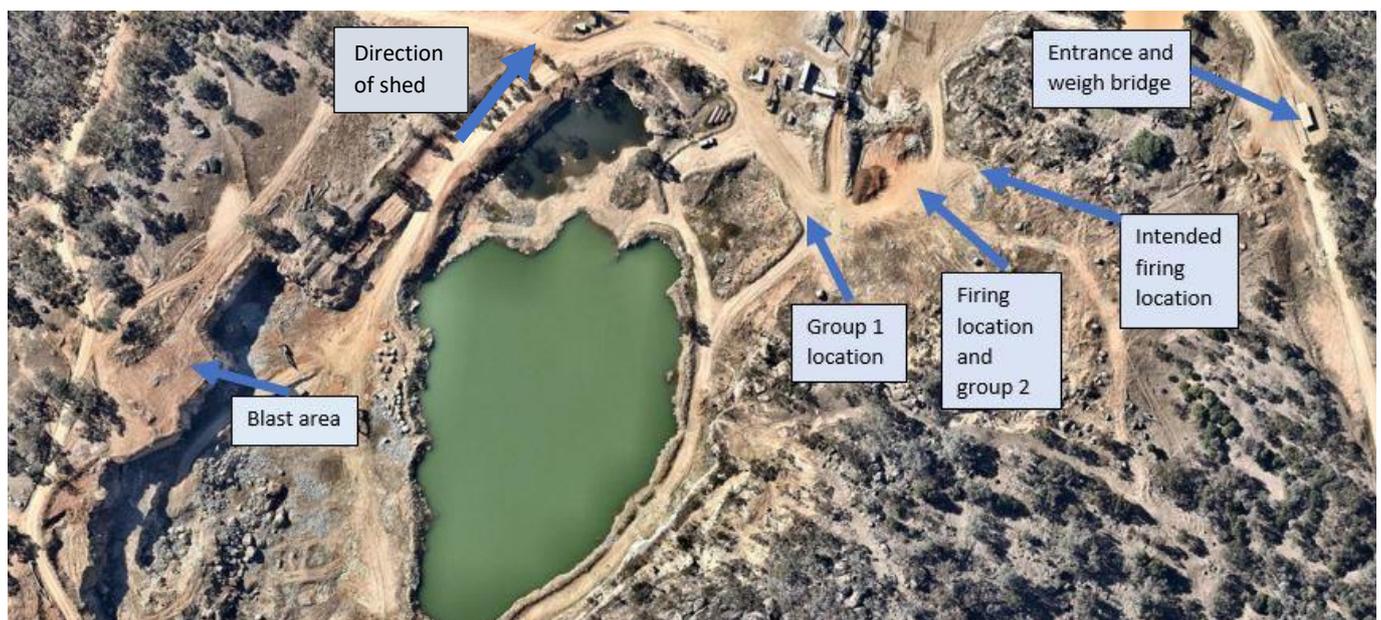
Figure 6 - Key locations at quarry

The shotfirer originally selected a firing location that was later determined to be about 360 metres forward of the blast. However, the main group of people present were gathered at a point about 40 metres forward of that location ('Firing location and group 2' in figure 6) so the shotfirer decided to establish the firing location at that point where the main group was gathered (320 metres from blast area).

The shotfirer stated that he chose a firing location so that he had good visibility of the toe blast, which was to occur prior to the main blast. He estimated that the firing location was about 400 metres from the blast area but did not measure it. He considered this to be a safe location having regard to the depth of burden and the use of a lower energy explosive in some of the blastholes.

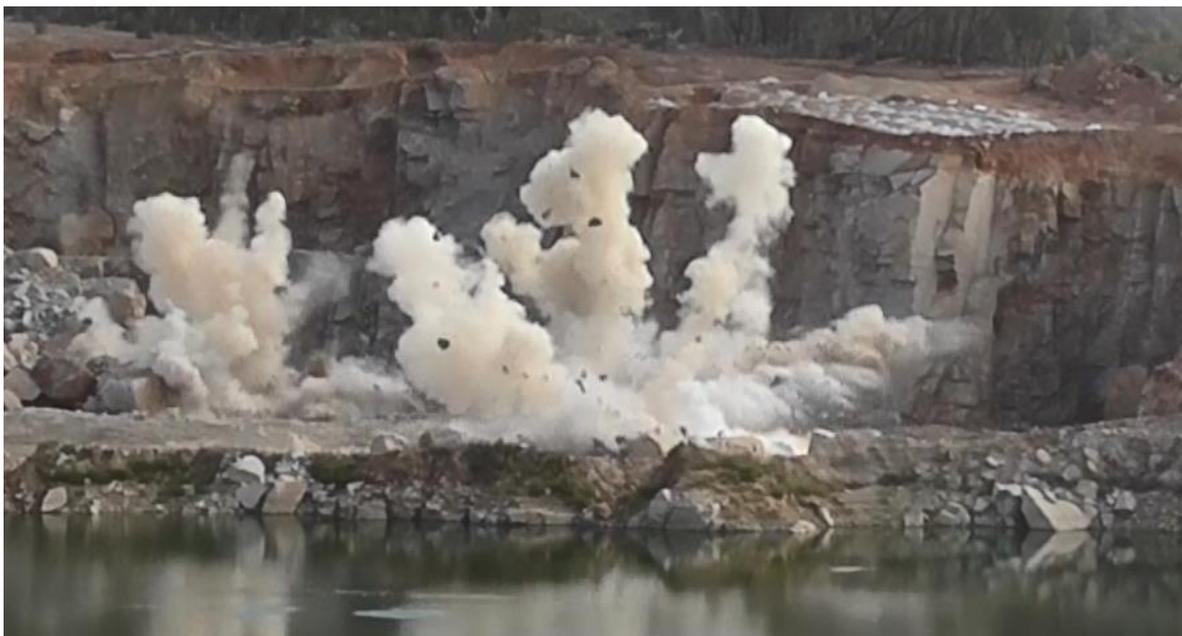
Figure 7 - Flyrock produced by toe blast

Blasting began about 2.30 pm. Although the toe blast involved a much smaller quantity of explosive than the main blast, rock from the blast was ejected a considerable distance into the air (refer to figure 7). Secondary blasts of this nature are considered risky because the direction and distance of rock movement is unpredictable.

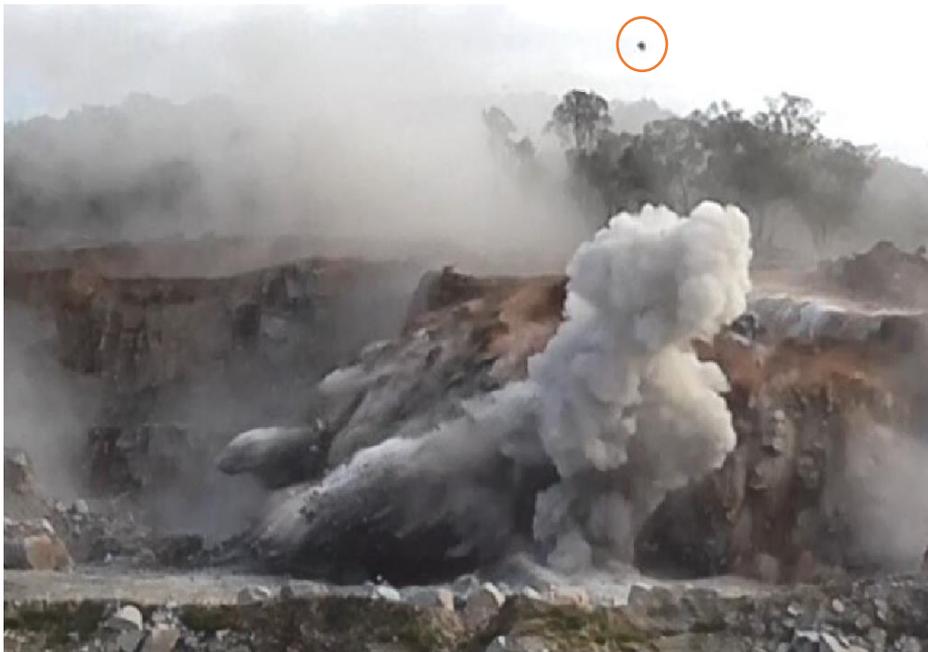
Figure 8 - Early stages of main blast (note large flyrock)

The main blast occurred at 2.32 pm. When fired, the blast projected granite rocks and other material into the air towards the firing location. The majority of the flyrock landed in the dam located between the blast area and the firing location. However, multiple rocks were ejected with enough force to clear the dam and fall around the locations where groups 1 and 2 were standing.

The largest piece of flyrock that was observed (refer to figure 8) struck the raised bonnet of the shotfirer's utility. The impact detached the bonnet from the vehicle. The rock smashed through the front windscreen and came to rest on the front driver's seat.

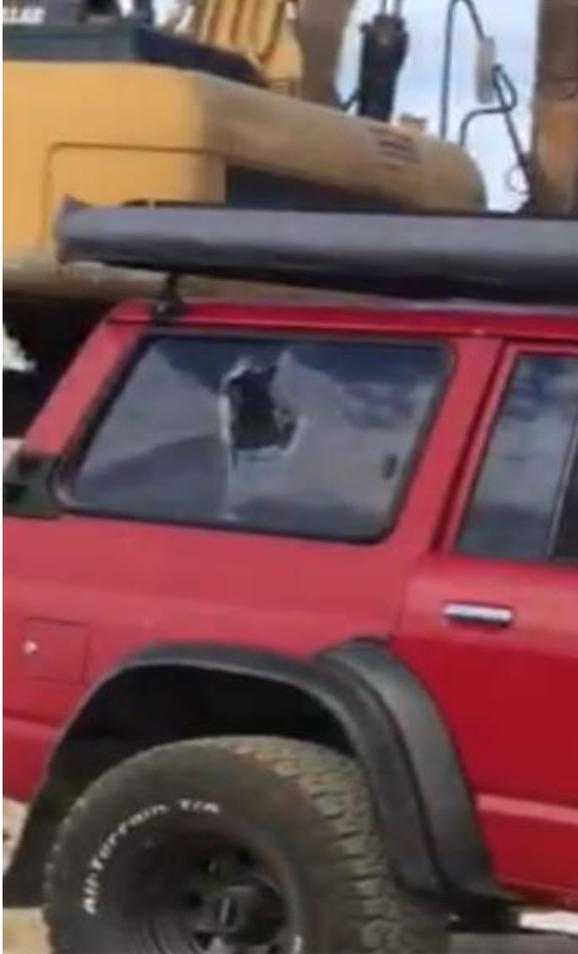
Figure 11 - Damaged red four-wheel drive

Separate rocks dented the roof of the four-wheel drive and smashed its rear driver's side window. Another rock smashed the windscreen of the quarry utility. A bolt securing a hydraulic line on the rear excavator was broken off after it was struck by rock.

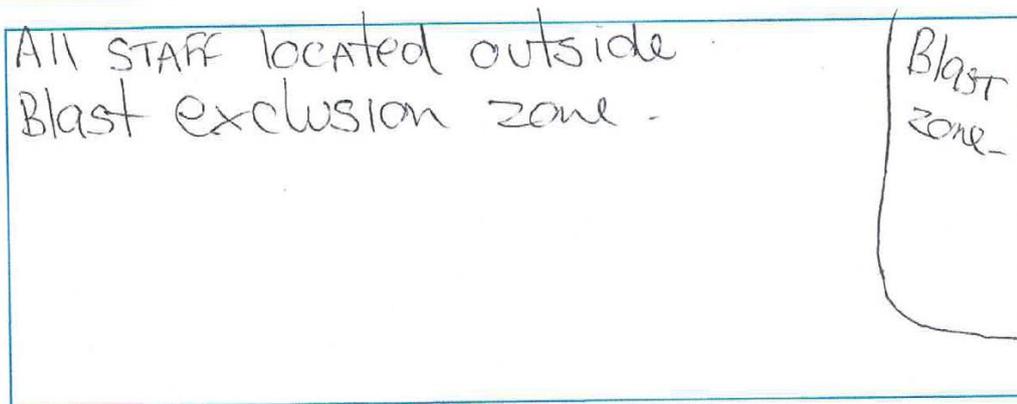
Figure 2- Blast diagram included in shotfirer's blast management plan

The mine operator and shotfirer each failed to comply with their own safety systems and AS 2187. Some failures involved completely disregarding requirements, others involved giving token compliance. An example of the latter is shown in Figure 12. It was prepared by the shotfirer as part of its planning procedures, and purports to identify a 'Designated Safety Zone.'

- Blast exclusion zones were not demarcated and effectively communicated to ensure the safety of those present.
- There was no signage installed at the blast area warning of dangers and no-go zones.
- Non-essential personnel, including members of the public, were present during blasting. The risks associated with blasting increases as the number of people in the vicinity of the blast increases.
- There was no protection such as shields and barriers afforded to those present at the firing location.
- There were no sentries positioned at all entry points to the quarry.
- There was no blast guard appointed to prevent unauthorised entry to exclusion areas.
- The people present during blasting and the firing location were too close to the blast area.
- The distance between the blast area and the firing location was not measured.
