NSW
Resources
Regulator

INVESTIGATION REPORT

DANGEROUS INCIDENT

Unplanned movement of continuous miner
Ashton Coal Mine on 30 May 2019

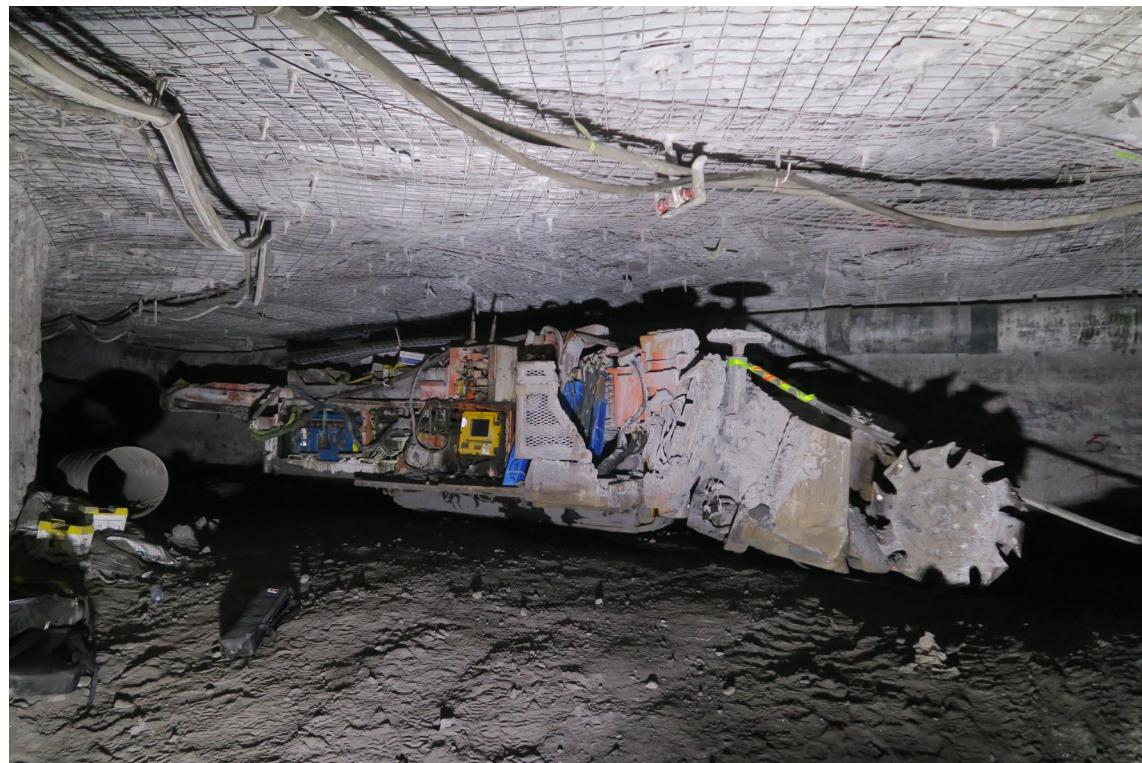
Figure 1 CM04 positioned for functionality testing

- The CM04 continuous tracks used for tramping were functioning as designed with no faults identified. The tracks were reasonably maintained, undamaged and were able to move freely in forward and reverse, maintaining traction at varying operating speeds.
- The CM04 braking system was functioning as designed with no faults identified. Brakes were reasonably maintained and observed to apply immediately on remote command with no delays and minimal braking distances recorded.

- The CM04 remote control was inspected and tested and observed to be in good working condition, undamaged and functioning as designed with no faults, interference or relay delays identified.
- The CM04 mode lighting and audible tramping indicators were observed to be functioning as designed with no defects identified.
- Data log information retrieved from CM04 did not identify any braking, traction system or any other system faults, trips or alarms attributable to the incident.

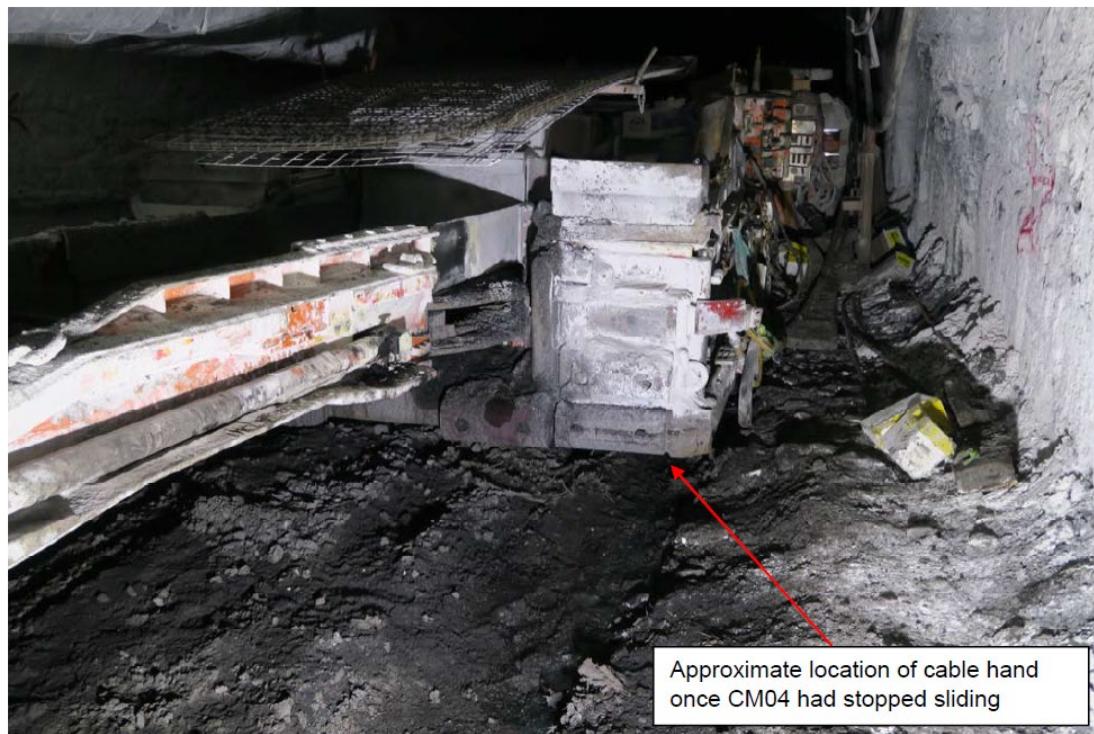
Figure 2 Position of rear of CM04 after the incident

The cable hand slipped and fell to the floor while attempting to turn and run clear of the path of the approaching continuous miner. The CM04 continued to slide back down the roadway with its rear bumper contacting the worker before coming to rest after travelling approximately 10 to 15 metres. The CM driver and deputy immediately rendered assistance to the cable hand who had been pushed to the ground by the continuous miner when it contacted him. When the CM04 came to rest, the cable hand was partially underneath the rear of the miner but was not trapped (see figure 2). The cable hand was provided with first aid, transported to the surface and later to the hospital for precautionary scans and treatment.

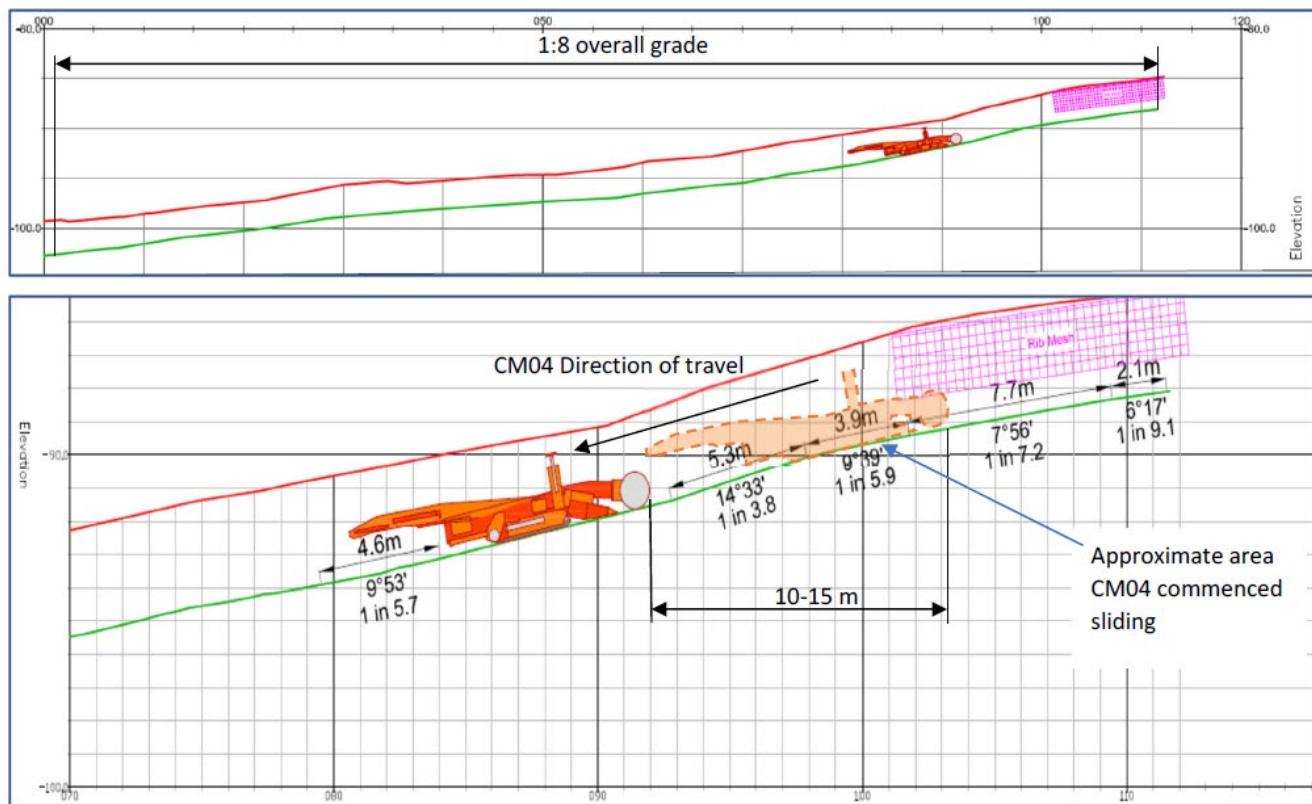
Figure 3 LW203A road longitudinal grade survey

- The approximate location where the CM04 most likely first lost traction and commenced sliding back had a longitudinal grade of 1:5.9 and cross grade of 1:23 which was within both the mines ROVOA management plan and the OEM's stated safe operating limits (see figure 3).
- The steepest section of roadway which the miner slid down had an uphill grade of 1:3.8 over a span of 5.3 metres. This section of roadway did not comply with the mine's ROVOA management plan but was still within the OEM's stated safe operating limits for the CM04.

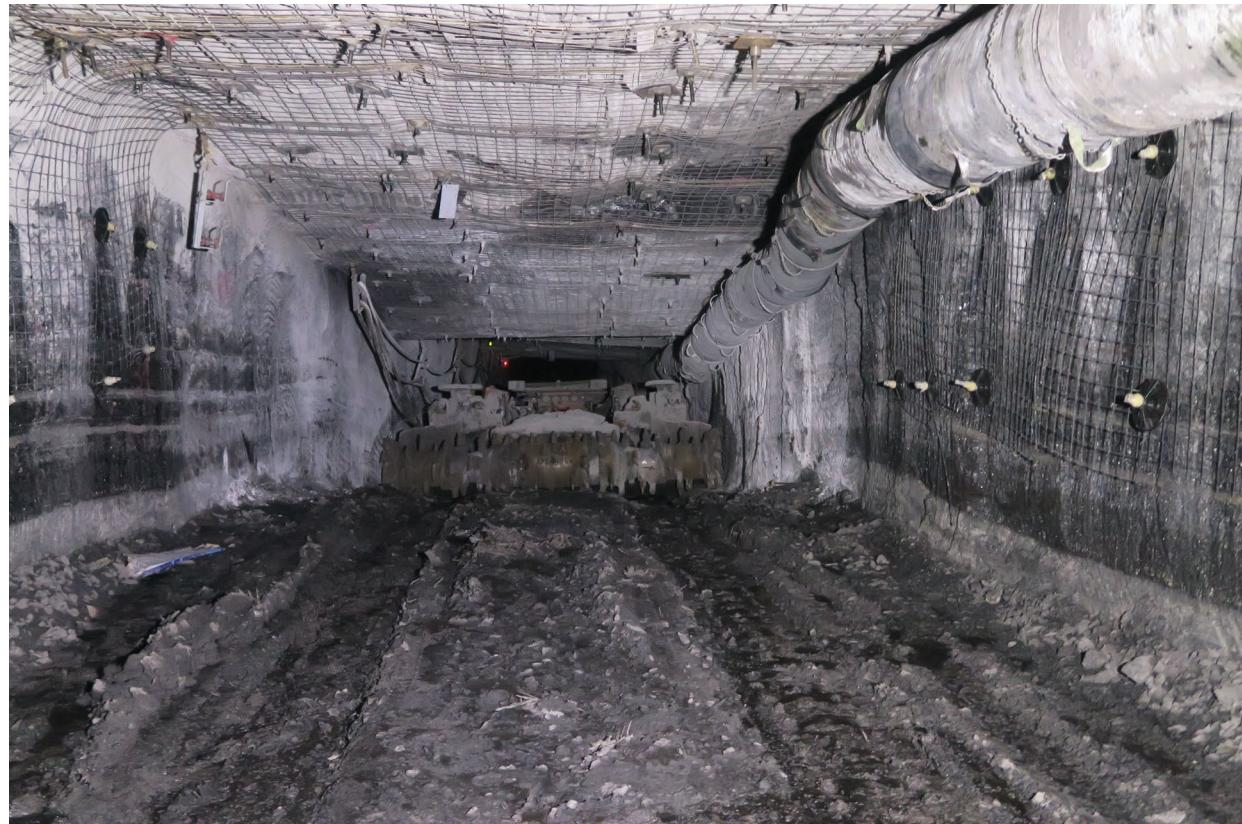
Figure 4 Front view of CM04 after the incident

Examination of the track marks left by the CM04 after the incident identified areas where stone floor substrate was exposed. During interviews, mine workers stated that they had observed sections of the roadway which contained exposed hard stone floor substrate.

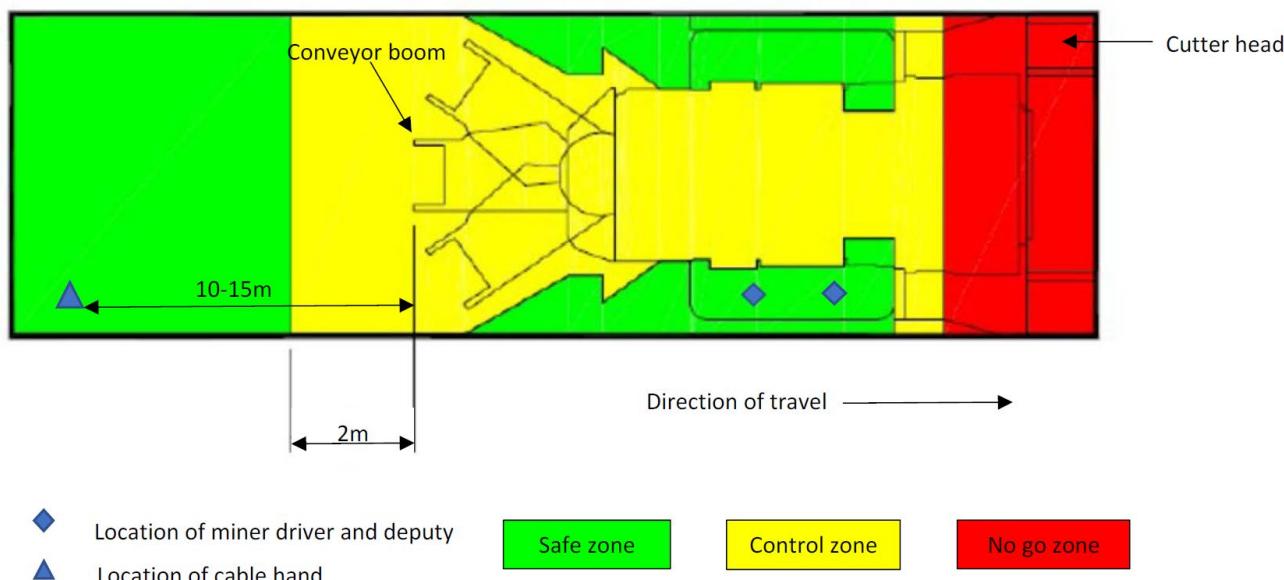
Figure 7 Safe standing zones and position of workers at the time of the incident

Figure 7 below depicts the safe standing zones implemented for straight cutting operations (including floor trimming) and the approximate locations of the workers when the incident occurred.

The zones prescribed that during straight cutting operations (including floor trimming) workers were required to be outside the yellow control zone perimeter which extended two metres from the end of the miner's conveyor boom.

The distance provided adequate clearance for workers to remain clear of the miner's swinging conveyor boom but had not accounted for the possibility of an unplanned movement causing the miner to move backwards in excess of two metres.

- review and update operating procedures to ensure safe standing and pedestrian access zone perimeters account for the possibility of a continuous miner losing traction and sliding down steep underground roadways
