SAFETY BULLETIN

DATE: NOVEMBER 2021

Threaded fasteners – Diesel engines systems in underground coal mines

CM9 reference	DOC21/203202
Mine safety reference	SB21-09
Date published	4 November 2021
Authorised by	Chief Inspector Office of the Chief Inspector

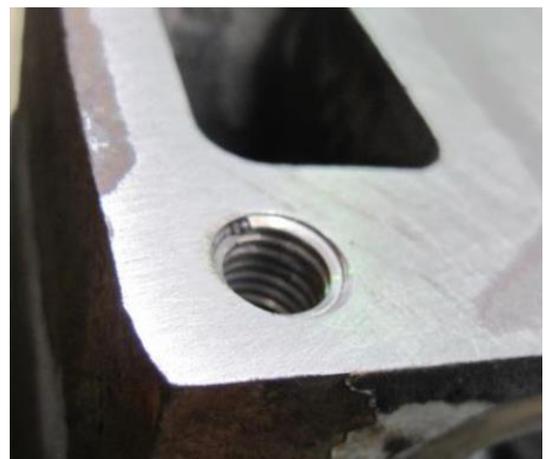
Figure 1: 'Heli-coil' insert

A leak was discovered during a pre-use inspection. Upon removal of the exhaust manifold, the bolt removed had some visible damage and part of a 'Heli-coil' threaded insert was found to be sitting proud of the cylinder head surface.

Investigation of the thread repair revealed that it was installed as per the supplier's recommendations. The Heli-coil was installed without the use of thread locking compound and passed thread form checks. There was no record of structural assessment for suitability for this type of repair recorded in the Code D report but it did however pass edge distance and flatness requirements.

Wherever practicable internal (female) threads should not be repaired, and the components should be replaced with a new part.

Where it is not practicable to replace the component with a new part, ExDES (RSF) workshops should develop and implement a documented process for thread repairs including the:

- guidance steps in AS3584.3-2012, cl 3.5.7.3 for internal thread repairs
- methods to assess and test the structural integrity of the part
- additional supervision provisions for the structural assessment, thread repair and reassembly of the bolted connections

- distance below the surface coil type inserts are installed and post-machining when using blind plug inserts
- identification of competent personnel involved in all steps of the process

- record keeping of the above steps including photos of the final repair.
- Sample (type) testing or proof testing that considers:
 - maximum expected thread torque plus a margin (i.e. 10%)

- pre and post thread form tests (i.e. go/no go gauges)
 - durability – repeated applications to determine how the insert behaves and estimate lifecycle recommendations

- installation depth below the machined surface for coil type inserts
 - flatness check of the surface after the bolt tension has been removed.

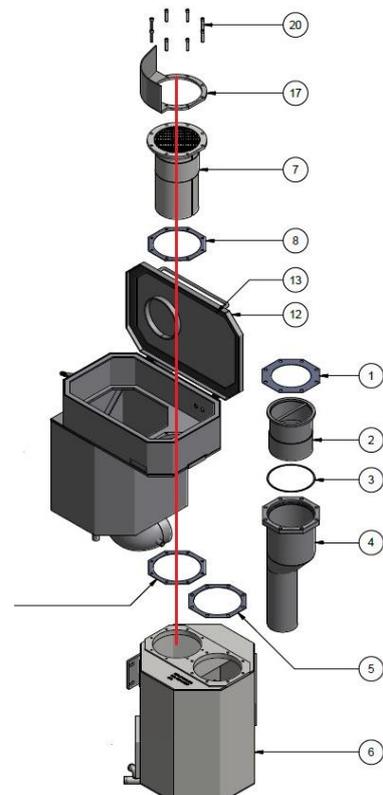
Figure 2: Bolted connection assembly

An RSF conducted an offsite Code D overhaul on the ExDES of an LHD. One week after returning to service, a maintenance fitter removed the positive flame trap (item 7 in figure 2) for cleaning and inspection. On reassembly, the fitter identified two fasteners failing to apply effective clamping force to the fixed connection.

- evidence that the ends of the bolts were tapered
- the fastener grade was found to be equivalent to Class 12.9 instead of the standard the OEM supplied Class 8.8
- the exhaust conditioner top flange blind holes had not been adequately tapped following a repair but was however sufficiently close to allow fasteners to be installed, torqued, and tested for gas tightness without presenting obvious cause for concern.

It is recommended that ExDES (RSF) licenced workshops:

- verify that reference documents identify the minimum required thread depth of blind holes
- verify procedures, include checking the thread tolerance and effective depth of blind holes

- verify that optional components, affecting the length of fasteners required for an assembly are identified and included in measurements when calculating fastener lengths

- verify that instructions to repairers (internal or external) include details for checking the final depth of blind threaded holes
- verify that workshop reports and procedures include methods to verify:

- the thickness of all components to be assembled (e.g. gaskets, flanges, washers)
 - fastener length is sufficient to provide effective clamping force and not too long to bind in the bottom of blind holes

- verify correct fastener material grades are being used. (Note: Use of OEM supplied components is one way to ensure the correct material grade of fasteners)

- competent personnel and trades working on ExDES are provided with training to emphasise the importance of using fasteners of the correct material grade and foreseeable errors in relation to blind threaded holes.

It is recommended that OEMs of ExDES:

- identify the minimum service thickness of individual components and correct fastener lengths for the thickness range where blind holes are used
- clearly identify the minimum thread depth of blind holes
- clearly identify part codes for the fasteners and optional part codes for shorter fasteners, where required, for assemblies approaching minimum service thickness.
