MINE SAFETY INVESTIGATION UNIT

INFORMATION RELEASE

Serious injury

Date	12 August 2012
Event	Surface drilling incident resulting in spinal injuries
Location	Ashton Mine, Camberwell, NSW

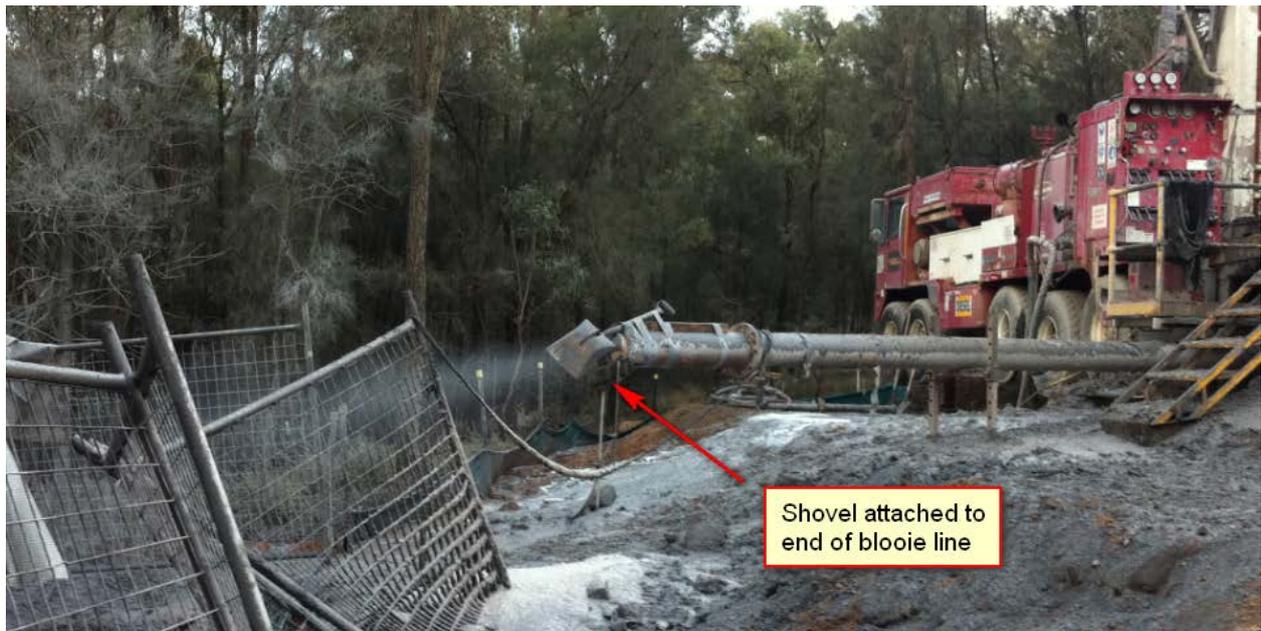
As an interim measure, a shovel was tied to the end of the blooie line to deflect material downwards.

Blooie line at borehole 3 passing under the driller's platform

Before starting borehole 4, the end of the blooie line was modified by fitting a 90° elbow on the end of it to try to direct the drilling fluids into the sump below.

A driller's offsider reported that the air discharge line was seen to move when in use, which led to attempts to anchor the pipe with two star pickets and fencing wire.

The modification to the blooie line configuration appears to have been ad hoc, and undertaken without proper design consideration or risk assessment.
