Week ending 25 January 2019

This incident summary provides information on reportable incidents and safety advice for the NSW mining industry. To report an incident to the NSW Resources Regulator: phone 1300 814 609 24 hours a day, 7 days a week.

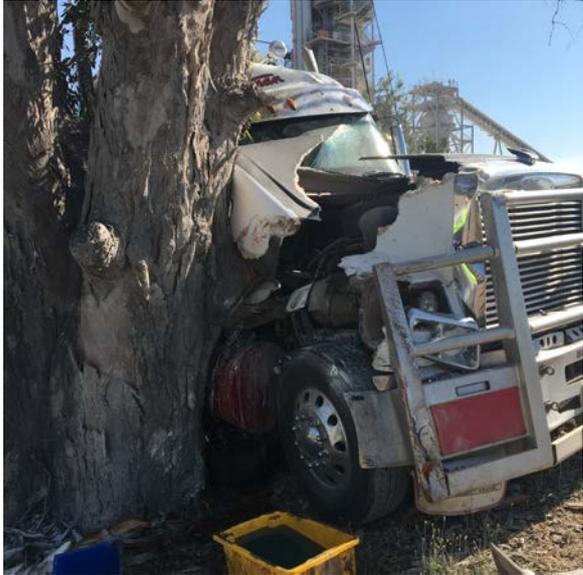
Incident type	Summary	Recommendations to industry
Dangerous incident IncNot0033734	<p>A pneumatic tanker truck carrying lime rolled about 50 metres and hit a tree. The driver was on top of the trailer at the time, as it started to move he climbed down and tried to chase the truck. The driver was not injured.</p>

<p>Mines should provide park-up areas with engineered controls to prevent trucks from inadvertently rolling away.</p> <p>Truck drivers must be informed of site park-up processes and should be compliance monitored.</p>

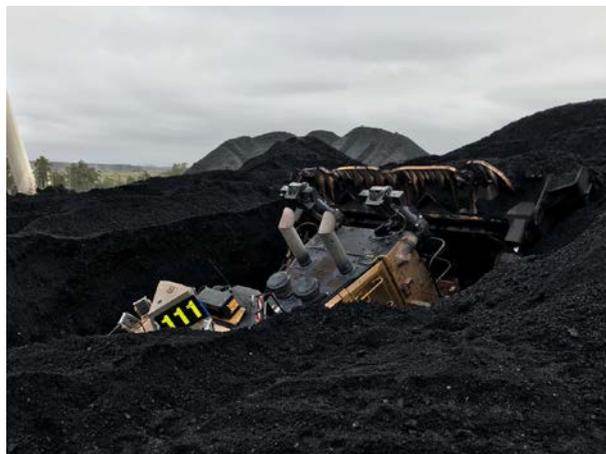
Dangerous incident
IncNot0033728

While operating on a clean coal stockpile, a dozer sunk into a void. The operator was able to safely exit the machine.

The hazard of concealed voids exists on stockpiles and must be included in risk assessments, training and procedures for operators.

Operators must be trained in identifying when the risk is present and how to control this risk.

When designated equipment fitted with risk controls (in this case toughened glass and GPS) is swapped, the alternative machine must have controls to manage the risk to an equivalent level.

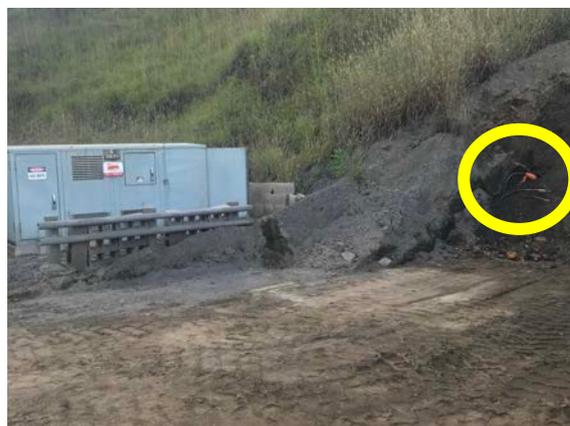
Dangerous incident
IncNot0033707

A loader damaged an 11,000 volt cable was damaged in a quarry. The operator was using a loader to clean up when he dug into a bund. A cable was damaged and tripped the power to the site.

All buried services at mine sites should be clearly delineated and marked on plans.

Operators need to consider services in areas around infrastructure.

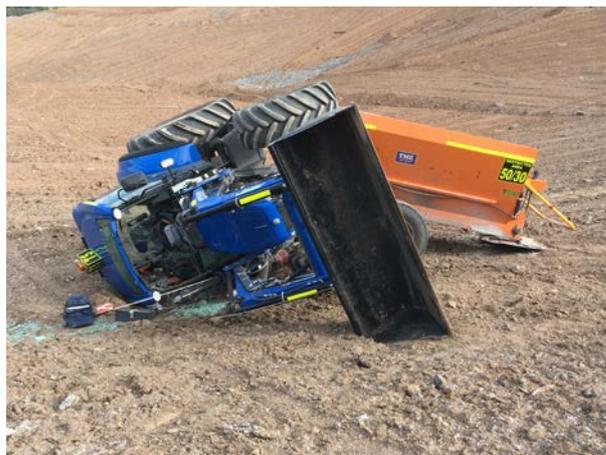
Dangerous incident
IncNot0033683

A tractor rolled while it was undertaking rehabilitation work at an open cut coal mine. The operator was not injured. The tractor was towing a spreader loaded with gypsum when the operator drove down a slope. The tractor started to skid and as it slid it overturned.

When assessing the risk of vehicles and equipment operating on slopes and grades, the effect of any trailers and attachments used must be considered.

When equipment is upgraded or replaced, any training, assessments and appointments must be updated to reflect the equipment being used.

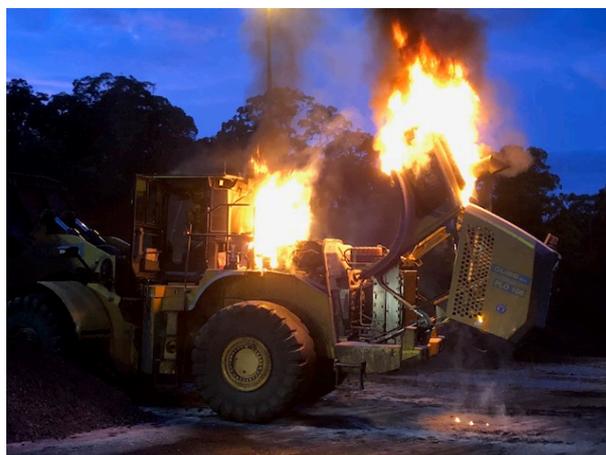
Dangerous incident
IncNot0033664

A loader was working on a coal stockpile when a fire occurred. The fire was localised to the air filter area. Investigations are continuing.

Any machines fitted with burn type diesel particulate treatment should have the risk of this process addressed in the fire risk assessment for the machine.

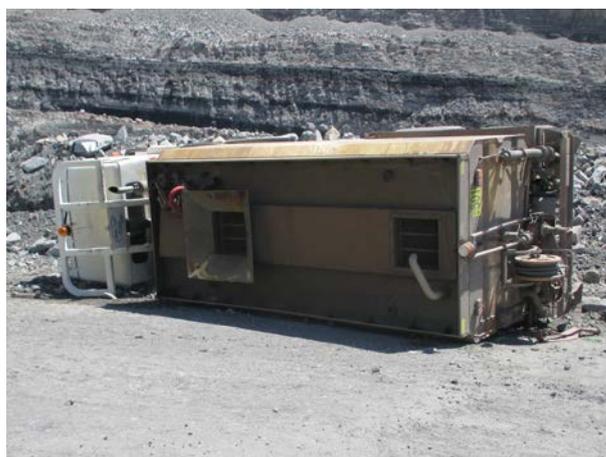
Dangerous incident
IncNot0033650

A road-registered truck being used as a water cart rolled over in an open cut coal mine. The operator was descending a ramp when the truck hit a windrow and rolled.

Maintenance plans should be reviewed when on-road vehicles are routinely used in mine sites.

Operators of mobile plant must remain focused on the task at hand and avoid tasks that may distract them from their primary duty of safely operating plant.
