WEEKLY INCIDENT SUMMARY

Week ending Friday 23 August 2019

Mine safety reference ISR19-33

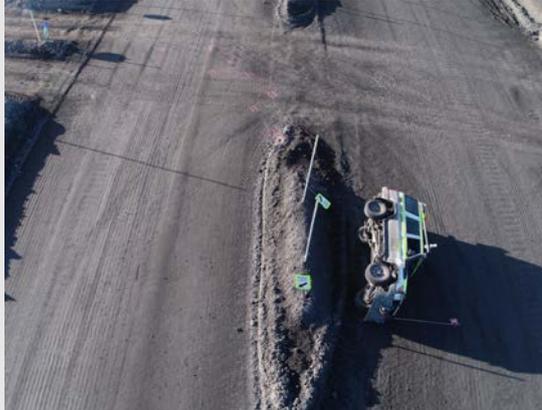
IncNot0035353

A light vehicle rolled over after making contact with a centre bund.

The driver said that the sun was in their eyes as they made a right-hand turn and the vehicle caught the edge of the centre bund causing the vehicle to ride up on one side and roll over. The driver was not injured.

Principal hazard management plans for roads or other vehicle operating areas should consider factors that may affect operator visibility or ability to control a vehicle:

- Fog, sunlight, storms or dust obstructions that affect lines of sight.
- Drivers should be reminded to travel at speeds suitable for the conditions.

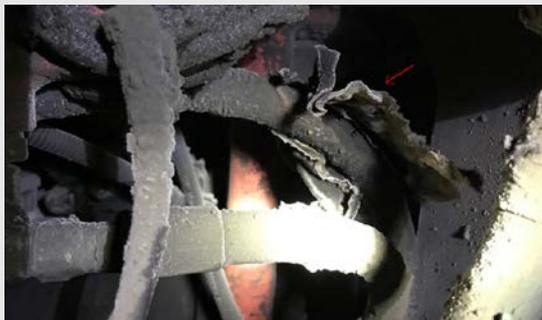
IncNot0035381

A Jumbo drill rig operator noticed a burning smell and hit the e-stop. When the operator dismantled the machine to

investigate, he saw flames in the engine compartment. He used a handheld fire extinguisher to extinguish the fire. A rag was found in the engine bay, draped over a hose. The rag had ignited and was the source of the flames.

Mine maintenance personnel should be vigilant when carrying out maintenance to ensure that no foreign materials are left in engine bays following maintenance.
