WEEKLY INCIDENT SUMMARY

Week ending Friday 24 April 2020

ISR20-17

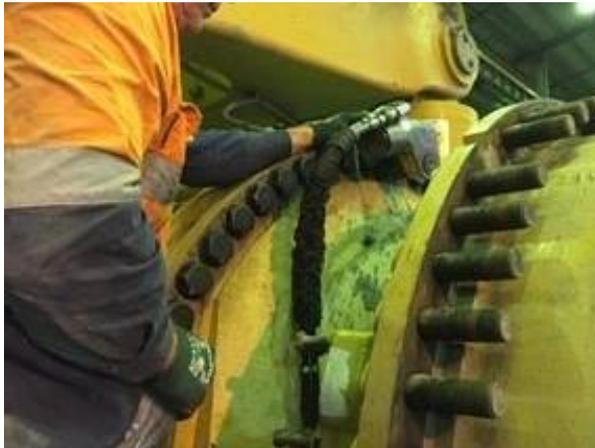
INCIDENT TYPE	SUMMARY	RECOMMENDATIONS TO INDUSTRY
Dangerous incident IncNot0037197 Open cut coal mine	<p>A fitter suffered an electric shock while using a Hytorc unit to torque bolts on the chassis of a truck.</p> <p>At the same time, a welder was carrying out air arc gouging on the truck.</p> <p>A mine investigation showed that air arc gouging generates an induced voltage into the frame of the truck.</p>	<p>When undertaking welding activities on truck bodies in a workshop, an earth bond cable should be installed between the truck body and the building earth. It is also recommended that when air arc gouging is being undertaken on truck bodies, no other tasks involving contact with the truck should be undertaken simultaneously.</p>

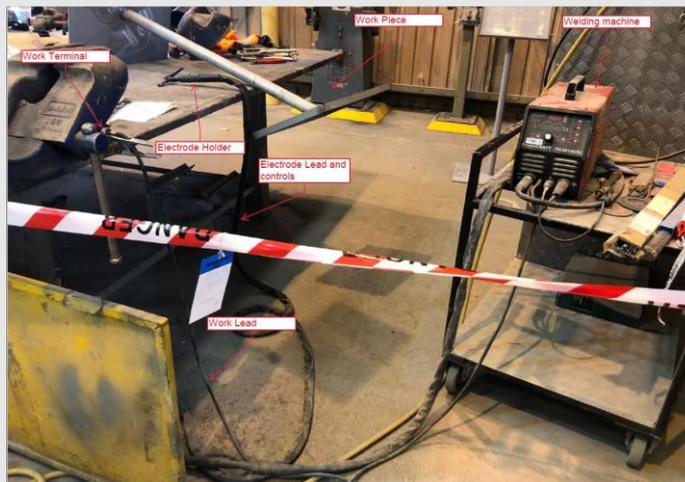
Dangerous Incident
IncNot0037201
Metals mine processing plant

A boilermaker suffered an electric shock while operating a 15A TIG welder in a surface hot work area. The electric shock occurred when the worker made contact with the welder electrode.

A preliminary investigation showed that the output voltage of the welder was 130 VDC while the nameplate output was 68 VDC. This suggested a potential internal fault.

Also, the operator was in contact with the electrode and metallic workbench with a suspected hand-to-hand current path.

All welding equipment should be inspected before use and should be properly maintained.

Workers involved with welding activities should remain insulated from the welding job. Welding gloves are not electrical insulators and if they are damp, they can enhance the effect of an electric shock.
