WEEKLY INCIDENT SUMMARY

Week ending Friday 08 May 2020

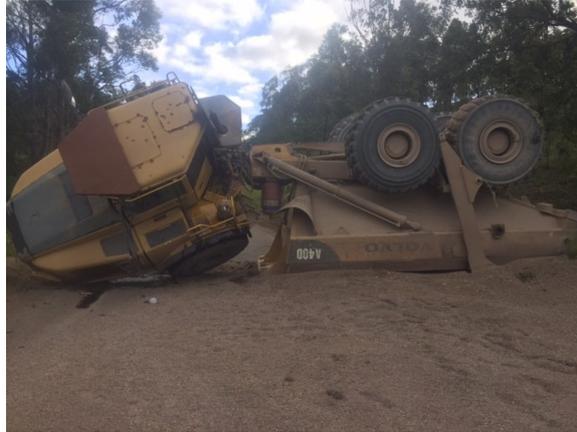
INCIDENT TYPE	SUMMARY	RECOMMENDATIONS TO INDUSTRY
Dangerous Incident IncNot0037278 Quarry

Roads or other vehicle operating areas	<p>A loaded, articulated haul truck was travelling down the main entry road of a quarry. The road was on a decline and was sealed. The driver tried to slow the truck using the retard brake, but the truck didn't slow sufficiently. The driver used the foot brake, but the wheels on the truck locked up, causing the truck to slide sideways and overturn. The driver was inexperienced, having only operated the truck for one week before the incident.</p> <p>The truck was travelling about 50km/h. The driver was not injured.</p>	<p>Mobile plant characteristics, including stopping distances, maneuverability and operating speeds for both the loaded and unloaded vehicle must be considered when developing control measures to manage the risks to operating vehicles.</p> <p>Mines should consider the use of speed limiting devices and the operating range of retarder systems.</p> <p>The risk of articulated trucks overturning has been highlighted to the industry by the Regulator</p>

through the following publications:

- [SB17-01 Industry reports more truck rollover incidents](#)
- [Articulated truck rollovers and falls from mobile plant](#)

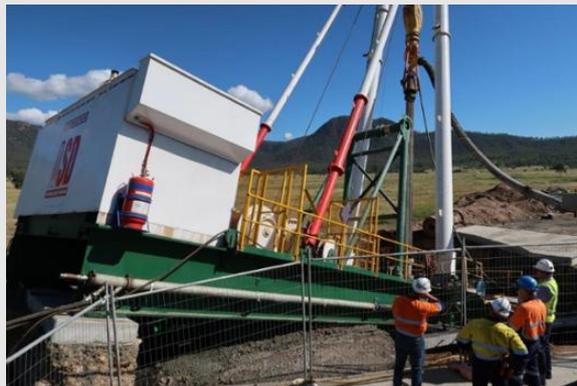
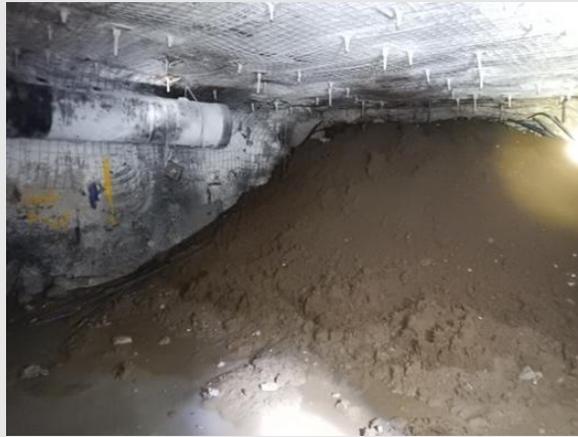
Dangerous incident
IncNot0037284
Underground coal
mine

While drilling contractors were drilling a ventilation shaft from the surface of an underground coal mine, they noticed a loss of return water from the shaft. Drilling was stopped.

It was identified that a bulkhead, installed underground to isolate the shaft construction from the mine workings, had failed. Further ground movement into the shaft void destabilised the drilling rig and platform, which partially collapsed into the collar of the shaft.

The Resources Regulator is carrying out a causal investigation with the cooperation of the relevant stakeholders. A preliminary report will be published soon.

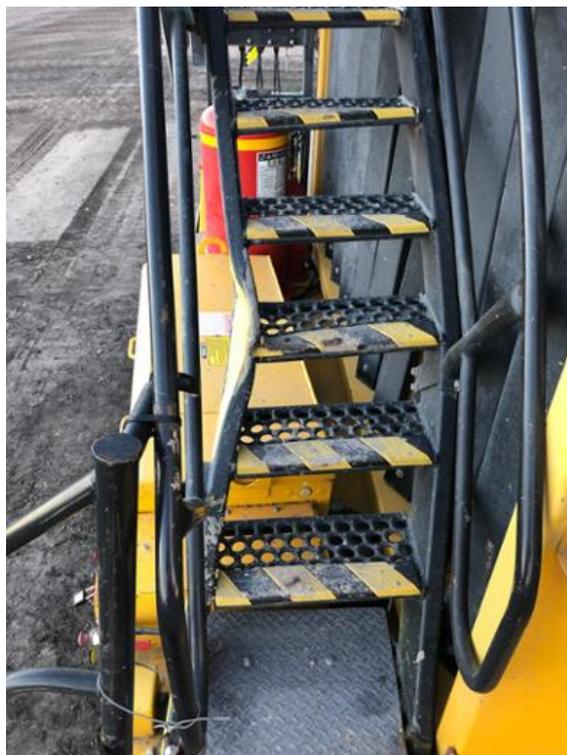
Dangerous incident
IncNot0037285
Open cut coal mine

A haul truck was parked in a loading queue with the headlights turned off because the light were distracting the excavator operator. Proximity lights on the truck remained on.

After a clean-up at the site, a dozer hit the haul truck on the left-hand side under the cab, damaging the ladder and bumper bar. Nobody was injured.

Neither operator reported the incident to the supervisor.

Dozer operators should always maintain situational awareness and pay attention to the movement and proximity of other machinery.

- [SB19-10 Dozer incidents increase despite warnings](#)
- [SB19-01 Rise in dozer incidents putting operators at risk.](#)

Incidents that cause harm to workers, or expose workers to serious risk, must be reported to the Regulator by law. Workers who do not notify supervisors of incidents may impede the work of the mine operator to manage the risk.

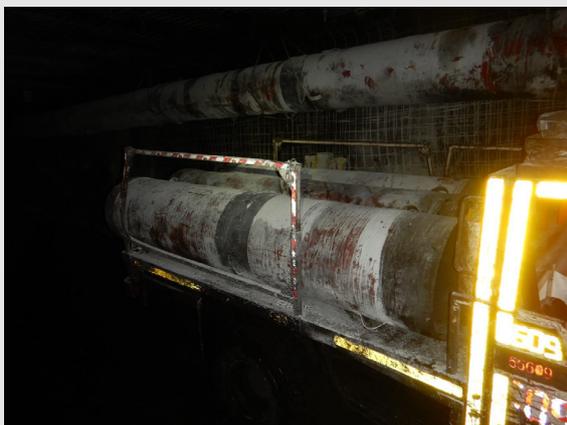
Serious injury
IncNot0037316
Underground coal
mine

A worker fell from the back of a ute while unloading ventilation tubes underground. There were three tubes on the tray. The worker was standing on top of an outer tube trying to remove the centre tube when the tube handle broke. The worker fell backwards over the side rail of the tray and onto the ground. The worker fractured his arm.

The mine's procedure for this task states that a maximum of two tubes are to be carried on the tray.

When a risk of falling is present, mine operators must assess the risk and minimise the risk of fall by providing adequate protection against falls.

Elevated areas that have not been identified as work areas/platforms must not be used as a work area.

When work situations vary from existing procedures, workers must identify the risk and implement additional controls.
