# INVESTIGATION REPORT

Serious injuries sustained by a worker at  
Cowal Gold Mine on 29 July 2018

First published: October 2020

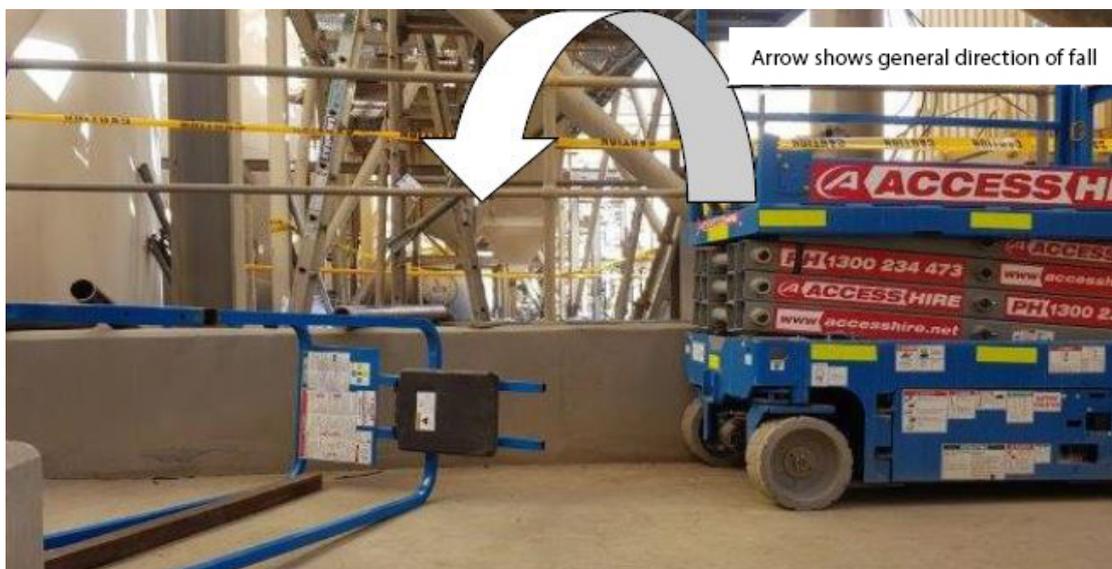
The worker crouched down on the scissor lift’s platform, which was in the stowed position. He began driving the scissor lift forward and under the angle brace using a wired control unit. As the worker did this, he lost his balance and fell forward. He fell over the front of the platform, taking the front guard rail that was resting on the platform with him. He struck his head on the concrete surface below him.

The worker was wearing a safety fall arrest harness, but it was not connected to the platform of the scissor lift. It is reasonably likely that if the worker’s harness had been connected to the rear anchor point of the scissor lift, via a suitably adjusted lanyard, he would not have fallen over the front of the scissor lift. However, the harness would not necessarily have prevented a fall over the side of the scissor lift. The investigation found that had the workers walked the scissor lift under the steel support, this incident would have been prevented.

*Figure 1 Direction of fall and guardrail on ground*

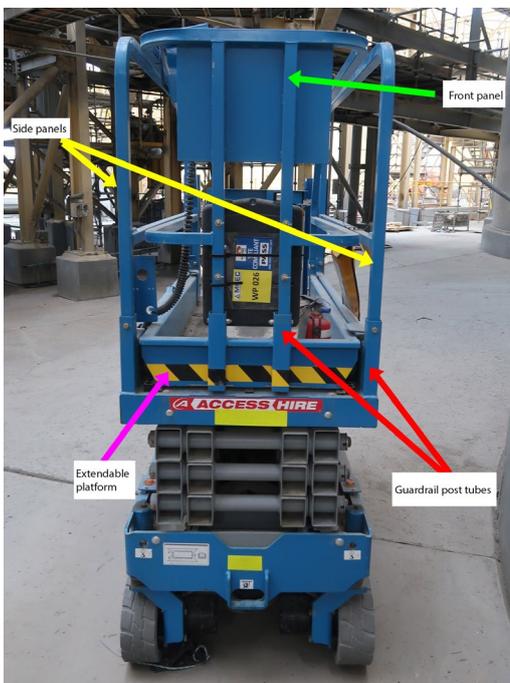
Figure 3 Guardrail and extending platform of scissor lift

The side panels were joined by nuts and bolts. The front panel was bolted to the extension platform. The posts of the guardrail panels were secured by bolts to metal tubes welded to the platform. The bolting system used was 3/8 by 2.75-inch bolts, washers and lock nuts. The manufacturer stated that it did not use a more permanent method to fix the guardrail in order to allow maintenance and repairs to be performed with hand tools. It stated that it did not intend for the guardrails to be removed during normal operation.

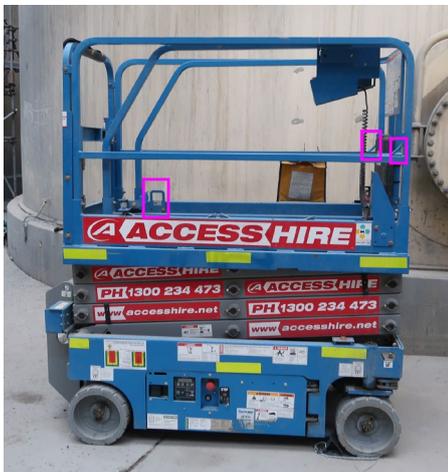
Figure 5 Personal fall protection anchor points on scissor lift

The platform of the scissor lift was equipped with three anchor points where personal fall arrest harness lanyards could be attached. The two anchor points fixed to the mid-rail of the guardrail were not labelled, but the anchor point fixed to the toe board of the extension panel was.

The worker was wearing a safety fall arrest harness, but it was not connected to the platform of the scissor lift. It is reasonably likely that had the worker's harness been connected to the rear anchor point of the scissor lift via a suitably adjusted lanyard, he would not have fallen over the front of the scissor lift. However, it would not have prevented him falling over the side of the scissor lift.

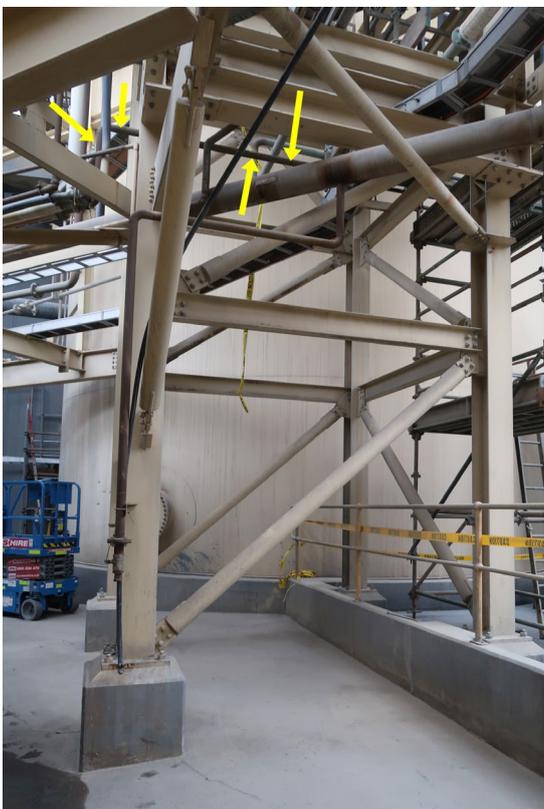
The pipe was required to be installed across a structure consisting of four braced columns, spaced 3.0 metres apart. The scaffolding shown on the right side of Figure 9 had already been installed to provide access to various levels, but not specifically for this task.

*Figure 9 Required location of pipe within structure*

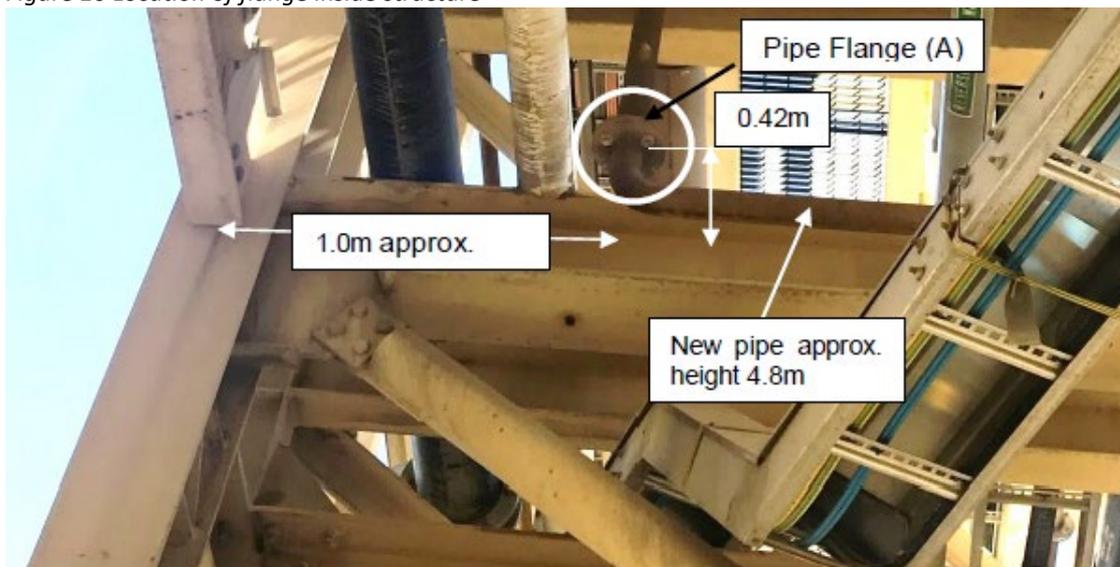
It is extremely unlikely that the tasks of rigging and fitting the pipe could have been completed with the scissor lift positioned outside the structure. One of the pipe flanges was located about one metre inside the structure, making it almost impossible to position and connect it from the outside. Also, the existing pipework inside the structure would have blocked access from the outside.

*Figure 10 Location of flange inside structure*

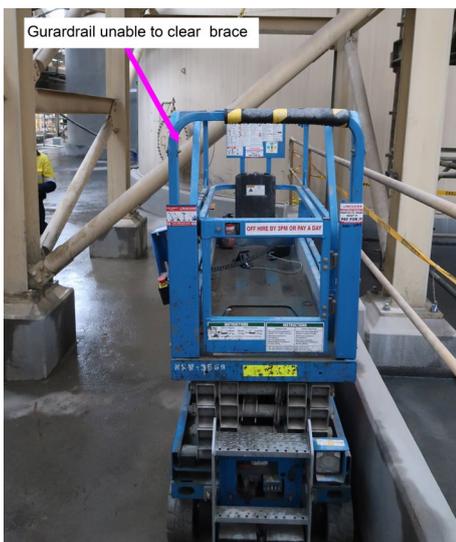
Figure 12 Approximate location of scissor lift when the worker attempted to move it under the brace

However, as shown in Figure 12, the scissor lift was too high to fit under the angled brace between the poles on the western side of the structure. The workers did not advise anyone of their inability to move the scissor lift inside the structure.

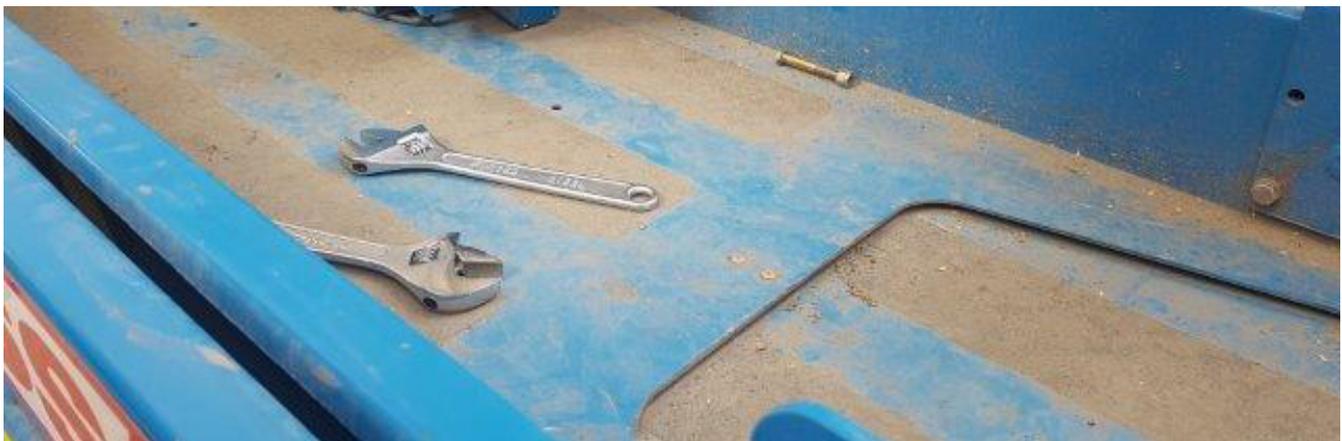
The front guard rail was moved a short distance to the right; away from the lower portion of the angled bracing. It was rested on the front edge of the platform of the scissor lift and held in place only by its own weight.

*Figure 13 Platform of scissor lift showing removed bolt and shifting spanners*
