# WEEKLY INCIDENT SUMMARY

Week ending Friday 9 July 2021

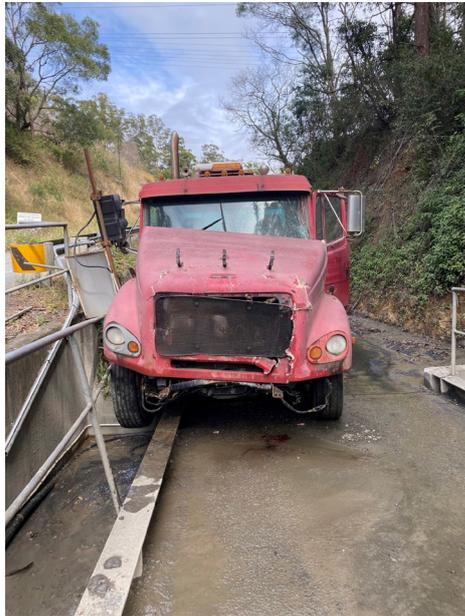
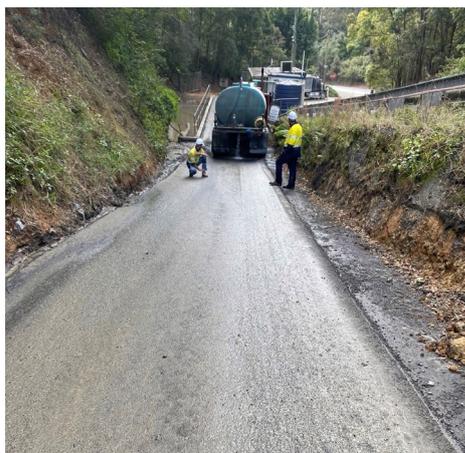
INCIDENT TYPE	SUMMARY	COMMENTS TO INDUSTRY
Dangerous incident IncNot0040269 Surface mine	A watercart passed through the site wheel wash enclosure and travelled down a sealed asphalt ramp towards the weigh bridge. The watercart was spraying the ramp to remove a build-up of dirt and silt that had dropped from vehicles using the ramp. The operator lost control of the watercart and tried to brake and steer it into the bank but couldn't stop. It then collided with a truck and dog trailer waiting on the weighbridge. The operator had mistakenly assumed the truck was in the process of exiting the weighbridge when he began his descent. The traffic control lights for the ramp were inoperable at the time. There were no injuries.	Mine operators should ensure traffic control devices are working as per design. Vehicle operators should always seek positive communication and should never assume the movement of another vehicle. Operators are reminded to always drive to conditions.
