# Investigation report

## **Investigation into the serious injuries sustained by a delivery truck driver at Tasman mine on 7 December 2011**

Extract of report prepared by the  
NSW Mine Safety Investigation Unit

Report date: 27 May 2013

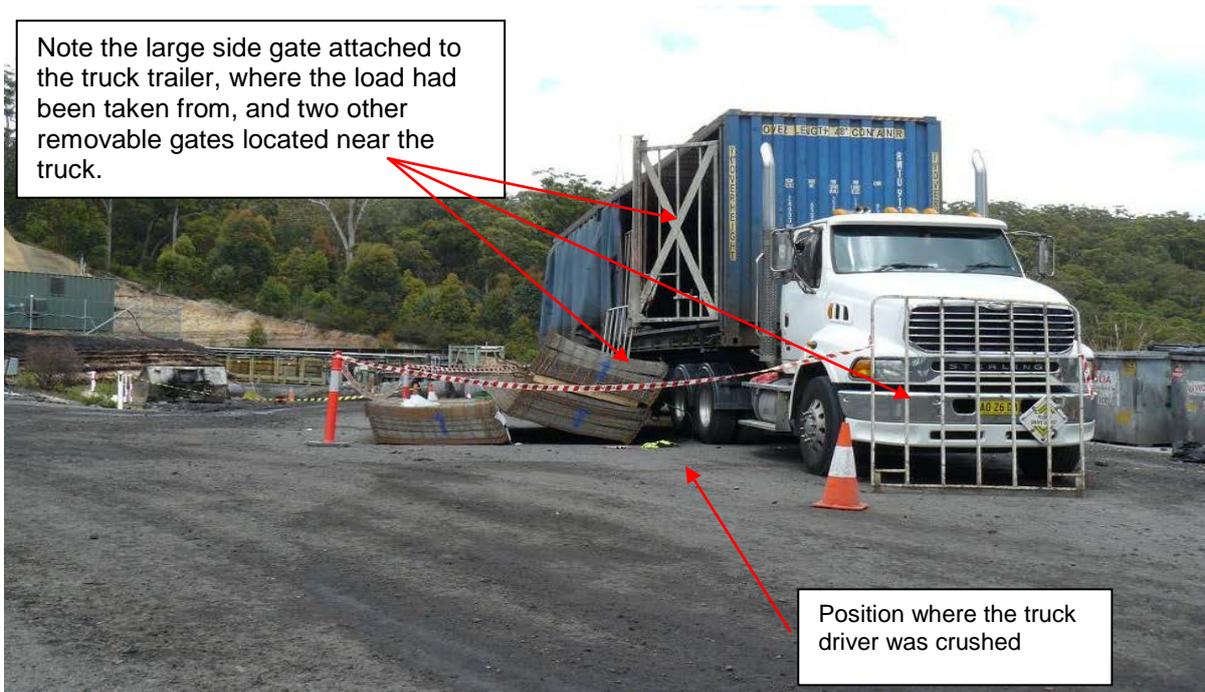
The deputy was using the forklift function of the telehandler when the mesh load slipped from the forklift tines and crushed the truck driver between the mesh, the truck and the ground.

**Figure 1:** Incident scene showing the position of the truck and the mesh bundles that crushed the truck driver. <sup>1</sup>

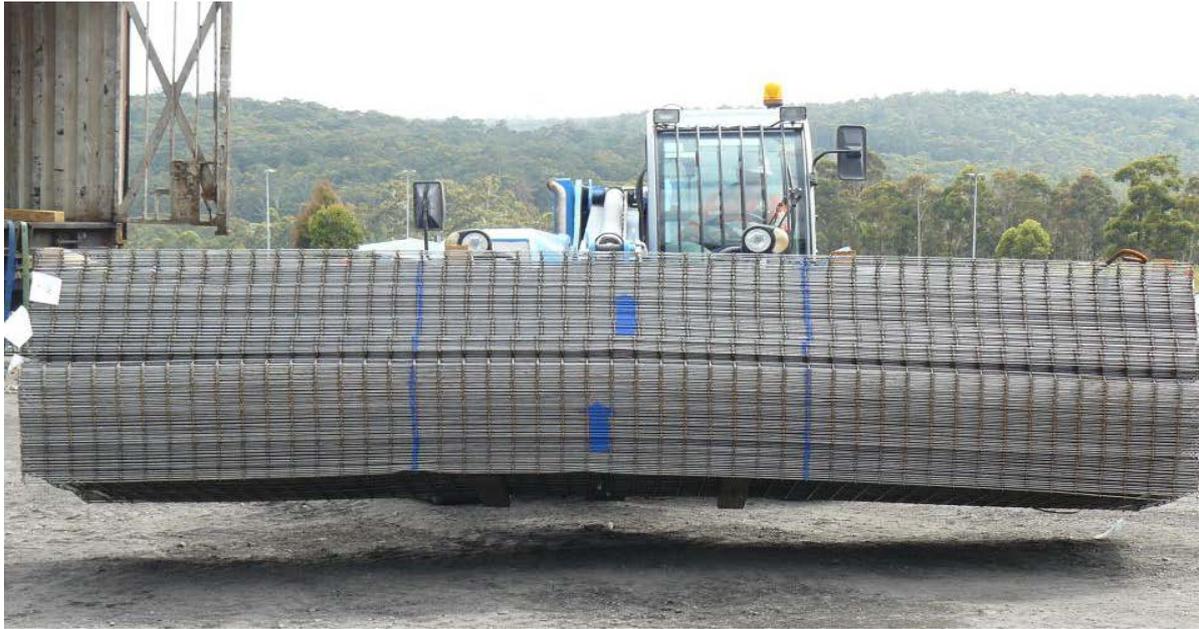
**Figure 3:** Telehandler carrying two bundles of mesh.

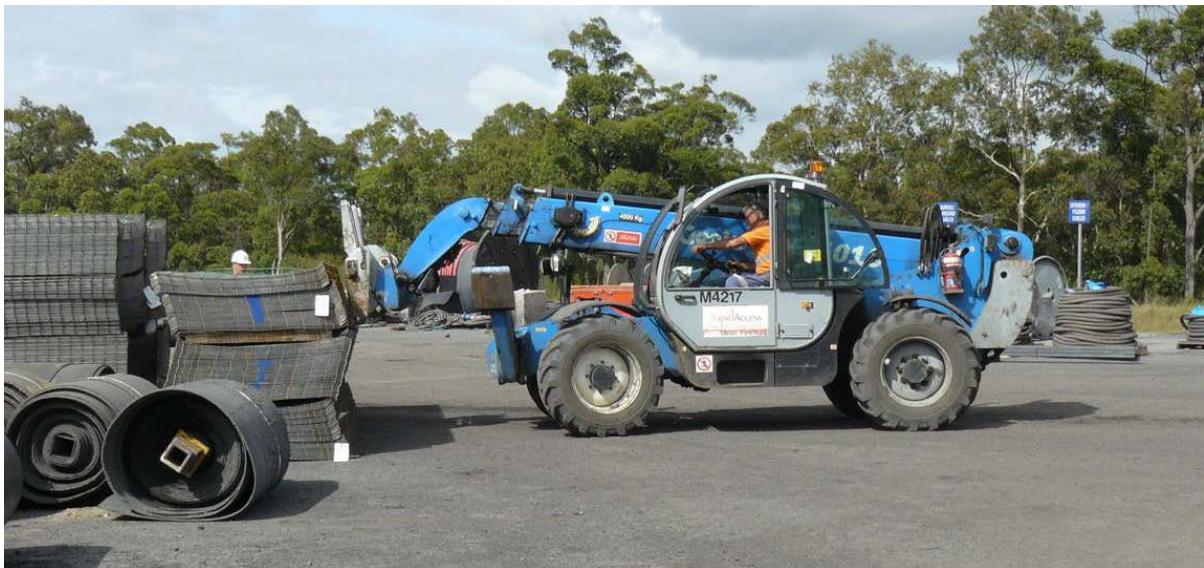
**Figure 6:** The telehandler that was being used to unload the mesh when the truck driver was injured.

The telehandler was tested after the incident for faults by the OEM. Some minor defects were found unrelated to the machine's lifting capacity. It is unclear if the defects were evident in the machine at the time of the incident.

Nevertheless, it would appear that the telehandler was working close to or at design specifications at the time of the incident and there is no evidence to suggest that there were any significant faults with the operation of the telehandler.

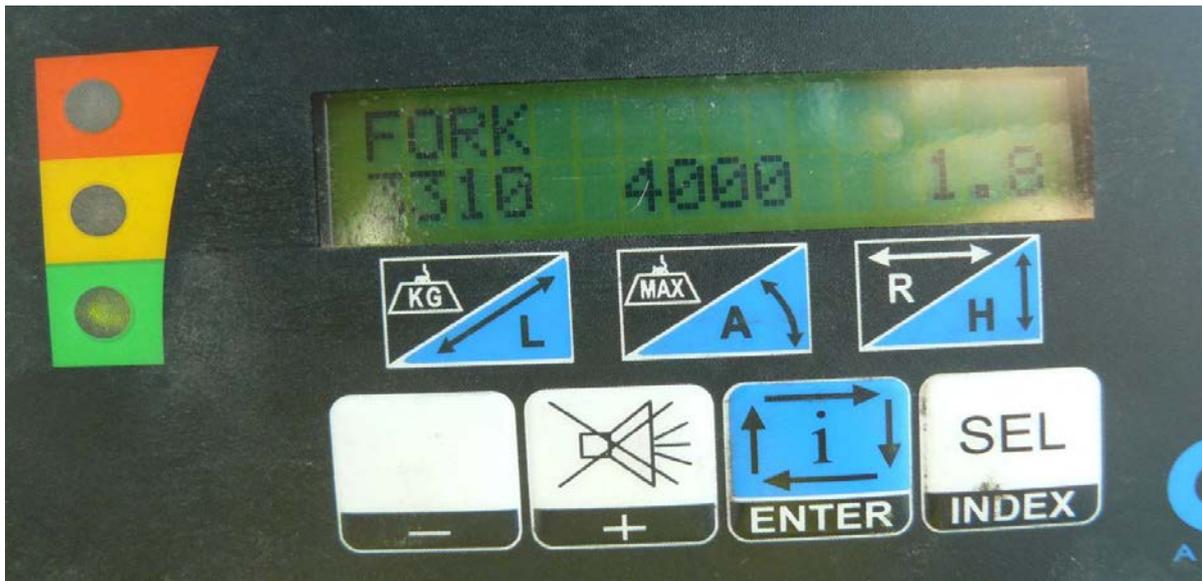
**Figure 7:** Operating panel inside the telehandler showing the three indicator lights that operate when the machine is lifting a load.

The green light on the left at the bottom indicates that the lifted load does not exceed 90% of the maximum allowable load at the given boom position.

The amber light indicates that the lifted load exceeds 90% of the maximum allowable load but is still less than 100%. An audible beeper emits an intermittent sound when this condition is reached.

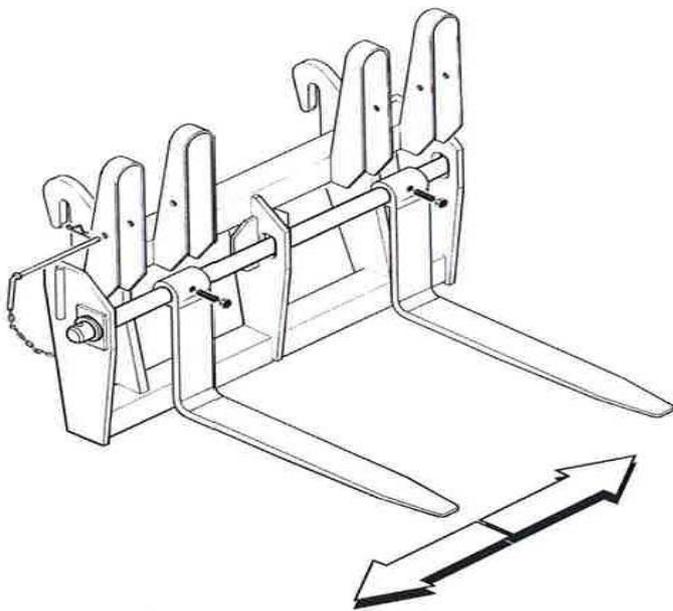
Another aspect of the operation of the telehandler is the setting of the width of the tines. Depending on the type of load to be lifted the two steel tines of the telehandler can be moved. This is achieved manually with the operator alighting from the telehandler and sliding the tines into position. According to the yardman, whenever he was loading the mesh he had the tines at their widest setting. According to the deputy he adjusted the forks to their widest setting immediately before he started unloading the truck. Figure 8 shows the fork attachments for the telehandler.

**Figure 8:** Diagram of fork attachments for the telehandler.<sup>14</sup>

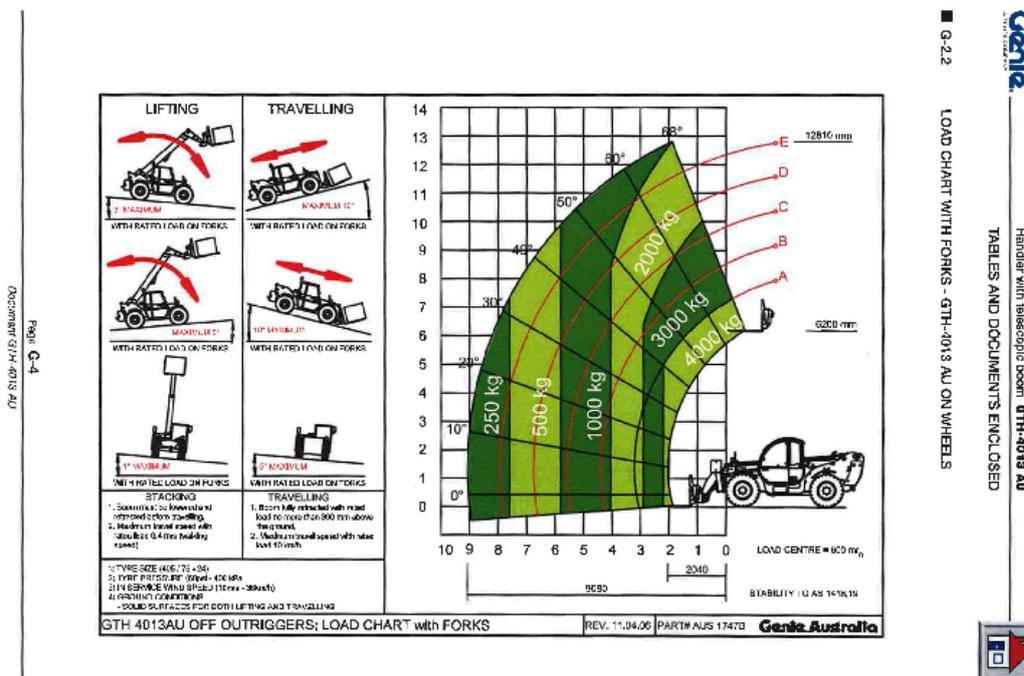
Figure 9: Load chart with forks- GTH- 4013 on wheels.

Figure 9 is the load chart for the telehandler that shows any extension of the load centre will dramatically reduce the maximum lifting capacity of the telehandler. Less than half a metre extension of the centre of the load will reduce the maximum capacity of the telehandler by one tonne.

When the deputy attempted to lift the three mesh bundles the telehandler would have exceeded or have been very close to exceeding the maximum lifting capacity of the telehandler.

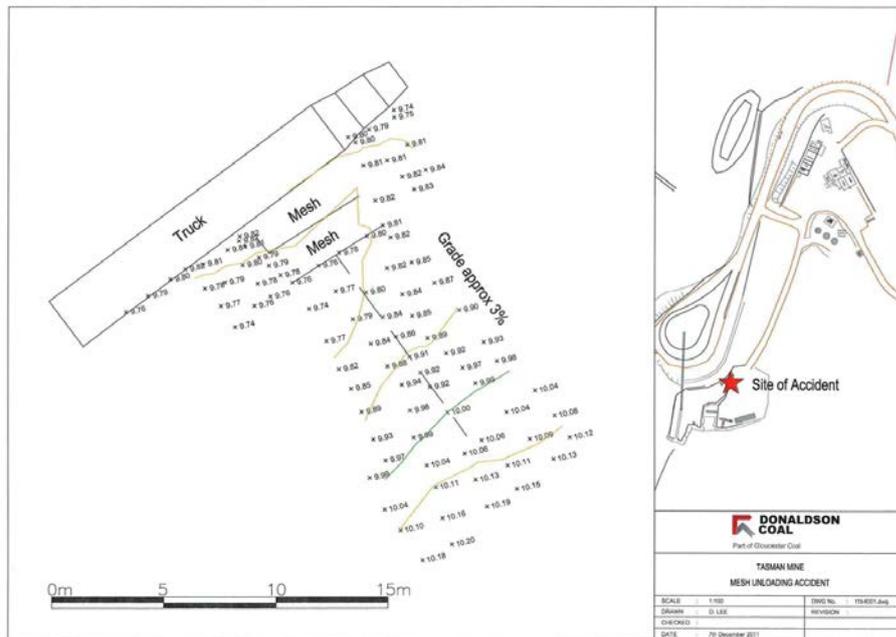
The designated unloading area is in the middle of the main access road into the mine's underground workings. This location is not level nor is it sealed or concreted but is constructed of a compacted material. The site is not clearly marked as the unloading bay nor is it signposted with any instructions for those charged with the responsibility of unloading the mine's supplies. The yardman considered the site as the best location available to unload. The surface part of the Tasman mine is confined by a number of arbitrary boundaries and there is not a great deal of room on the surface of the mine for infrastructure. Accordingly the location of the unloading bay for larger trucks and loads at the mine has been included as part of the mine's roadway and surface transport system.

**Figure 10:** Survey plan of the incident scene and Tasman mine surface installations.
