# MINE SAFETY INVESTIGATION UNIT

INFORMATION RELEASE

## Serious injury

<b>Incident date</b>	22 January 2016
<b>Event</b>	Severe head laceration from damaged roof support strap
<b>Location</b>	Mannering Colliery, Mannering Park NSW

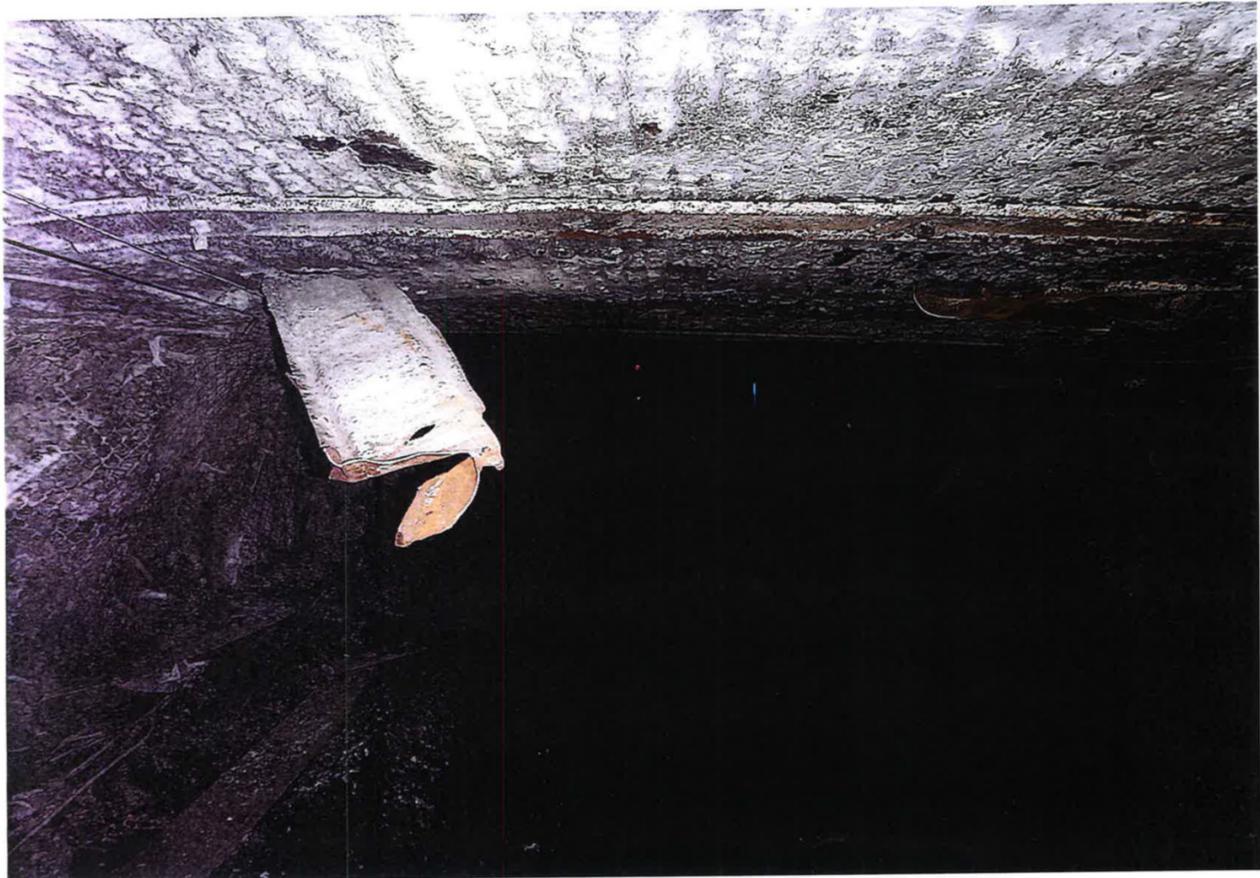
An operator was driving a load haul dump vehicle (LHD) when a damaged roof support strap (W Strap) that was hanging down into the roadway entered the LHD cabin and struck the operator's head near his left eye. The operator received a severe laceration to his head that needed medical treatment.

Photograph of the damaged W Strap hanging down into the roadway. *Photograph taken by the mine.*

As he entered the Sump Road the operator was travelling at low speed (second gear) as the roof was low in this section of the mine. The operator did not see a damaged W Strap hanging from the roof in the Sump Road as he was concentrating on following the other vehicle. As the operator drove the LHD forward the W Strap entered the open driver's cabin striking the left-hand side of his head near his left eye. The operator suffered a severe laceration.

The damaged W Strap was made safe and the road height increased by excavating the floor (roadway).

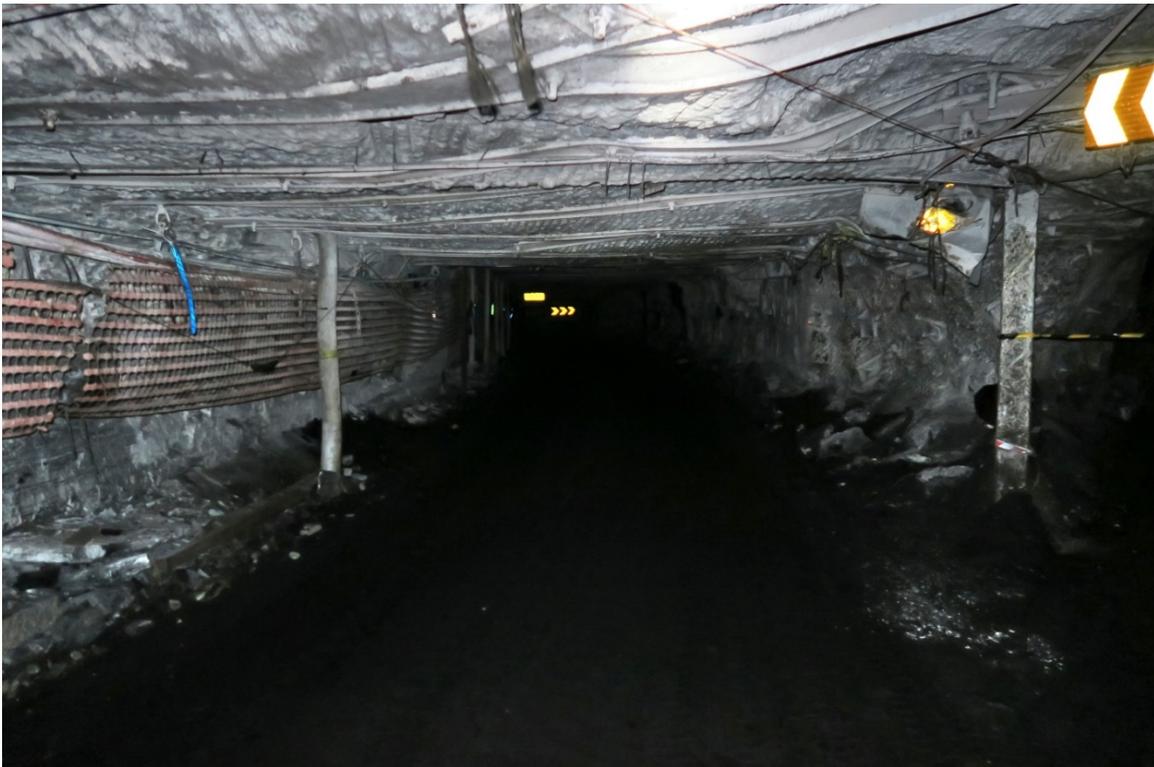
The roof support where the incident occurred consists of steel roof support straps, known as W Straps, in conjunction with roof bolts. The W Straps are fixed to the roof with bolts. The straps often distort to conform to irregularities in the roof. The W Straps are positioned on the roof perpendicular to the roadway direction and are spaced about one metre apart.

Photograph of roof support straps (W Straps) in the travel roadway. *Photograph taken by investigators.*
