COLLISION BETWEEN SEMI-AUTONOMOUS DOZER AND AN EXCAVATOR

Causal investigation

Published by NSW Resources Regulator

First published: October 2019

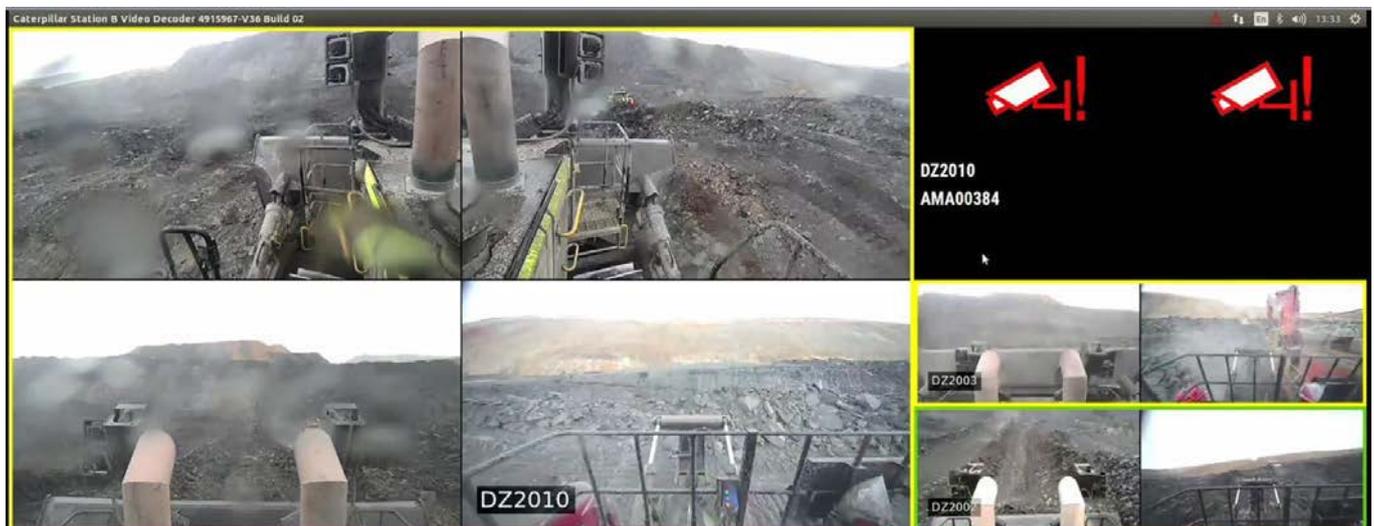
Figure 1 Overview of the SATS operator camera display screen immediately before the incident

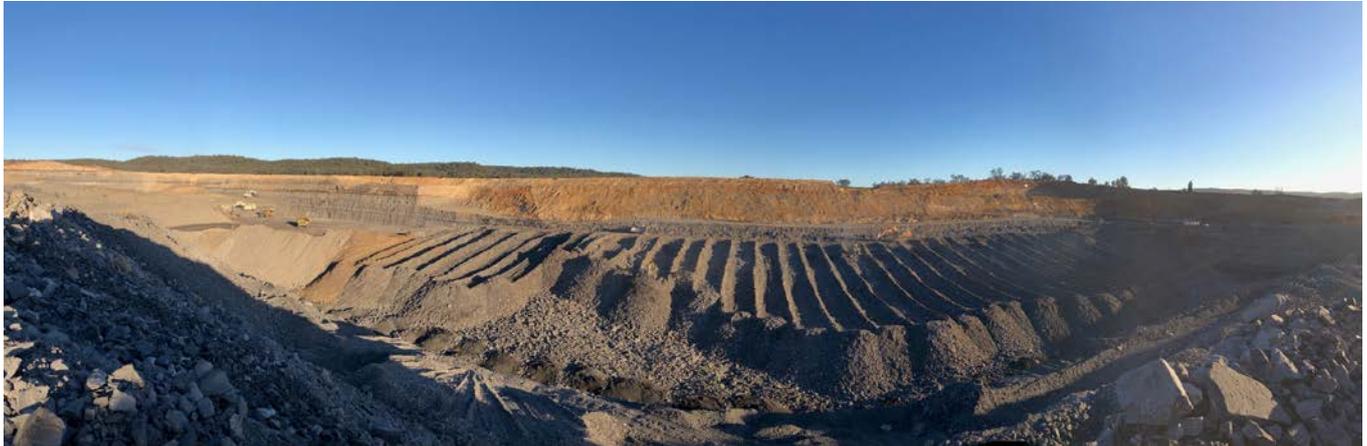
At the time of the incident, the strip being mined included an established avoidance zone that was approximately 300 metres long, 135 metres wide and consisted of 30 slots.

Figure 2 Overview of the SATS operational area on the morning of the incident

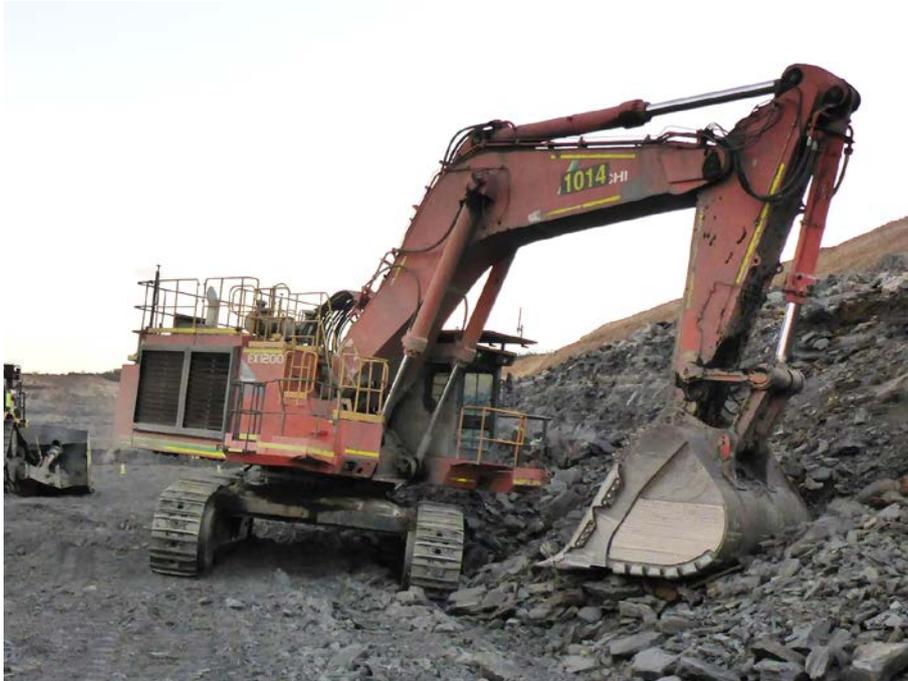
The excavator was not fitted with the Caterpillar MineStar system. At the time of the incident, a Leica MineOPS system was fitted but was inoperable due to a damaged boom sensor. With both avoidance systems non-operational, the location of the manned excavator was not visible to either the SATS dozers or the SATS operator.

Figure 4 The Hitachi hydraulic excavator

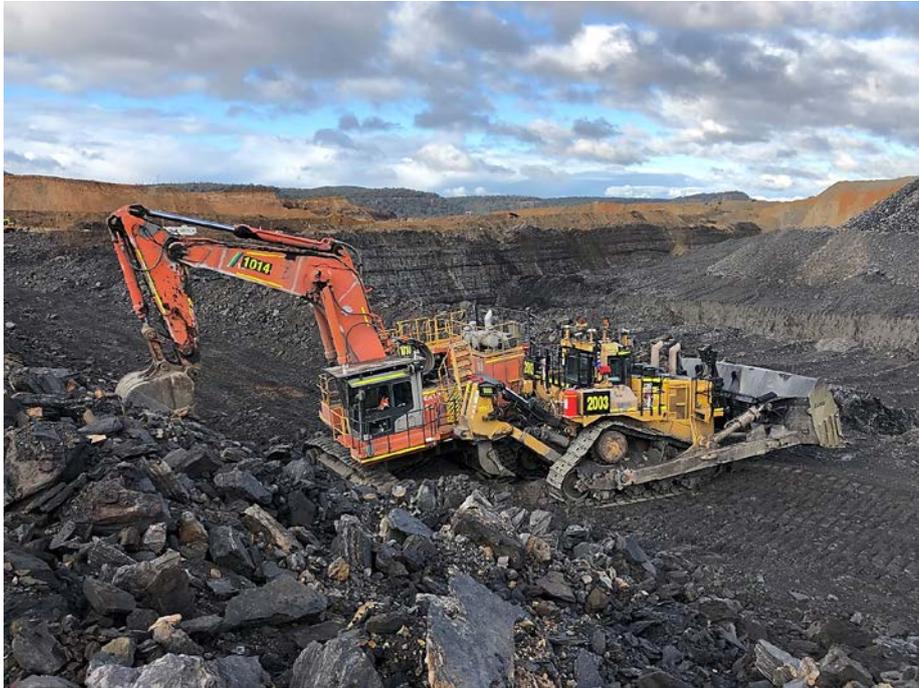
Dozer DZ2003 had completed a push and was reversing towards the rear of slot 16 to start the next push. At this time the excavator proceeded past the windrow, into slot 16. About 1.40pm, dozer DZ2003 hit the rear of the excavator. When initial contact was made, the excavator was pushed about 1.5 metres sideways, into the base of the highwall. The excavator then stopped sliding and dozer DZ2003 continued to tram in reverse, colliding with the excavator multiple times trying to reach its programmed GPS coordinates.

Dozer DZ2003 eventually lost traction and after five seconds, the control system faulted and stopped tramping. From the initial contact to dozer DZ2003 stopping was about 14 seconds. The excavator had some damage however the operator was uninjured.

Figure 8 The incident scene immediately following the collision

All SATS dozer operations were initially paused and then shutdown following the initiation of the emergency response. The collision damaged the platform access ladder on the excavator resulting in the excavator operator being unable to safely exit the machine. A rescue plan was developed and the Regulator was notified of the incident.

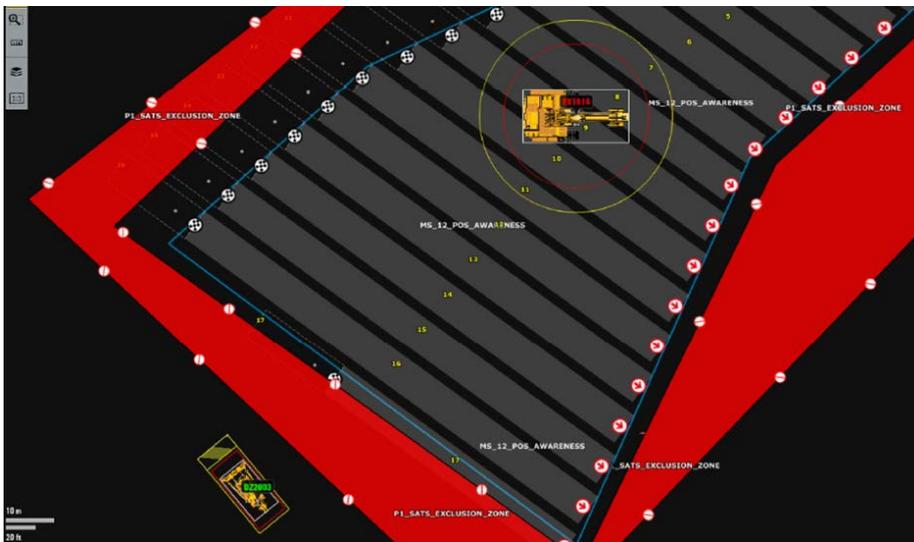
Figure 9 Caterpillar MineStar system displaying the alarm and trip proximity boundaries for the excavator and dozer DZ2003

As a result of the investigation, the mine installed a proximity awareness system and an autonomous stop system to the excavator involved in the incident. This additional system functionality allows the control systems of SATS dozers and the excavator to track the real-time location of each machine and apply virtual proximity boundaries through high precision GPS.

These proximity boundaries automatically alert and initiate a proximity stop of any SATS dozer that encroaches within a set radius of the manned excavator. From the centre of rotation on the excavator, a yellow alert boundary is set at 25 metres and a red proximity stop boundary is set at 20 metres. Alternatively, the manually operated excavator will receive an alert and apply a proximity stop on a SATS dozer when the manually operated excavator encroaches within an active dozer slot.
