WEEKLY INCIDENT SUMMARY

Week ending Friday 29 November 2019

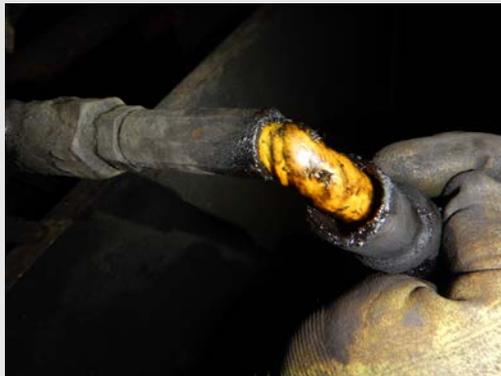
While checking the chain tension on the AFC, at the tail gate of a longwall, a hose to the Porta-power burst. A fitter, who was approximately 30 centimetres away, was hit on the left wrist and hand through his overalls and cut 2 rated gloves.

The mine adds a fluorescent dye to hydraulic oil. When exposed to blue light, the dye glows, indicating the presence of oil. The blue light was used to confirm a fluid injection injury and the worker was transported to hospital. During surgery, the blue light was also used to minimise the extent of the surgery.

The Porta-power had previously been damaged.

All portable tools should be subject to pre-use inspections and used by trained competent persons.

Workers are to be instructed not to use equipment that has been damaged or that could affect safety.

Workers should be reminded to position themselves out of the line of fire when completing tasks that involve high pressures.
