INVESTIGATION REPORT

REPORT INTO THE DEATH OF MR QUINTON MOORE

Title: Report into the death of Quinton Moore at Bengalla mine 3 November 2018

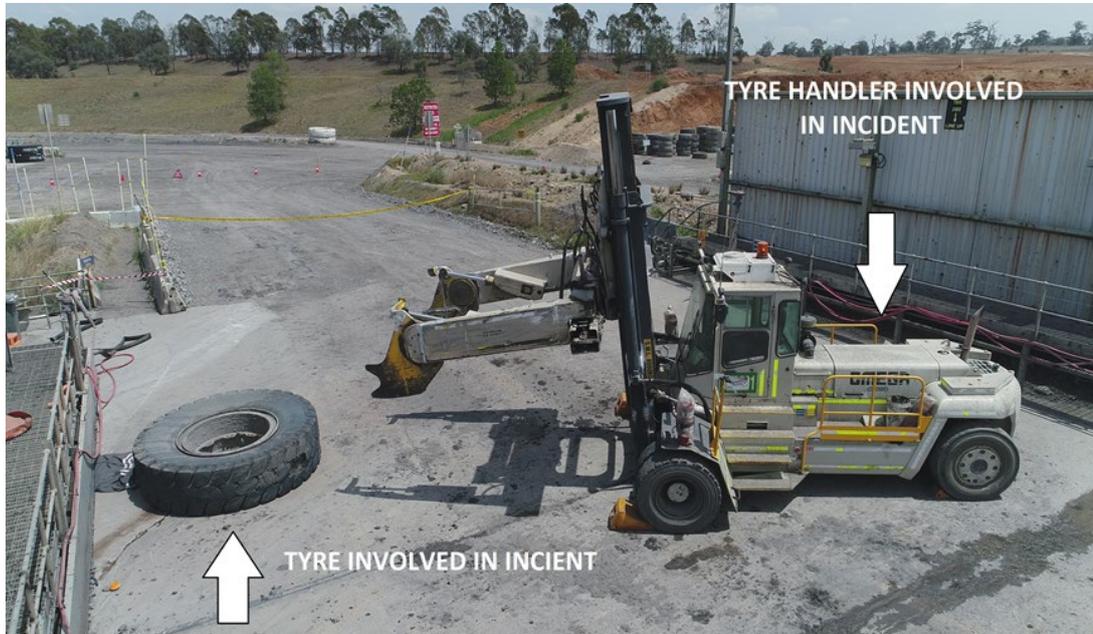
Figure 3 Omega tyre handler THL001

The plant involved in the incident was an Omega lift truck model 16-12TH, designed and manufactured by Clark. It was fitted with an attached 16 – 1200 tyre handler model 176HDT21I (refer to figure 3) which was designed and manufactured by Cascade. The lift truck was identified by the mine as THL001. The tyre handler is owned by the mine and was purchased from Clark in 2005.

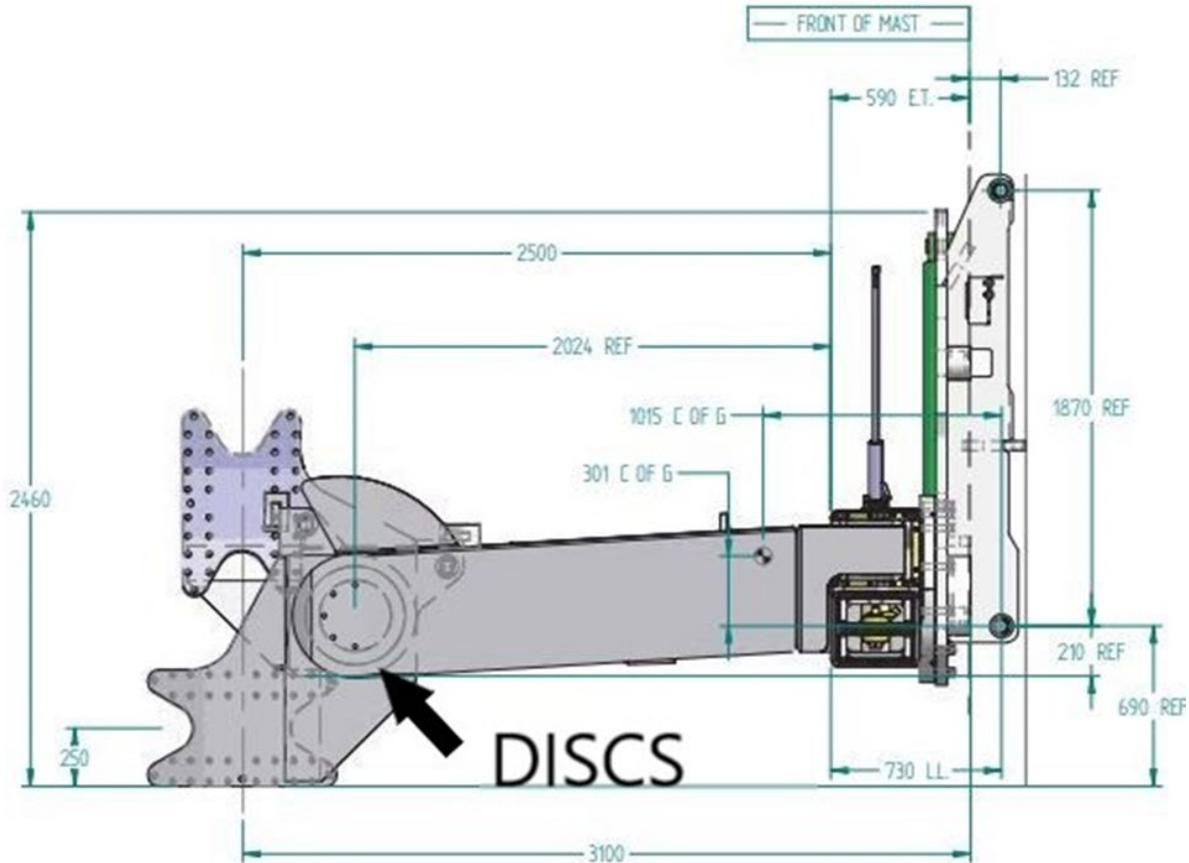
Figure 7 Grabs on tyre handler THL001

The grabs (refer to figure 7) are capable of rotating 90 degrees. The tyre handler attachment, including the grabs, are hydraulically operated. They have a lifting capacity of 8,000 kilograms. The tyre handler was last serviced by Crowne on 9 August 2018, with no repairs or rectifications being reported. In 2008, the grabs and teeth supplied by the OEM were changed by the mine to the grabs and teeth on the tyre handler at the time of the incident. The mine was unable to identify or locate any documentation regarding why or who made these modifications.

Responsibility for checking the teeth on the grabs rested with the tyre handler operator and was recorded in the tyre handler’s prestart book prior to operation. In September 2018, workers reported issues with the grabs not rotating in sync, and in October 2018, eight days prior to the incident, workers were required to tighten the hex screws to the discs of the grabs after they became loose. The use of the tyre handler is supported by an operation and maintenance manual. Tyre handlers were not to be parked on a grade, without wheel chocks being applied. A copy of the operator safety warning plate, located inside the cabin of the tyre handler stated, ‘no person should stand or pass under load of lifting mechanism.’ Instruction No. 19 provides that the lifting mechanism should be fully lowered and wheels chocked when leaving the tyre handler. It warns a failure to follow these instructions can cause serious injury or death.

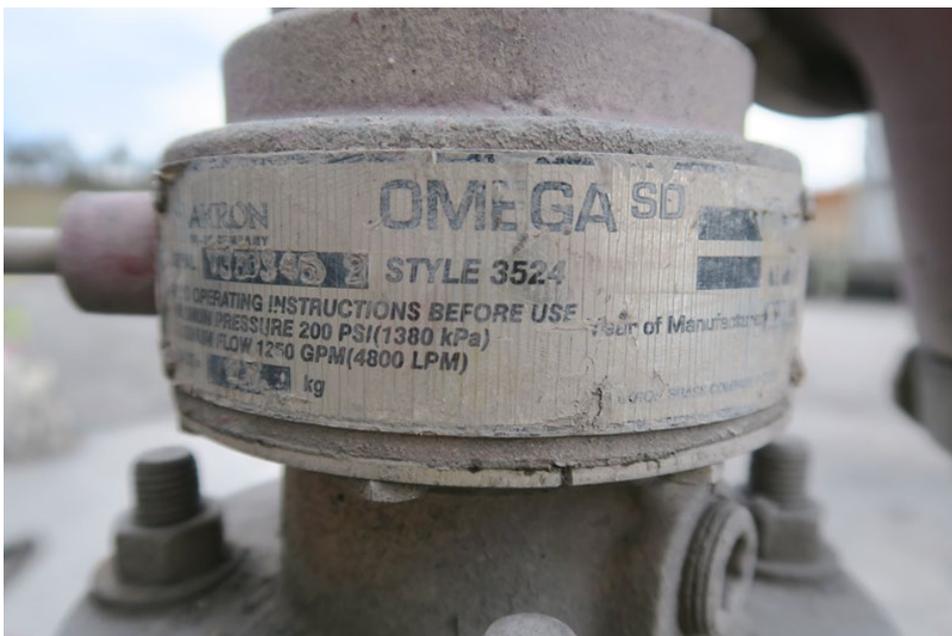
Figure 11 water cannon operating instructions

There was no specific induction for workers to operate the cannons despite the following warning, 'Read operating instructions before use'.

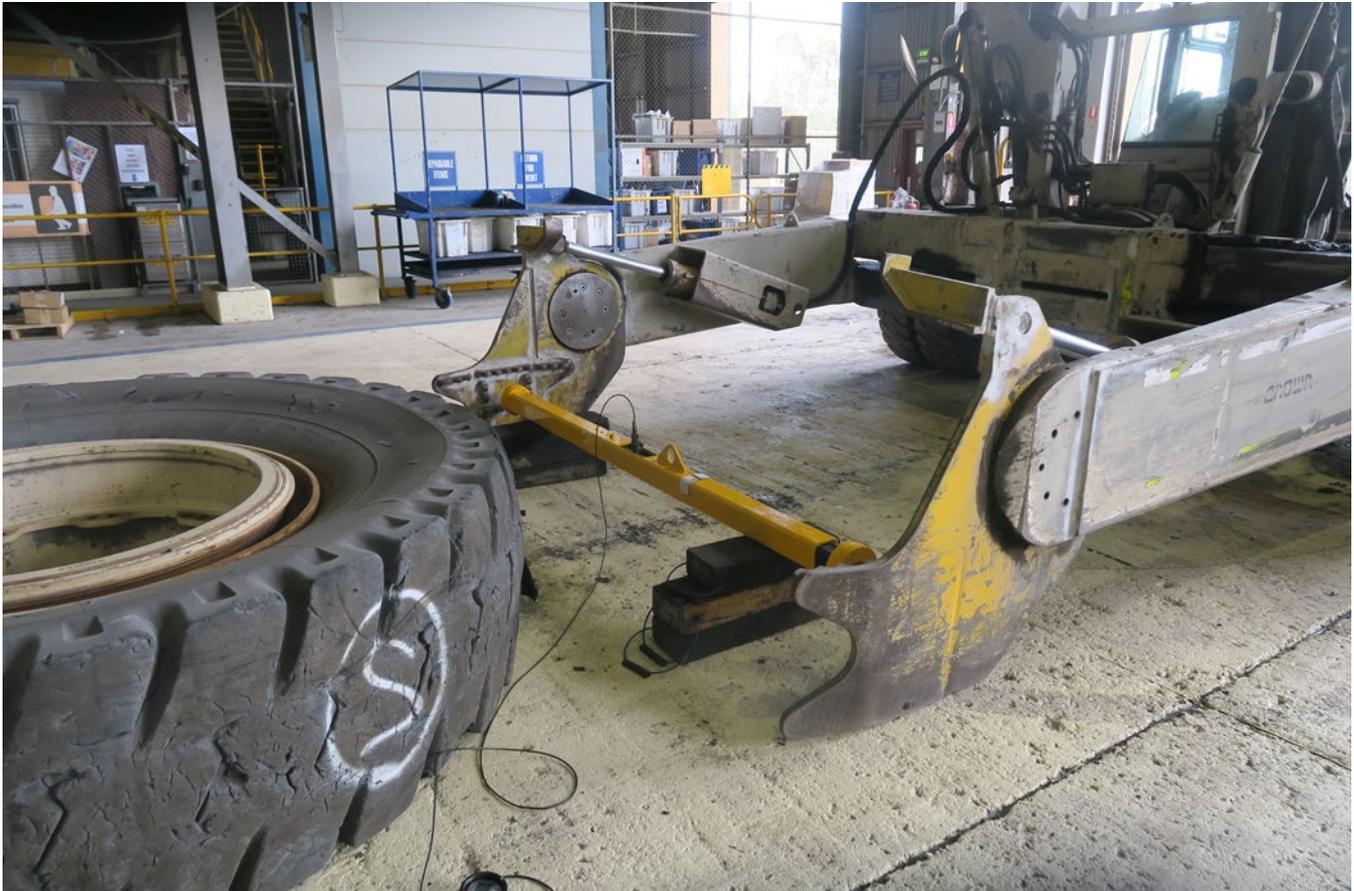
Figure 14 Clamp force pressure test on THL001 by Cascade

The hydraulic auxiliary circuit at the valve bank, which controls the Cascade tyre grab attachment, was tested. The oil pressure supplied by the lift truck should be approximately 210 bar (3050psi), however, it was only measuring 148 bar (2046psi). This resulted in a clamp force cylinder pressure of 123 kilonewton. The likely cause of this was reported to be either a defective/incorrectly fitted relief valve or pump wear.

Cascade's report concluded hydraulic pressure supplied to the grab attachment was not likely to be a potential cause of the tyre dislodging from the grabs.

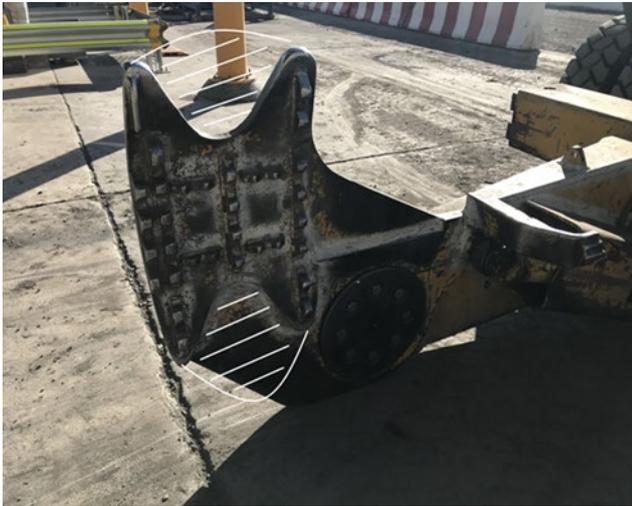
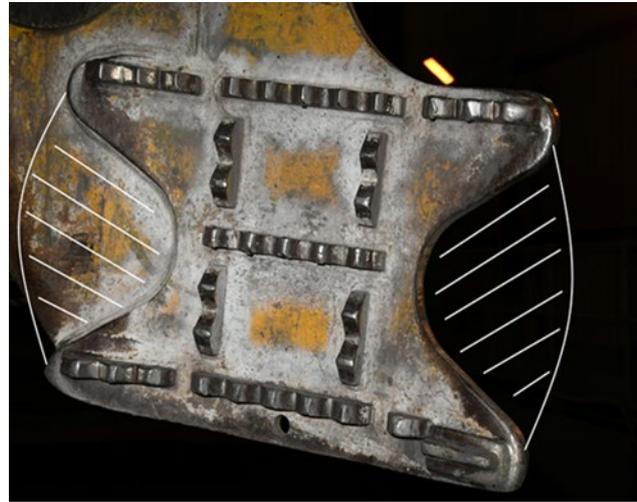
Figure 20A & 20B Grab of tyre handler from M04 and grab from tyre handler THL001

The grabs on tyre handlers (refer to figure 20A and 20B) owned by the mine were fitted with the same shaped OEM grabs referred to in the ACARP report, however, the teeth pattern was found to be modified. The area represented by shaded white, indicates the portion of the grabs, with what the report claims, reduces a grab's gripping surface area on tyres.

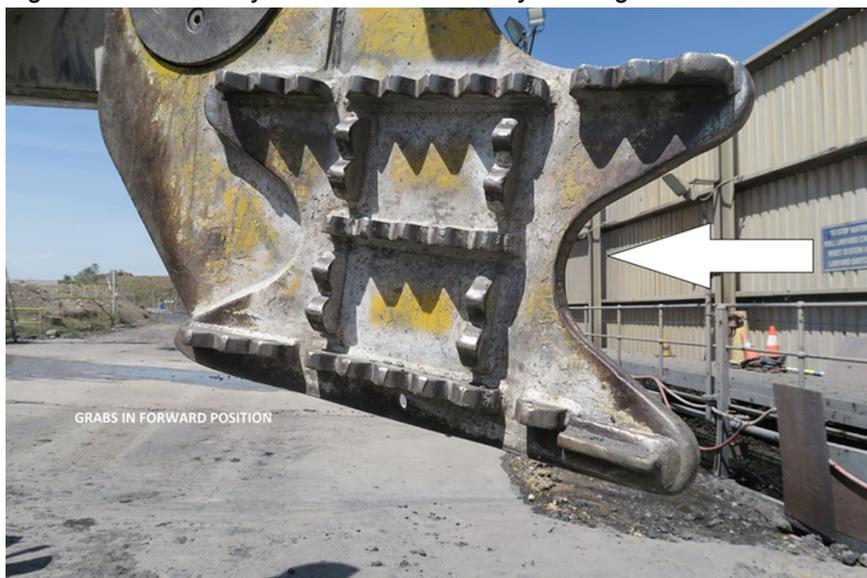
Figure 25 Grabs on tyre handler as found by investigators

The report noted the current OEM of the grabs, Cascade, declined to participate in the study. During an examination of the scene, the tyre handler grabs were found to be in the horizontal position as shown in figure 25.

Information received during the investigation identified neither the mine, Marathon Tyres or Cascade Australia, prescribe an orientation the grabs should be in while handling tyres either vertically or horizontally. This was left to the determination of operators.

The ACARP report suggests grab orientation when handling tyres may affect the ability to retain a tyre within the grabs. If CMP Engineering's theory of preferred grab orientation is applied, it is reasonable to conclude the orientation of the grabs at the time of the incident did not provide the highest level of support. However, the investigation was unable to determine if this materially contributed to the tyre falling from the grabs.

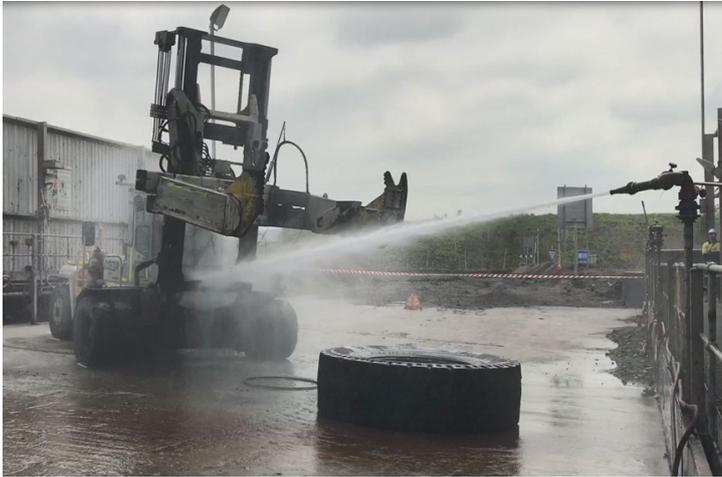
Figure 26 Photo of tyre location after falling from grabs during test 1

The tyre was horizontally positioned in the grabs and rotated to the vertical position (opposite position as found by investigators at the time of the incident). The tyre was then exposed to high pressure water. The test resulted in the tyre falling from the grabs (refer to figure 26).

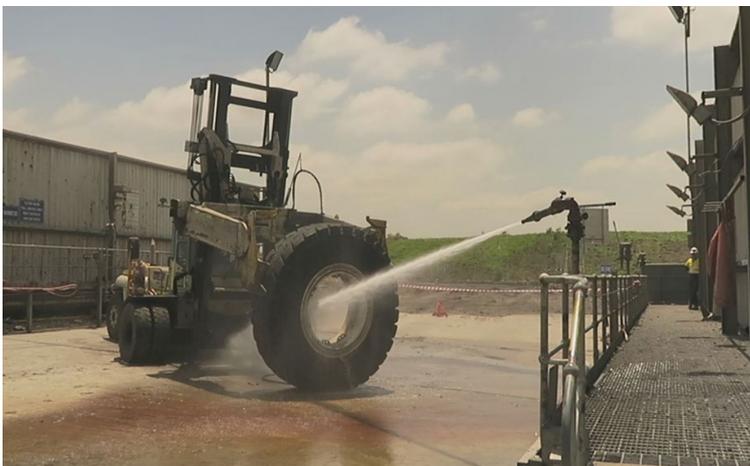
Figure 27 Photo of tyre location after falling from grabs in test 2.

Test 2. The tyre handler was repositioned as per test 1. The tyre was held with the grabs in the horizontal orientation as found following the incident. The tyre was then subjected to high pressure water from the cannon for a period not exceeding three minutes. The tyre fell from the grabs, however the tyre remained horizontal after catching on the teeth of the grabs (refer to figure 27).

Data logging measured during the tests identified that when the hands of the grabs were set at the distance measured by investigators after the incident, between 20 and 30 kilonewton (kN) of pressure was applied to the tyre. When the experienced operator assisting during the tests was asked to subjectively secure the tyre, the pressure applied was measured at 70kN, almost double the force.
