SAFETY ALERT

Elevated work box falls from integrated tool carrier

CM9 reference	DOC21/23994
Mine safety reference	SA-21-01
Date published	27 January 2021
Authorised by	A/Chief Inspector Office of the Chief Inspector

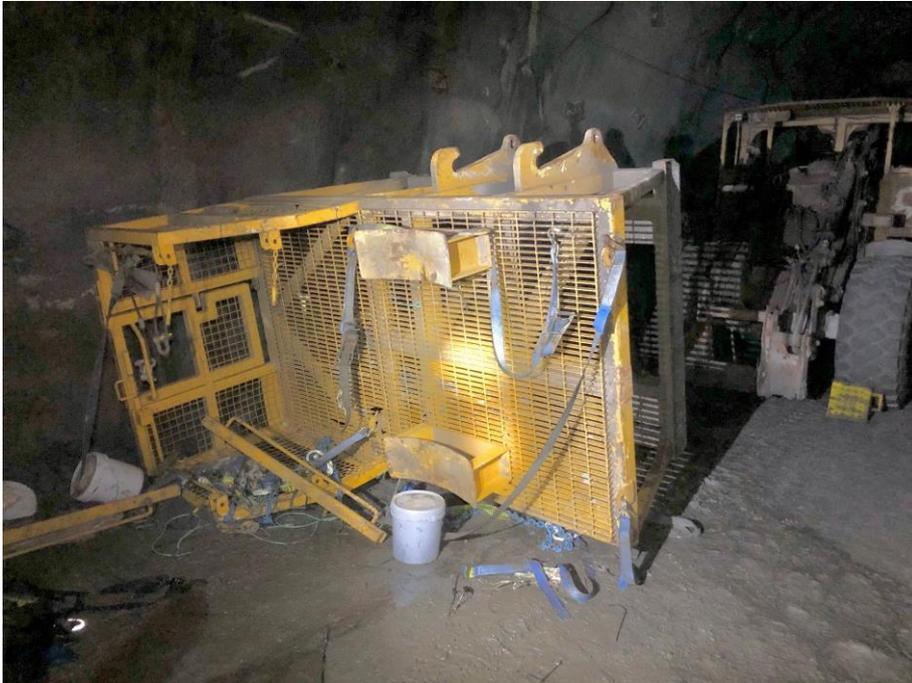
The fan was raised and secured to the roof (backs) before the work box was partially lowered. During this lowering, the work box has detached from the IT and fallen to the ground. Upon hitting the ground, the work box rolled 90 degrees onto its side, ejecting the two workers.

Figure 1. Workbox on its side with integrated tool carrier in the background

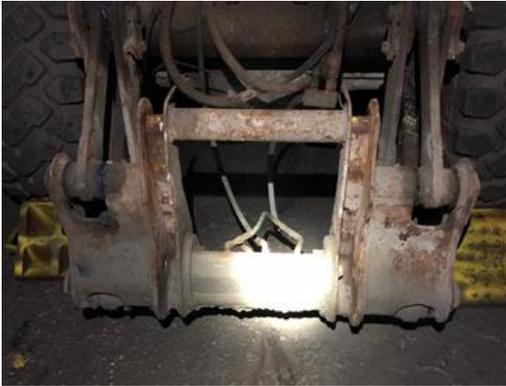
Figure 2. IT workbox attachment point

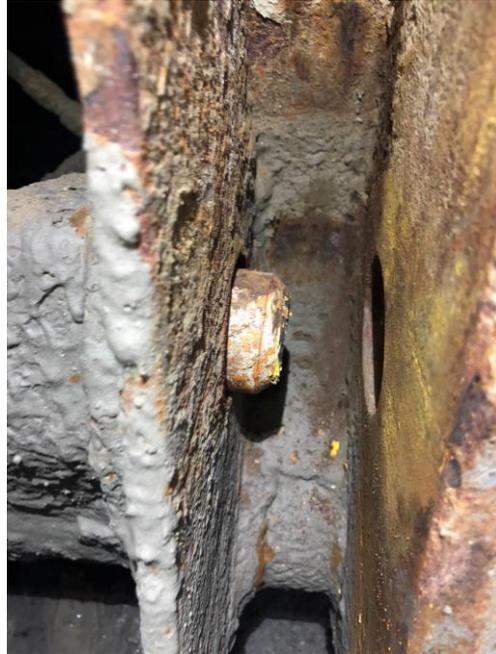
- The attachment locking pins appear to have been only partially extended and had not fully engaged the work box's attachment to the coupler of the IT.
- A visual inspection of the locking pins to confirm the full engagement of the attachment was not undertaken.
- Workers relied on the IT operator to have properly assessed the effectiveness of the locking pin control measure prior to placing their locks on the hydraulic isolation valve.

Figure 1. LHS locking pin partially extended

- Control measures employed to ensure the effective and secure coupling of work boxes and implements to mobile machinery are reviewed, taking into account the hierarchy of risk controls.
- Operational switches in mobile equipment are of an appropriate type, positioned and labelled appropriately to prevent inadvertent operation and consideration is made to install additional barriers or protection of the locking pin release switch.
- Each worker verifies the effectiveness of a control measure prior to placing their isolation lock and tag.
- Information, instruction and training are provided to, and implemented by workers for the safe use of workboxes.

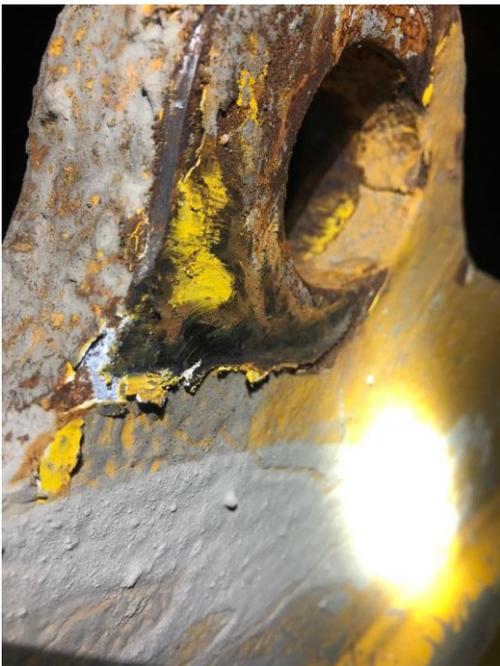
Figure 4. Gouge marks on face of workbox locking pin receptacle
