# SAFETY ALERT

## Sudden burst of truck tyre

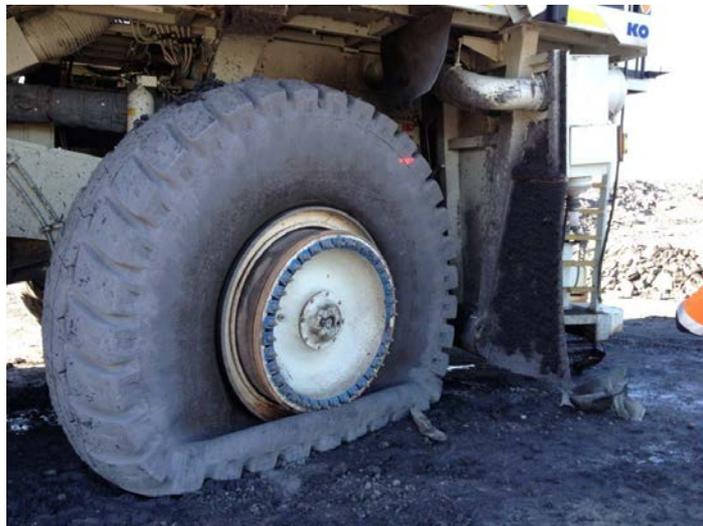
*Photo 1: Position two tyre after incident.*

After exiting the truck, the operator approached the truck from the front and saw that the position two tyre was deflated. The engine bay sound attenuation door was severely damaged. A slit in the inside sidewall of the failed tyre was evident.

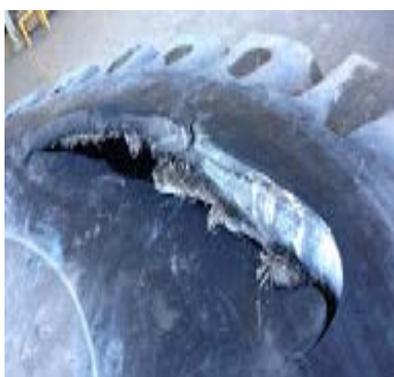
- the tyre failure was caused by sidewall failure
- internal visual inspection found no inner tyre damage to explain failure of the tyre sidewall
- the tear of the sidewall was on the truck side of the tyre
- the position of the tear was consistent with contact being made with an open sound attenuation door in the engine bay
- this occurred while the truck was reversed into the designated parking area
- the driver's (or previous driver's) prestart check did not identify the sound attenuation door had been left open and unlatched, at previous truck maintenance
- the truck manufacturer provided an option for interlocking of the door, which was not installed on the truck.

*Photo 2: Sidewall slit in the tyre*

- Check trucks at their next service to see if it is possible for tyres to be damaged by engine bay doors (or similar) being left open during maintenance activities.
- Where there is a potential risk, install engineering control measures that do not rely on human behaviour, such as:
  - modifying doors so there is no physical contact with the tyre, or
  - installing interlocks that prohibit truck propulsion or provide a disconcerting alarm, in the event doors are inadvertently left open.
- Remind drivers to be diligent in carrying out prestart checks.

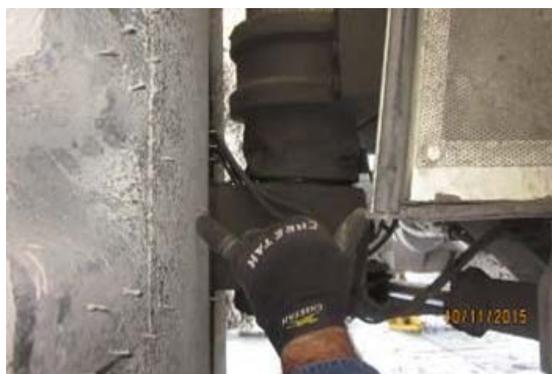
*Photo 3: Open sound attenuation door*

Manufacturers should provide safety controls (such as interlocks) as mandatory items when plant is supplied. Safety controls should not be optional extras with supply of plant.
