## Week ending 18 January 2019

This incident summary provides information on reportable incidents and safety advice for the NSW mining industry. To report an incident to the NSW Resources Regulator: phone 1300 814 609 24 hours a day, 7 days a week.

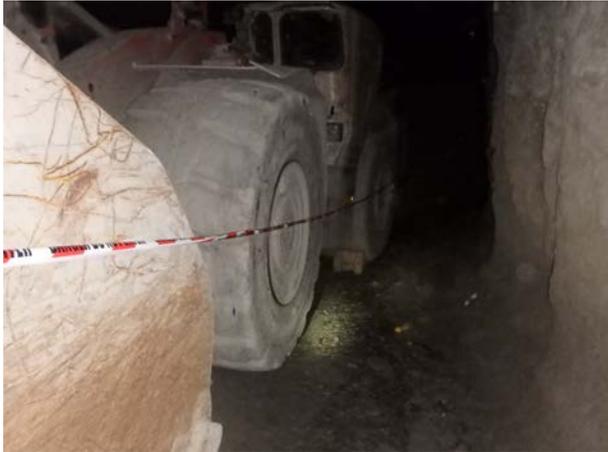
Incident type	Summary	Recommendations to industry
Dangerous incident IncNot0033646	<p>A load haul dump vehicle was descending a decline in an underground metalliferous mine when its bucket hit a wall. The door opened, activating the door interlock, which applied the park brake. The operator was ejected from the cab.</p>

<p>Seat belts and door interlocks must be treated as safety-critical items on mobile plant. Where defects are identified, the plant must not be operated.</p> <p>The <a href="#">Work Health and Safety Act 2011 Section 28</a> details workers' requirements while at work. This includes complying and co-operating with directions and procedures given, as well as the wearing of seat belts and personal protection equipment.</p>

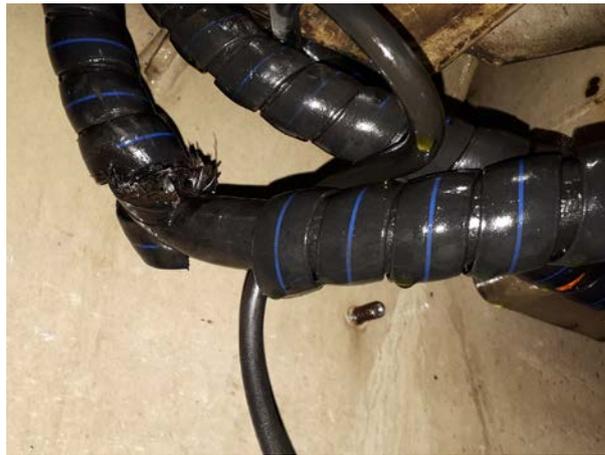
Dangerous incident  
IncNot0033643

A fire occurred on a haul truck at an open cut coal mine. A brake hose failed and sprayed oil into the engine bay, which ignited. The operator saw flames through the passenger side window. The operator stopped the truck, activated the fire suppression system and left the vehicle safely.

When conducting audits and assessing fuel sources, ensure hydraulic hoses outside the engine bay, as well as other ignition sources, are assessed and maintained to the same standards as those within the engine bay.

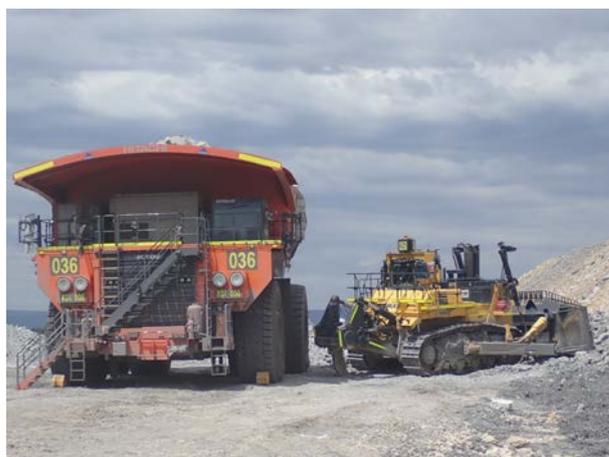
Dangerous incident  
IncNot0033598

A collision occurred between a dump truck and dozer at a dump in an open cut coal mine. The truck driver stated the dozer driver gave him permission to reverse to the tip behind the dozer. The dozer driver stated he

thought the truck was dumping further away and that he should have waited for the truck to pass behind the dozer. The dozer driver continued to reverse and made contact with the truck. No injuries were sustained.

Supervisors need to regularly monitor compliance with mine site rules for vehicle interactions.

The safety management system should detail the minimum requirements for supervisor inspection and monitoring of work areas and practices.
