WEEKLY INCIDENT SUMMARY

Week ending 19 April 2019

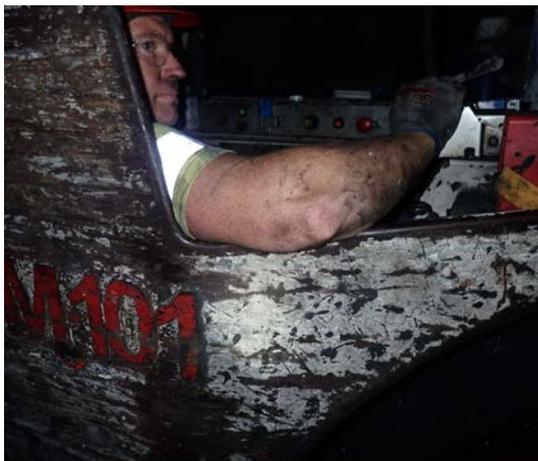
INCIDENT TYPE	SUMMARY	RECOMMENDATIONS TO INDUSTRY
Serious incident IncNot0034407	An operator suffered lacerations and a hairline fracture to the upper right arm while driving a load haul dump machine (LHD). The LHD operator ran over a bump in the road which caused him to pinch his arm which he was resting on the ledge of cab door, and a secondary support 'can' installed in the roadway.	Mine operators should reinforce to equipment operators that they must keep body parts within the confines of the operator's cabin when the equipment is in motion. Mine operators must maintain roads to minimise equipment instability and the amount of operator input required to maintain machinery on the intended course.

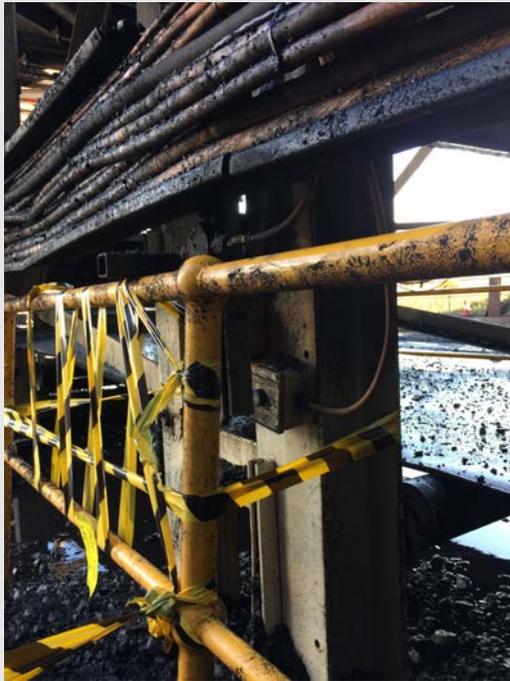
Dangerous incident
IncNot0034397

A plant operator was cleaning coal spillage from around a coal transfer conveyor. The area was reported to have been sprayed and was wet. Once the conveyor was started, it was tracking off. When the operator activated the wander switch override, he reported feeling an electric shock.

The control circuit involved was supplied at low voltage (110V)

Electrical equipment that has an ingress protection (IP) rating is critical in wet areas and should be maintained as fit for purpose throughout its life cycle.

Mines that have control voltages to field devices above extra low voltage (ELV) should review how they manage the risk of electric shock, including the modification of field control circuits to extra-low voltage.

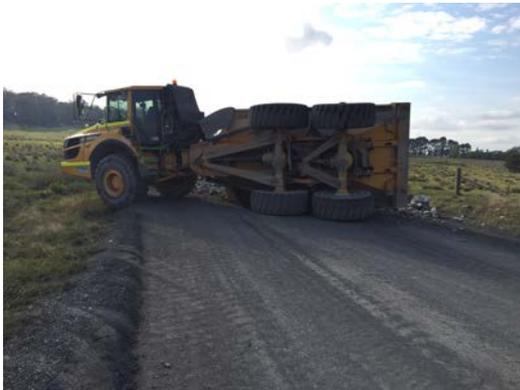
Dangerous incident
IncNot0034378

An articulated dump truck veered off a haul road. The truck driver over-corrected the steering when trying to bring the truck back onto the road, resulting in the truck rolling over.

Operators of articulated dump trucks are reminded to drive to conditions and consider their experience level, prevailing light, tightness of corners, and gradients.

Any concerns over performance of the vehicle to operate as expected should be investigated or notified to supervisors.

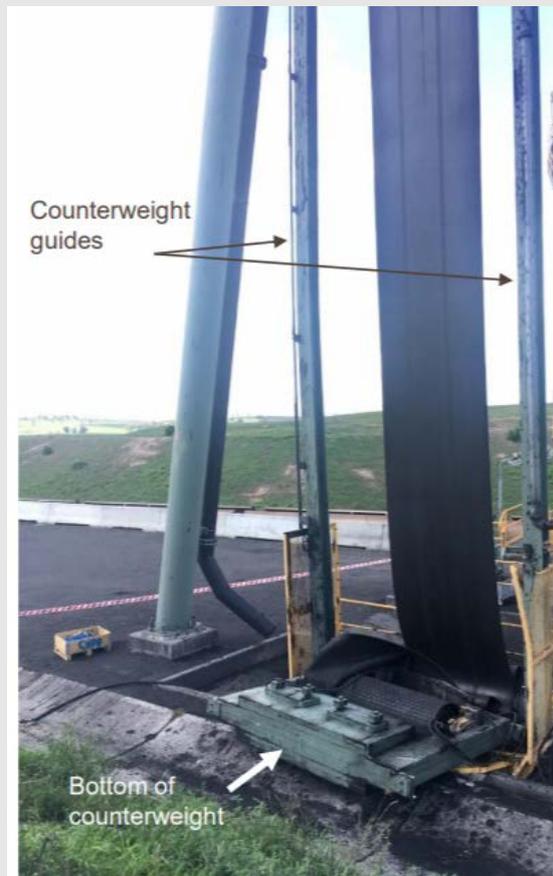
Dangerous incident
IncNot0034388

When investigating a tracking issue on a train load out conveyor system, the belt became erratic, causing it to make contact with the structure and resulting in the conveyor belt tearing. This caused the gravity tower loop take-up counterweight to fall about 15 metres. The investigation is ongoing.

Operators of gantry conveyor systems should review the adequacy of restricted access areas under conveyors and near gravity loop take-up guides.

Where major repairs are undertaken on conveyor systems, recommissioning should verify all belt protection devices are working effectively and tracking issues are fully investigated and remedied.

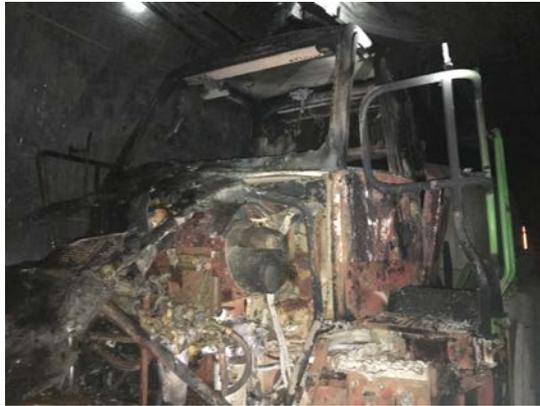
Dangerous incident
IncNot0034377

At an underground metalliferous mine, an agitator truck was taking shotcrete underground. As the truck was travelling up a grade, the operator observed smoke coming from the truck. The operator activated the on-board fire suppression system, however non-metallic covers intensified the fire. After the incident was notified to control via the emergency call, workers underground went to the refuge chambers until the fire was extinguished.

Operators are reminded of the importance of elimination and segregation of ignition sources from potential fuel sources in various failure scenarios. Introduction to site standards and sound maintenance practices are essential in the prevention of fires.

MDG15 specifically addresses fire risks on mobile plant, including the fitting of fire-resistant covers, shields and guards, as well as matters for

consideration in fire risk assessments for mobile plant.

Mine operators should consider the risks of using non-metallic covers as part of the fire risk assessment.

Every time a fire on an item of mobile plant occurs, the mine operator should immediately arrange to inspect all similar plant in service at their mine to ensure the defective condition that initiated the fire does not exist on other plant.

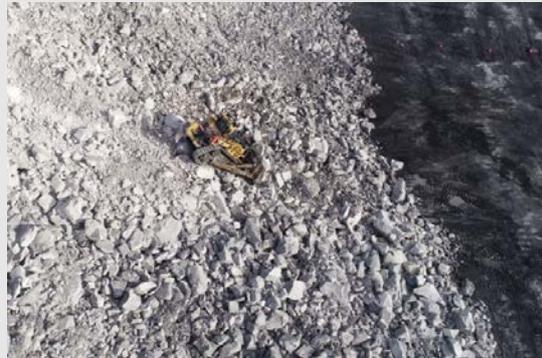
High potential incident
IncNot0034360

A dozer was working on a bulk push task to establish ramp access when the operator noticed a fire in the engine bay. As the operator had already pushed past the crest and was some way down the slope, he made the decision to continue dozing down the slope but got caught up on a large rock. The operator decided to activate the fire suppression system and evacuate the dozer.

The operator also accessed a fire extinguisher on the right-hand side of the dozer platform but slipped and fell while fighting the fire. He suffered hand and rib injuries and was unable to perform his normal duties for more than seven days.

The cause of the fire is yet to be determined.

In an emergency, equipment operators must follow site emergency procedures to ensure their safety.

Mine operators should regularly re-train their workers in the requirements of these procedures.

Matters to be addressed in these procedures should include:

- stopping the equipment immediately
- activating fire suppression systems if fitted,
- calling emergency with the location and other information and exiting to safety.
- fighting a fire only when it is safe to do so, consider all hazards present including ground stability, light available, slope, fumes, wind

direction as well as fire intensity, and so on.

Mine operators should plan earth moving operations to maintain access (roads) for emergency vehicles, as far reasonably practicable.
