SAFETY BULLETIN

Conveyor pulley failures initiate fires

CM9 reference	DOC19/932250
Mine safety reference	SB19-14
Date published	7 November 2019
Authorised by	Chief Inspector Office of the Chief Inspector

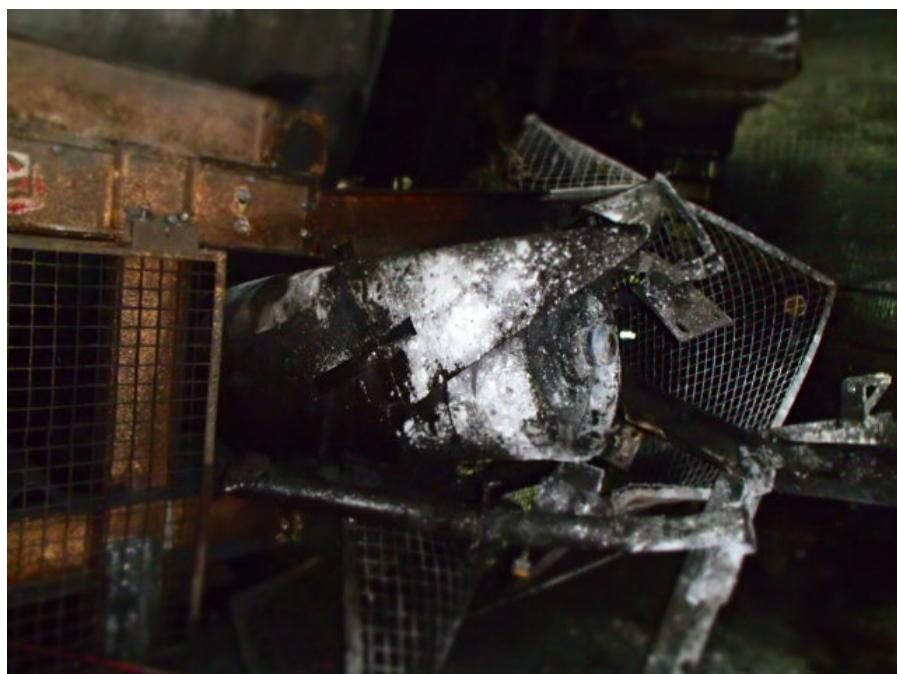
A trunk belt stopped on a lanyard trip. When a worker arrived to inspect the conveyor, the tail pulley was found seven metres outbye of the installed location (refer to figure 1 below). Molten metal was found around the mount plates. A camera was monitoring the transfer. When the footage was reviewed, a glow could be seen for 50 seconds before the failure occurred, with flashes of increasing intensity. At the instant of failure, the structure violently shook (refer to figures 2 and 3). The pulley was fitted with temperature monitoring, which showed an increase from 33°C to 45°C before the failure. A previous vibration survey did not identify any issue. The carbon monoxide monitor detected a 1 ppm rise.

Figure 1 Failed pulley final location

In each incident, the temperature trip points were defined and set to alarm and stop the conveyor when the temperature exceeded 65°C or 85°C at the monitoring point. In incident 1, the failure occurred at a much lower temperature.

1. Review the trip points of condition monitoring devices. Consider the location of the device, the heat source and the effect of heat soak into other materials.
2. Periodically test and validate the operation of temperature monitoring devices against the actual temperatures of components when operating.
3. Confirm adequate commissioning checks are in place for condition monitoring devices.
4. Review the location of carbon monoxide monitors. Consider potential carbon monoxide sources and the local effects of the ventilation system.
5. Review the trigger action response plans (TARPs) for condition monitoring. Confirm that any contract condition monitoring providers are aware of the TARP triggers and associated response necessary.
6. Confirm that workers know how to respond to fires on conveyor systems.

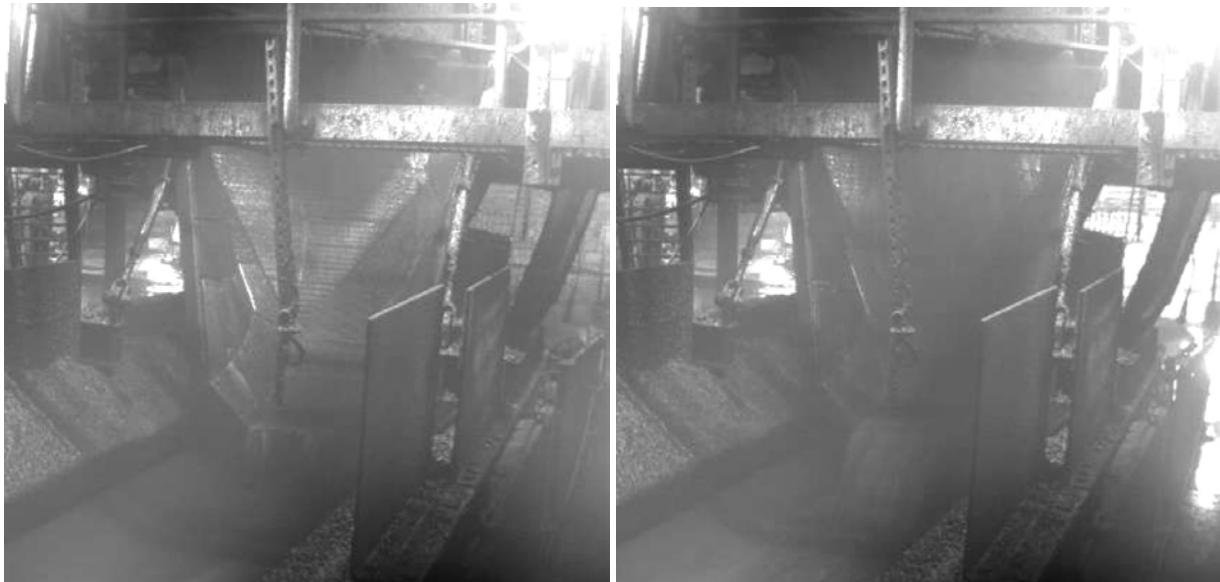
Figure 2 and 3 Transfer before the failure and at time of failure. Flash on right hand side in figure 3

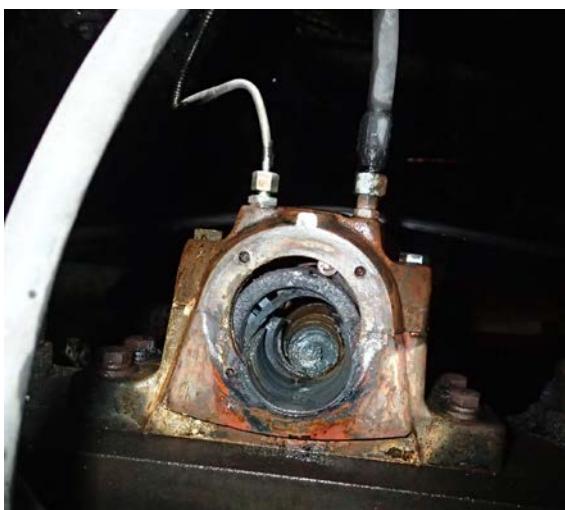
A worker was completing an inspection when he identified a hot bearing in a tension pulley. The belt was stopped and the pulley was doused with water. An investigation identified the pulley had been changed three months prior, with the temperature probe changed at that time. During the change out, the faulty temperature probe was reinstalled, with the new probe left tied up nearby. There were also issues identified where the connections for the new probe had been terminated. Following the incident, the mine audited all other temperature probes to confirm they were operational and measuring correct temperatures.

Figure 3 Failed bearing

The incorrectly installed temperature probe was not measuring the temperature of the bearing housing. At no point was it identified that the bearing temperature was not rising or decaying when the conveyor was operating or stopped.
