The incident

CM9 reference	DOC21/216014
Mine safety reference	IIR21-04
Date published	26 March 2021
Authorised by	Chief Investigator, Major Safety Investigations

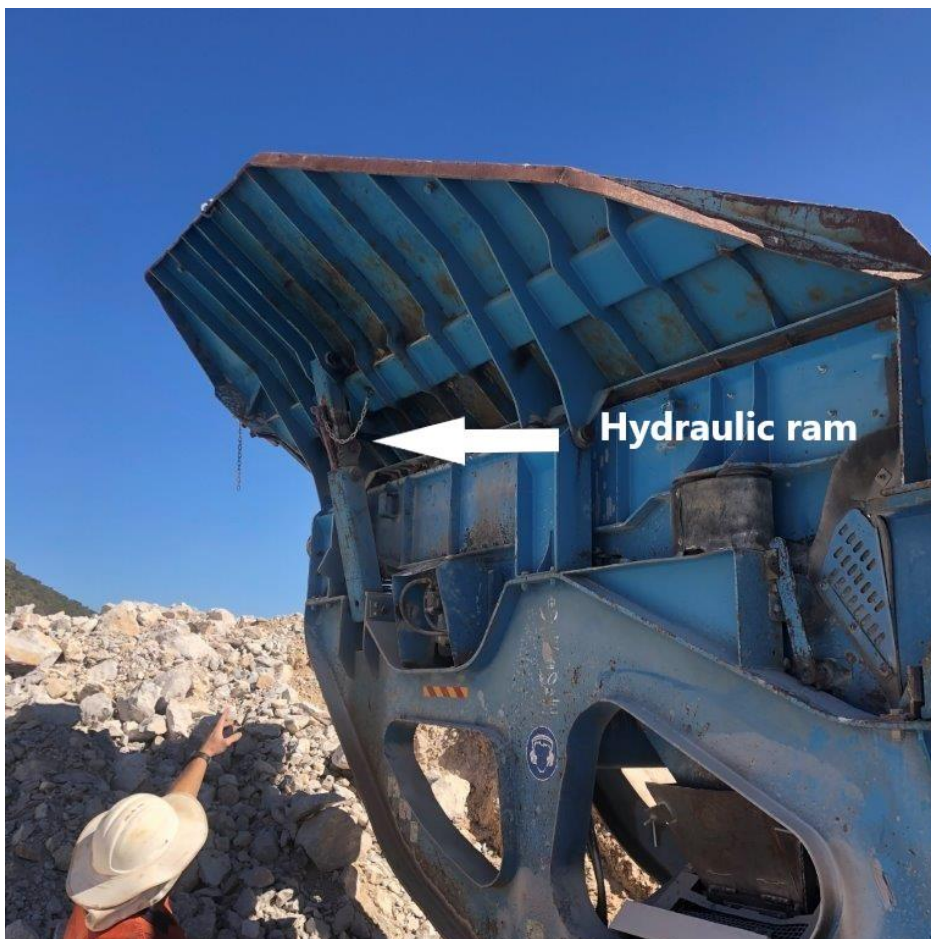
At about 8:30am on 26 February 2021, workers at the quarry were attempting to free a jammed hydraulic cylinder to lower the wing on a mobile jaw crusher.

Figure 1: Arrow pointing to the hydraulic cylinder (ram) that normally raises and lowers the wing of the crusher.

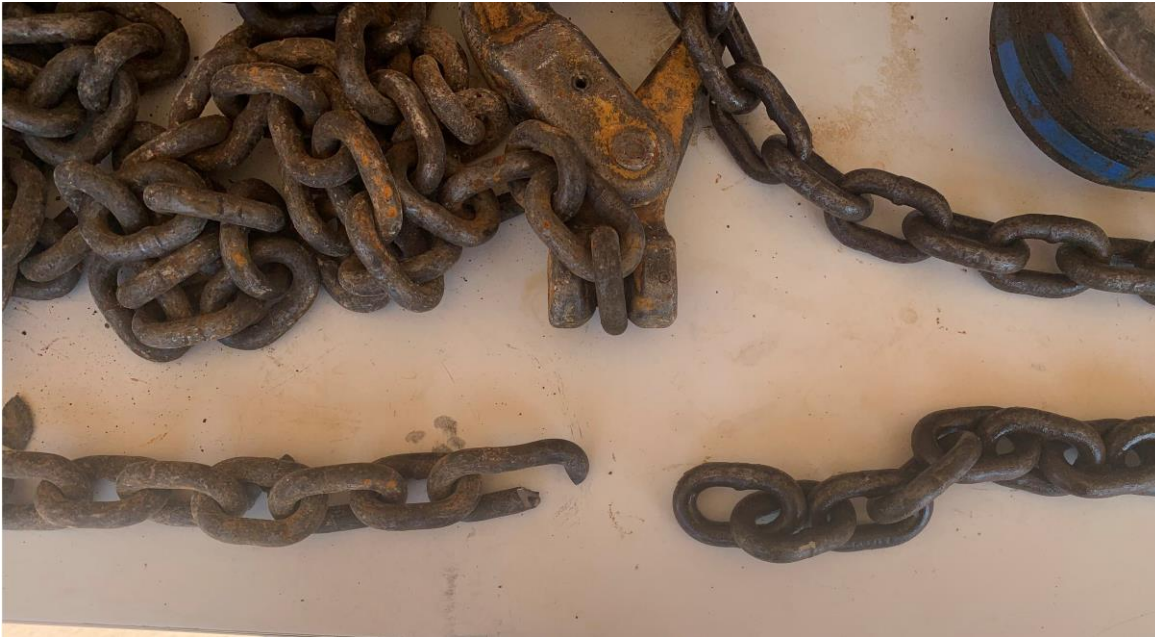
The workers connected an 8-millimetre alloy sling grade T80 chain assembly (WLL rated at 3.5 tonne in straight lift) between the excavator and the crusher wing. During the task, the excavator was used to apply a sideways pull force to components of the hydraulic cylinder.

An uncontrolled release of energy occurred causing the chain assembly and components of the hydraulic cylinder to fail and a worker to sustain a serious laceration to an ear.

Figure 2: Failed chain components of the chain assembly used

When planning tasks involving lifting equipment, the WLL rating of the chain assembly and maximum pull/lift force (including potential for shock loading forces) that could be applied to the chain assembly, including selection of connection points, must be considered in a pull/lift system design.
