WEEKLY INCIDENT SUMMARY

Week ending Friday 30 April 2021

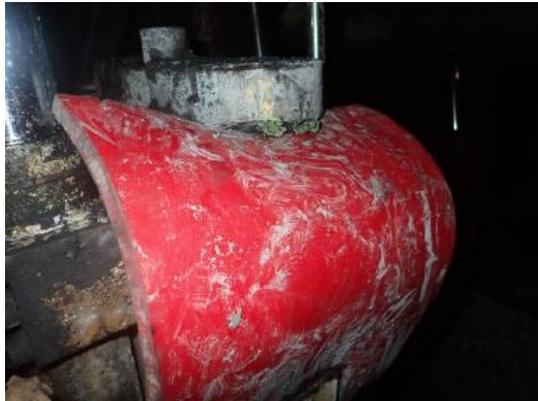
INCIDENT TYPE	SUMMARY	COMMENTS TO INDUSTRY
Serious injury IncNot0039769 Underground coal mine	A worker received crush injuries to two fingers when their hand was caught in a pinch point while operating a roof bolting rig. The worker was wearing gloves when her fingers became caught between the feed carriage end plate and the carriage retainers. The gloves had to be cut to free the worker's fingers. The worker sustained degloving of the end of her left ring finger and the tip of her little finger. A polyurethane flap had been fitted to prevent access to the pinch point, but this proved to be an inadequate risk control.	Mine operators should ensure that training of persons involved in roof bolting includes the identification of pinch points and associated hazards. Adequate controls should be put in place to control the risks. Operators should ensure that the installation of 'lobster' attachments does not introduce new, unidentified pinch points without risk controls.

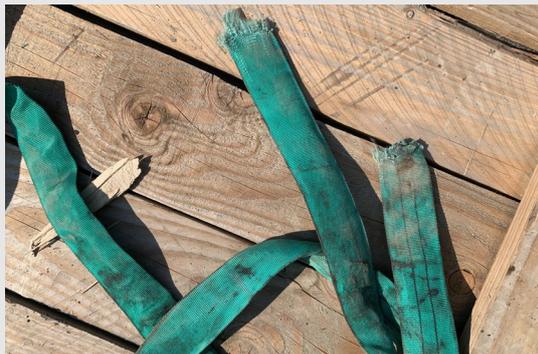
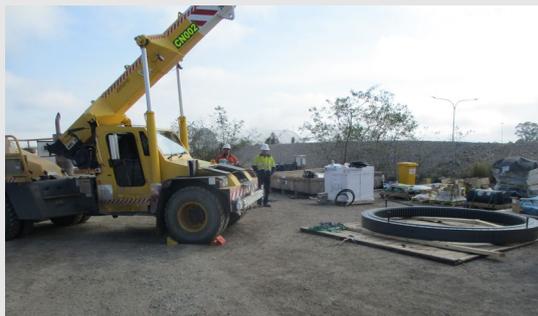
Dangerous incident
IncNot0039733
Open cut coal mine

While lifting a four tonne excavator slewing ring from the ground, the lifting sling snapped when the slewing ring was upright, allowing the ring to fall back to the ground. The lifting sling was rated for a two tonne lift and an inappropriate slinging technique was used for the lift. More appropriate lifting equipment was available at the time, including rubber sections to wrap around the load. No one was injured.

Workers have a legislative duty to care for their own health and safety and that of others (s28 Work Health and Safety Act 2011). One of the duties is to cooperate with any reasonable policy or procedure. Procedures are developed to help protect workers from injury or illness. Where a procedure exists for a particular task, workers should follow the procedure. Any deviation from a procedure should first be discussed with a supervisor and appropriate risk control measures put in place.

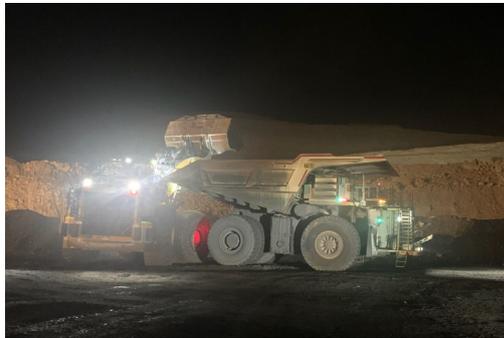
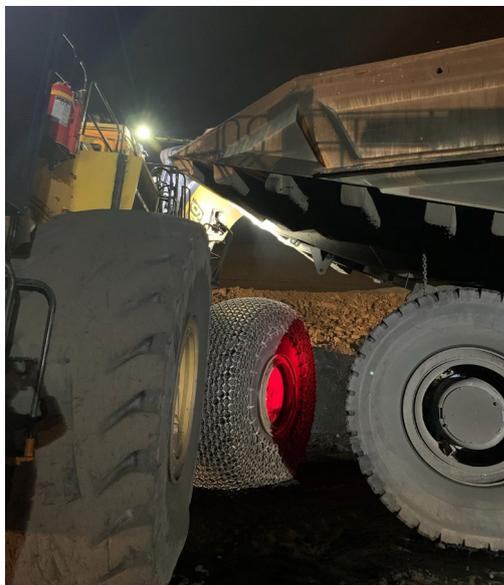
Dangerous incident
IncNot0039770
Open cut coal mine

The tray of a haul truck collided with the lift arm and handrail of a front-end loader, putting the loader operator at risk. The haul truck was backing under the loader, however, the operator's view was obscured by dust and he lost sight of the loader. The loader operator had earlier switched to offside loading due to visibility issues with dust and lighting. No one was injured.

The consequences of vehicle operators not establishing positive communications with other vehicle operators can, and has been, fatal. Despite the prevalence of site procedures, operator training and the introduction of assistive technology, many operators continue to ignore the importance of following basic procedures. The continuous repetition of a task does not negate their responsibility to establish positive communications every time a task is repeated.

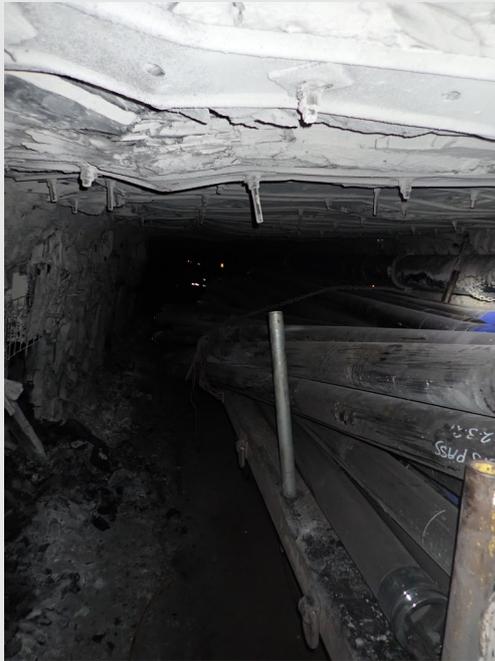
Serious injury
IncNot0039717
Underground coal
mine

A worker sustained a punctured lung when he was struck in the chest by a poly pipe. While moving a pipe trailer into a roadway, a pipe has moved rapidly and struck the worker in the chest.
