WEEKLY INCIDENT SUMMARY

Week ending Friday 18 June 2021

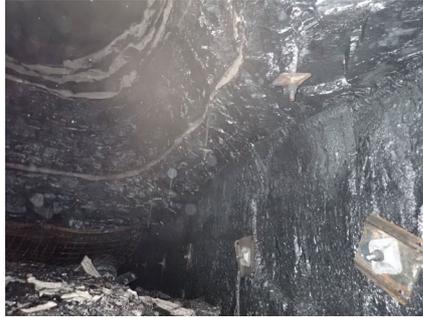
INCIDENT TYPE	SUMMARY	COMMENTS TO INDUSTRY
Dangerous incident IncNot0040098 Underground coal mine

Ground or strata	A roof fall, approximately six metres long, measuring the full width of the drive (5.4 metres) and two metres high, occurred in the main gate of an underground coal mine directly behind the continuous miner where the area was supported. Two fitters on a continuous miner noticed some flaking in the roof and immediately went outbye just prior to the fall of ground. The ground failure was sudden.	Underground mines must have systems in place to ensure the correct installation of designed strata support. This includes requirements and frequency of encapsulation test, pull test, torque test on drill rigs, inspection of installation spacing. Once these requirements are determined mine operators must make compliance variations.

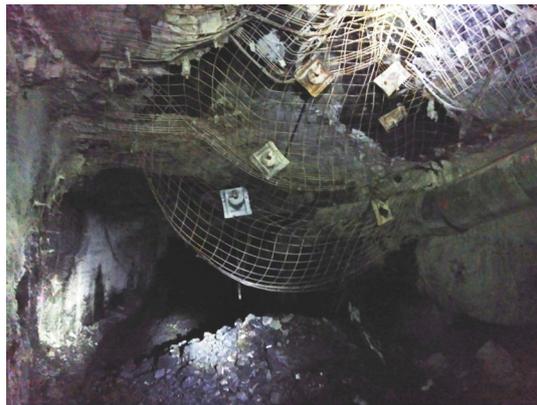
Dangerous incident
IncNot0040099
Underground coal
mine

A fall of roof occurred on the inbye side of a fault plane. The continuous miner was operating inbye approximately 60 metres. Operators were able to retreat past the fallen material under supported roof. Ventilation was not disrupted.

See recommendations from incident number IncNot0040098 above
