# WEEKLY INCIDENT SUMMARY

Week ending Friday 06 August 2021

**Mine safety reference** ISR21-31

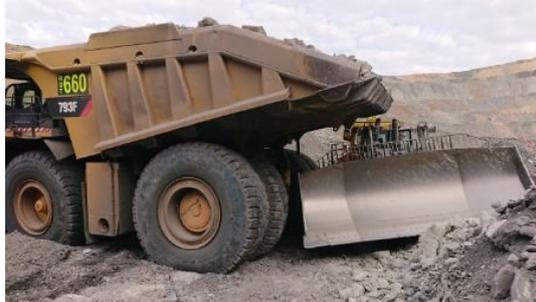
Roads or other vehicle operating areas	A dump truck collided with a dozer at the tip head, when it rolled backwards at speed, as the dozer was reversing out of its path. The truck operator had made positive communication advising the dozer operator that he was entering the dump. The truck operator was positioning the truck to reverse to the tip head when the truck shutdown. The truck began rolling backwards and the operator was unable to stop the truck. Initial reports suggest a loss of brakes or mechanical failure with the truck. No one was injured.	The cause of this incident is still being investigated. Further information may be published later.

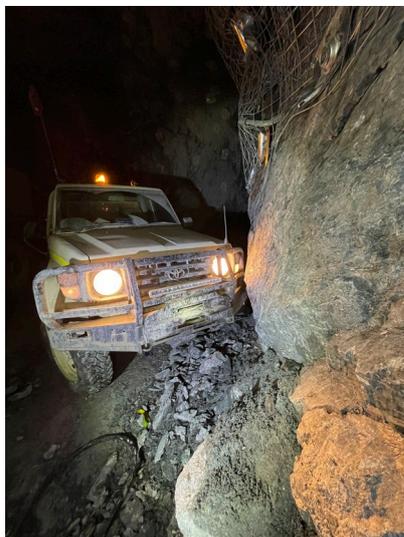
A light vehicle was parked behind a jumbo in a decline. After the worker left the vehicle, it rolled 13 metres before hitting a wall. The vehicle had not been parked to site standards.

Vehicle operators must comply with correct park-up arrangements, particularly when parking on a grade. Mine operators should consider installing interlocks or warning systems for park brakes on light vehicles and other mobile equipment. Refer to Safety Bulletin: [SB13-02 Unplanned movements of vehicles - too many near misses](#).
