# INVESTIGATION INFORMATION RELEASE

## Worker suffers serious injuries after falling into conveyor chute

**Event:** Dangerous incident at an open cut mineral mine

**Location:** Thuddungra Mine, Young NSW

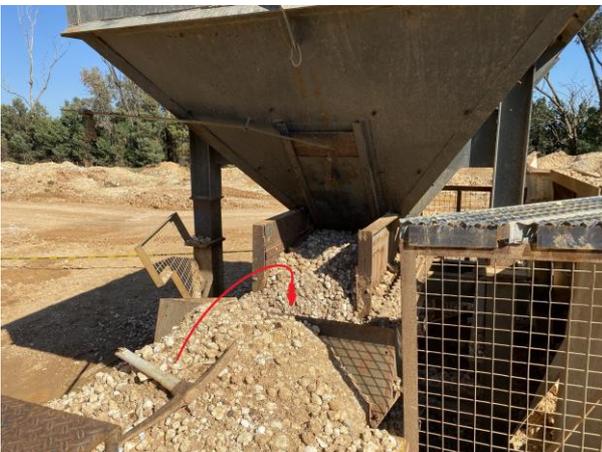
*Figure 1: Direction of worker's fall*

The worker slipped on the material he was standing on and fell forward into the chute. The worker attempted to stand up in the chute but, as he did, the reciprocating feeder struck him and knocked him down. The worker landed on his back in the chute and was covered in a large amount of rock, which continued to be fed from the hopper.

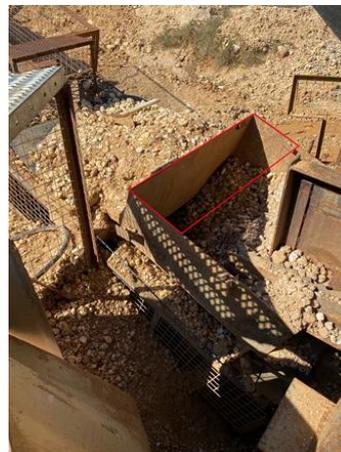
*Figure 2: Chute where worker became buried*

The operator heard the worker's screams and rendered assistance. When he arrived at the chute, the worker was fully buried except for his head and hands. The operator pulled the emergency lanyard at the side of the conveyor, but it did not have any effect on the reciprocating feeder which continued to operate and feed product onto the worker. The operator went to a nearby isolation point and switched off the feeder. The operator and the contractor dug the worker out by hand, which took about 15 to 20 minutes.

- The emergency lanyard on the PS25 conveyor was not sufficiently tensioned. When the lanyard was pulled by a responding worker, it did not have any effect on the operation of the reciprocating feeder.

- Ensure that emergency stop devices are maintained and tested regularly.
- Ensure that the areas around conveyor systems are well maintained and effectively drained.

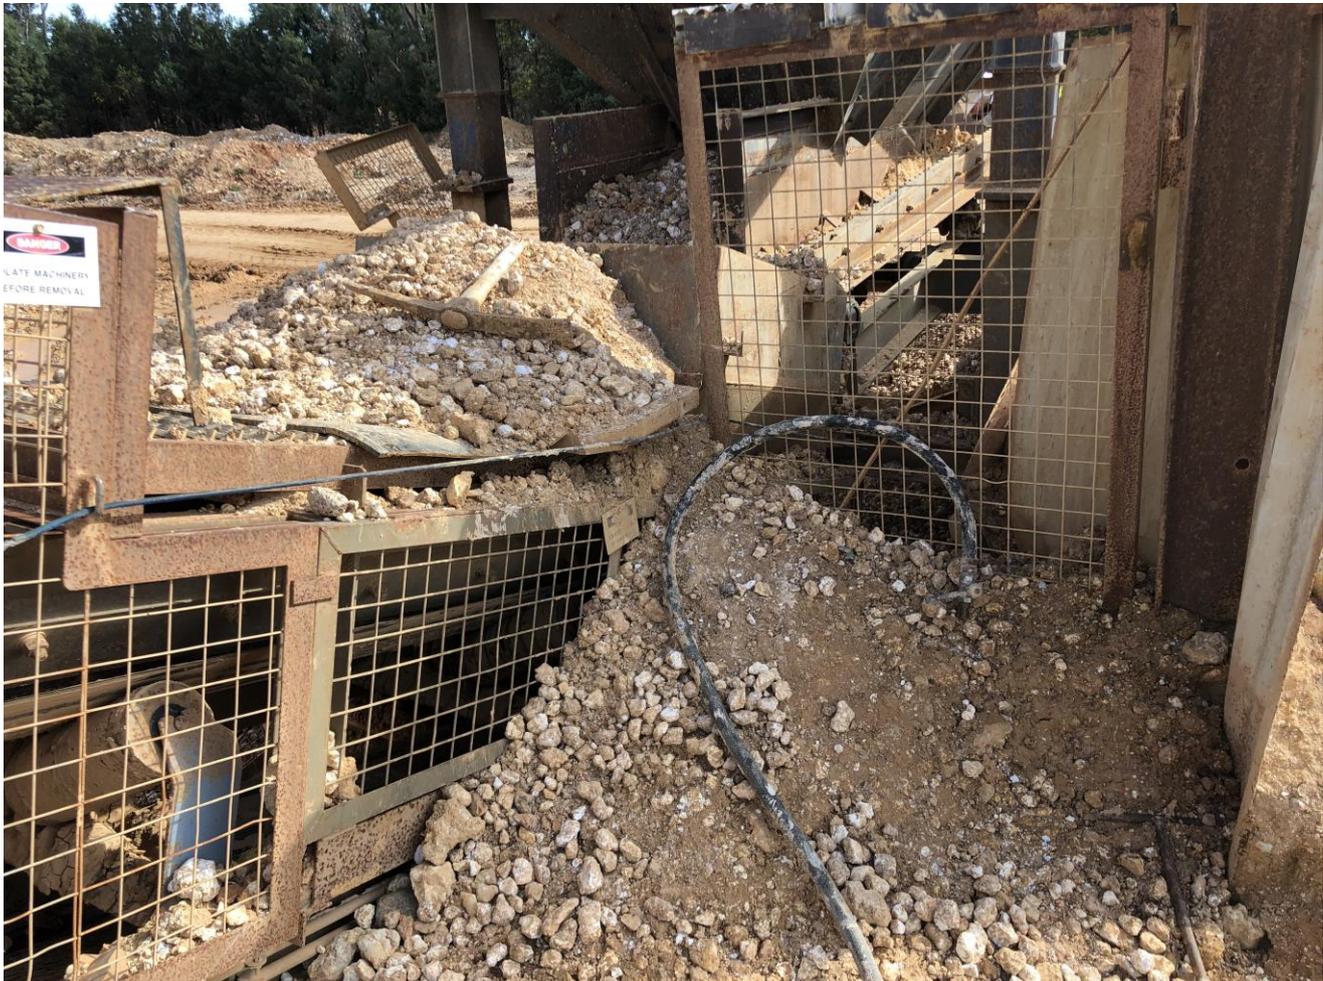
Figure 3: Build-up of material next to the PS25 conveyor which allowed the worker to access the top of the conveyor guard

- There had been increased rain activity at the mine in the preceding months and the drainage was ineffective. The ground around the PS25 conveyor was wet and muddy at the time of the incident.

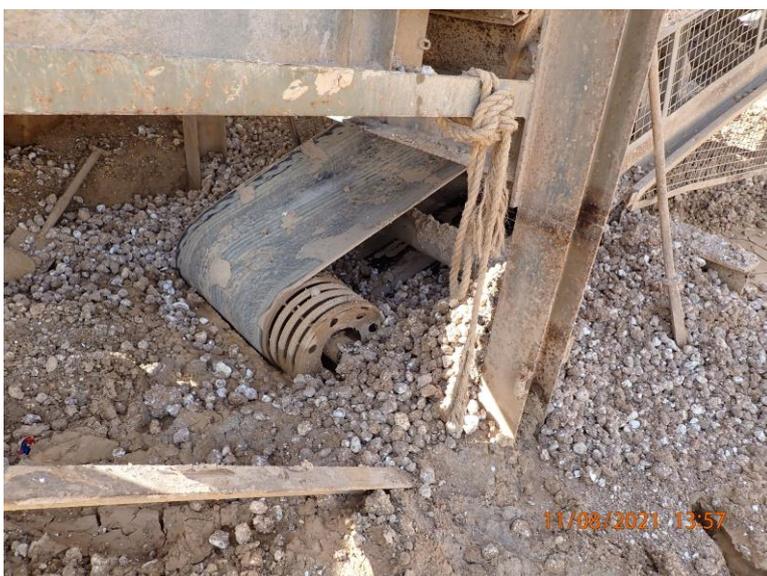
- Housekeeping was not maintained. There was a large build-up of loose rock and other material on and around the conveyor, and the tail pulley was buried. Workers were required to remove guarding to dig out buried tail pulleys. This led to a situation where conveyors at the mine were regularly being operated without effective guarding in place.

Figure 4: Unguarded tail pulley which was partially buried in loose material

- Ensure that the PLC on conveyor systems are configured to control connected or related plant in an emergency situation.
- Ensure that fixed guarding is in place on conveyors to prevent access to, and contact with, moving parts. Guarding should comply with AS/NZS 4024.1 Safety of machinery series.
