# **Investigation Report**

Serious injury involving a fall from height at  
the Perilya Broken Hill Southern Operation on  
6 November 2007

Report prepared for the Director-General of the  
Department of Industry and Investment by the  
Investigation Unit, Thornton

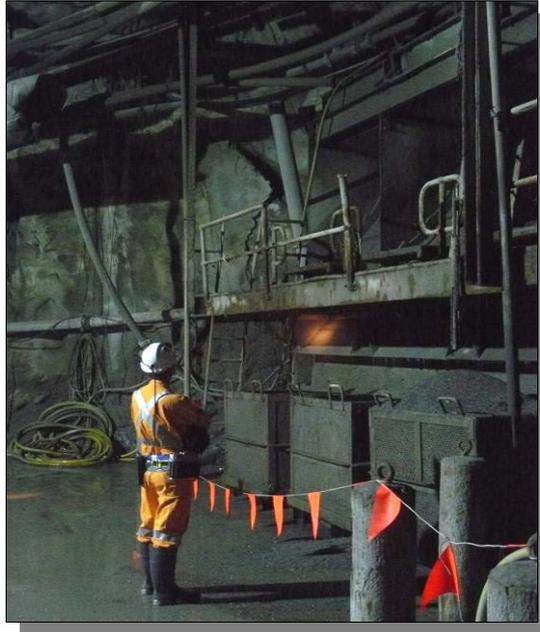
23 Level Pre-screens  
(Photo by Investigator  
Mark Freeman)

The plant:	Pre-screens
Location:	Underground at 23 Level of the Southern Operations
Function:	Dirty water from the mine workings is piped to the pre-screens where it is filtered by a series of screens before being sent to the 24 Level where large pumps are used to recycle the water to the surface for use in ore processing and underground mining.
Date built:	The plant was commissioned by Pasminco Limited in about 1991 with the maintenance platform (walkway) being added in 1992.
Construction standard:	The plant, at that time, was required to be built to the relevant Australian Standards (SAA codes), including SAA Code for Fixed Platforms, Walkways, Stairways and Ladders (AS1657-1985).

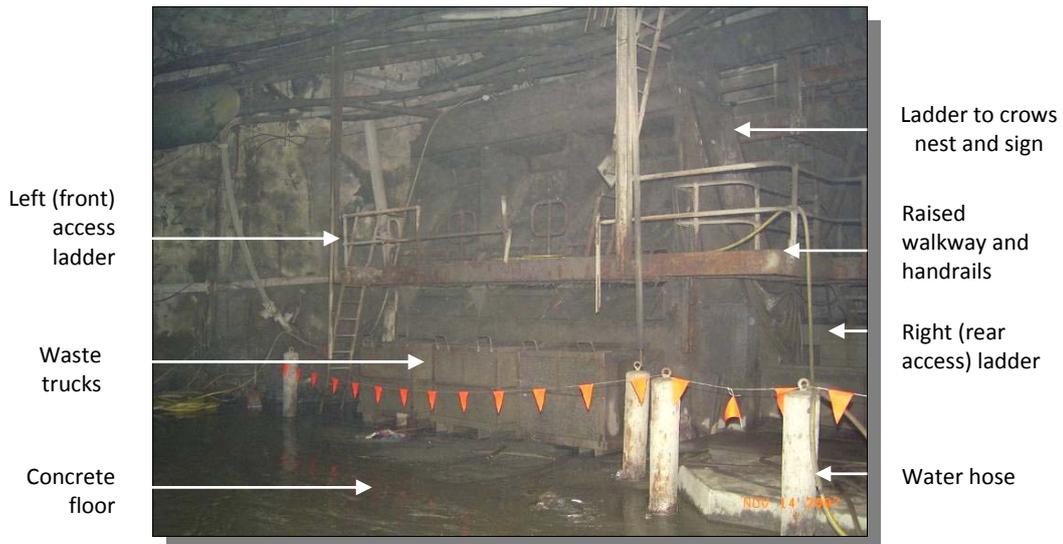
<b>Final check on the pumps</b>	<p>After having lunch in the crib room, Mr Battams returned to the 24 pump station to do a final check that the pumps were running satisfactorily. Then he went to where the Integrated Tool carrier (IT) was parked and completed a pre-start check.</p>
<b>Driving IT to 23 level</b>	<p>Mr Battams drove the IT up the incline to the 23 Level maintenance bay. He parked the IT and then walked back past the 23 plat into the pre-screen area. On arrival he did a quick visual check of his surrounds.</p>
<b>Cleaning pre-screen from floor</b>	<p>Satisfied the area was safe from rock fall, Mr Battams got the nearby water hose and hosed down the two troughs at floor level on each side of the pre-screens.</p> <p>When he finished the floor level clean up he dragged the water hose up onto the raised walkway so he could hose the screens (see the following photo).</p>

Mr Battams used the ladder near the steam high pressure cleaner to access the walkway (seen on right of photo above). On the walkway he picked up the hose and cleaned the steps that were raised above the walkway. That done he hosed down the screens standing on the raised step, with the waste material falling into the trucks below. Each section of screen has a strainer at each end. Mr Battams hosed one strainer and then turned to step back onto the walkway to go to the other strainer.

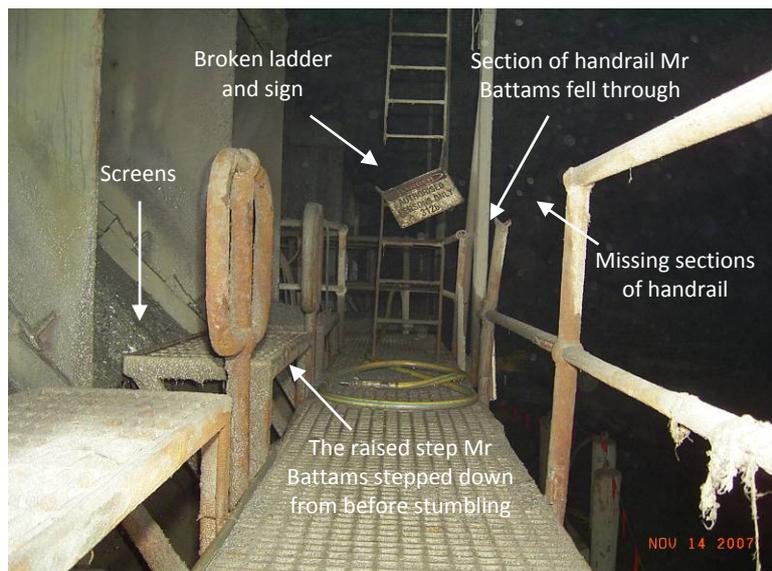
23 Level Pre-screens walkway  
(Photo by Investigator Mark Freeman)

According to Mr Battams, while stepping back onto the walkway, he stumbled hitting the handrails of the elevated platform. He could not explain why he lost his footing. As he fell it appears he grabbed at the ladder near to him to stop himself, but a piece of ladder came away in his hand (see following photo).

<b>Falls to ground</b>	<p>The handrail gave way under the impact of Mr Battam's falling body and he fell about 2.5 metres to the concrete floor below.</p>
<b>Injured and waits for help</b>	<p>Lying on the floor, Mr Battams saw he had dislocated a finger on his left hand. Although he couldn't see his right leg he could wriggle his toes. But when he tried to get up he found the leg would not support him and he was in pain. He lay back down to ease the pain, using his helmet to support his head.</p> <p>Mr Battams got his cap lamp and shone it up the drive in the hope someone would see it and come to his aid. He checked his watch and found it was about 3.00 pm.</p> <p>He made himself as comfortable as possible and continued to call out for help. At one point he appears to have lost consciousness for some time.</p>
<b>Team becomes worried</b>	<p>By about 6.20 pm the other team members became worried. Mr Battams usually returned to the 24 Level with his IT at about 6.15 pm.</p> <p>A maintenance fitter went in search of him. He drove his Toyota ute up the drift from the 24 Level to the 23 Level pre-screens to check on Mr Battams.</p>

**Unsafe plant** The handrails provided at the pre-screens raised walkway to prevent persons from falling off were found to be corroded:

- steel of the pipe of the handrail was found to be very thin, offering little strength when a force or load was applied, and
- inspections of the pre-screens plant after the incident by the Inspector and Investigator readily identified surface rust and possibly deep corrosion on other steel components of the plant.

Further examples of unsafe plant and equipment were identified, in particular the ladder that went from the platform up to a crows nest near the roof of the cavern. This ladder appears to have been redundant for some time and had a sign attached prohibiting unauthorised access.

As Mr Battams fell he grabbed at the ladder hoping to stop his fall, only to find that a section of the extremely corroded ladder stile came away in his hand.

**Corroded steelwork removed** The redundant ladderway to the crows nest above the pre-screens was removed, along with the walkway structure and its access ladderways.

**New walkway completed** Following the incident the mine reassessed the pre-screens and began an evaluation and upgrade project. Pipe work and other structures were replaced, with a permanent raised walkway and access being completed in June 2010.
