MINE SAFETY INVESTIGATION UNIT

INFORMATION RELEASE

Fatality

Date	Incident occurred on 30 November 2013
Event	Collision between haul truck and light vehicle
Location	Ravensthorpe Open Cut Mine, Ravensthorpe, NSW

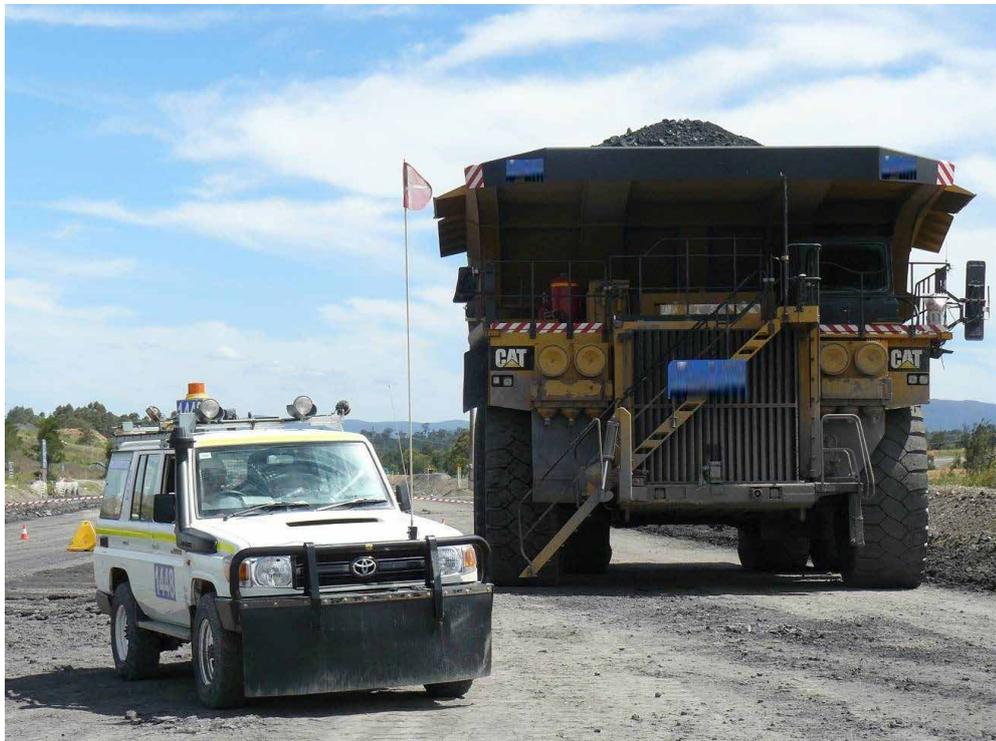
Similar light vehicle and truck at the intersection in daylight

The LV had a pole and flag attached to its bonnet as depicted in the photograph on page 1.

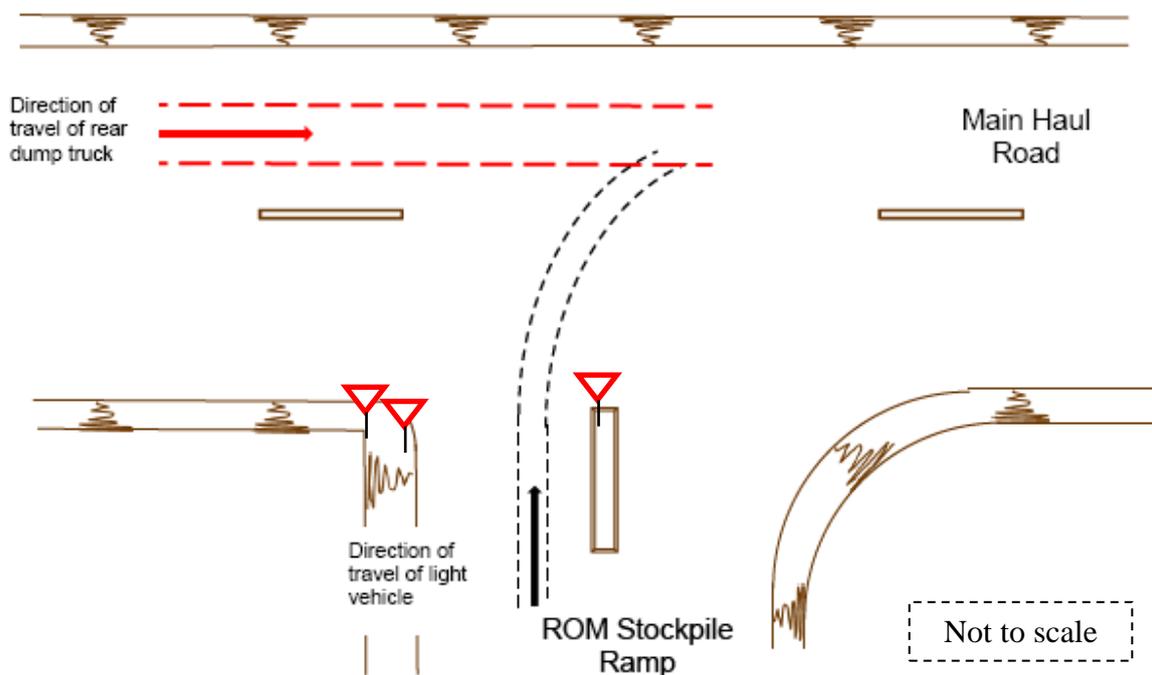
After delivering a haul truck to a stockpile area the worker drove the LV, a Toyota Landcruiser, back toward the main haul road. It appears that the light vehicle has entered the main haul road at a T-intersection, and made a right hand turn across the main haul road onto the left hand side of the road.

A fully laden Caterpillar 793D rear dump truck (RDT) hauling coal was also approaching the intersection. The orientation was such that the LV was entering the road on the right hand side (the blind side) of the RDT.

Illustration of intersection – does not depict actual scene *Sketch by Investigation Unit*

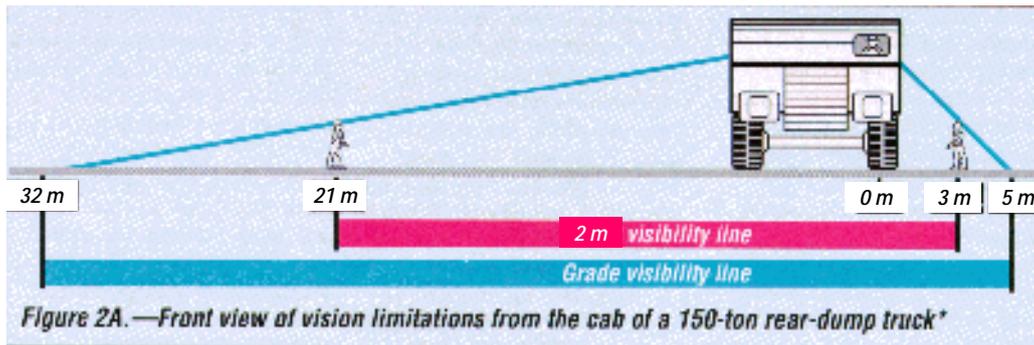
The operator's cab is situated on the left hand side of the truck and is almost 5 metres above the ground. As can be seen in the diagram below, the truck operator has very limited vision for at least 20 metres off to the right side (blind-side) of the truck for anything that is less than 2 metres tall. The truck operator's vision is further restricted by the cab rollover protection structure, mirrors, handrails and other equipment on the truck cab deck.

Illustration of blind spots around a mining truck (from Miller, 1975)²
 Illustration indicative of vision from a large RDT, distances shown are approximate.
