WEEKLY INCIDENT SUMMARY

Week ending Friday 27 March 2020

Mine safety reference ISR20-13

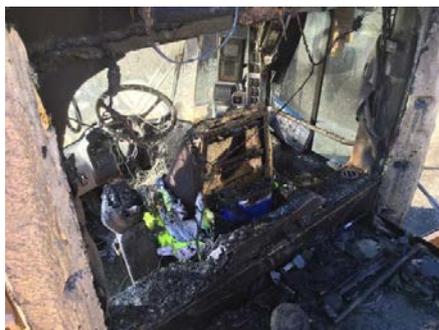
A dump truck operator observed oil on the ground under a front-end loader (FEL) and advised the operator. Some 30 seconds later, the excavator operator, who was loading the dump truck, saw flames on the FEL and instructed the operator to get out of the loader. The fire suppression system and a water cart were used to extinguish the flames. The FEL was extensively damaged.

The cause of this fire has not yet been established.

For further information refer to our dedicated website page about [fires on mobile plant](#)

Refer to our position paper: [Fires-on-mobile-plant-position-paper-October-2019](#).
