# WEEKLY INCIDENT SUMMARY

Week ending Friday 09 April 2021

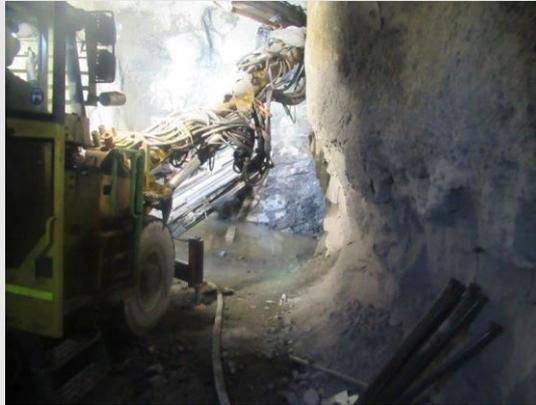
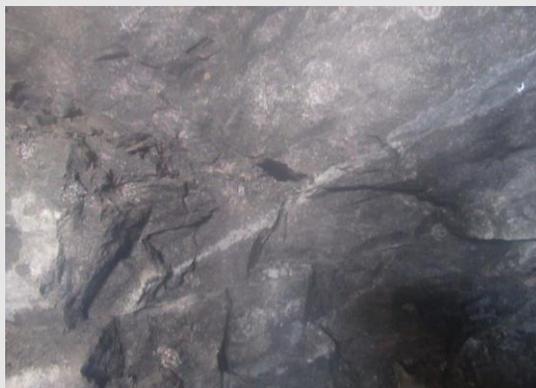
| INCIDENT TYPE | SUMMARY | COMMENTS TO INDUSTRY |
|--|--|--|
| Dangerous incident<br>IncNot0039601<br>Underground metals mine | A jumbo operator's off-sider sustained lacerations to his leg and arm when he was struck by flyrock. The operator was mechanically scaling the face with a 45 millimetre bit, when the bit entered an unidentified blast hole. The blast hole contained explosive residue which | A risk assessment should be undertaken to identify blast hole remnants prior to commencing scaling work. Mine operators should consider using a scaling bit that is larger in diameter than a blast hole bit to eliminate the risk |

initiated the explosion. The offsider was standing towards the rear of the jumbo at the time of the incident.

of the bit entering an unidentified blast hole remnant.

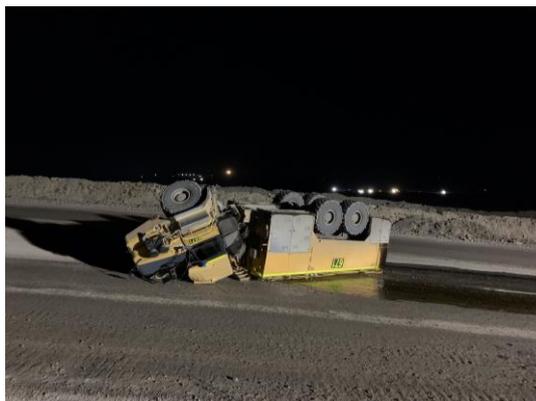
A service truck overturned when the operator lost control of the vehicle while descending a ramp. The road surface was wet following recent dust suppression watering. The operator was able to exit the vehicle and was uninjured. The truck had approximately 20 kilolitres of fluid on board and a capacity of 32 to 34 kilolitres.

When developing control measures to deal with the risks associated with articulated service trucks, plant characteristics, including stopping distances, manoeuvrability and operating speeds, both the loaded and unloaded vehicle must be considered. Movement of fluid in tanks mounted on mobile plant can significantly influence the centre of gravity and overall stability of the vehicle. Consideration should be given to tank shape, baffling and compartmentalisation to control fluid surge. Mine operators should provide operator training specific to wet roads and ensure drivers are made aware of dust

suppression activities on roads. Operators of articulated trucks need to remain situationally aware and drive to the conditions.
