WEEKLY INCIDENT SUMMARY

Week ending Friday 14 May 2021

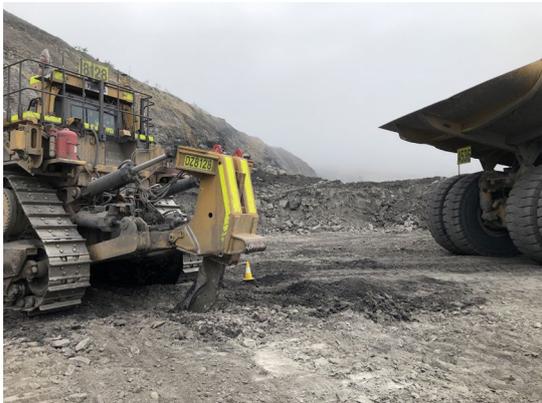
INCIDENT TYPE	SUMMARY	COMMENTS TO INDUSTRY
Dangerous incident IncNot0039848 Open cut coal mine

A dozer operator communicated with a haul truck that he was about to clean up across the face behind the truck. The dozer operator completed one push and reversed back to commence a second push. The truck operator saw the dozer	Operators of mobile plant must establish positive communications with other plant operators before moving into impact zones. There is no room for assumption when the consequences could be fatal. Mine operators should consider periodic refreshers in positive communications protocols for operators using mobile equipment. Refer to: Safety Bulletin 18-06 Lack of positive communications

reversing out of the area and assumed it had finished cleaning up. The truck operator then reversed towards the face, narrowly missing the dozer cab with the dovetail of the truck. The truck operator assumed the dozer was clear without waiting for positive communication from the dozer operator.

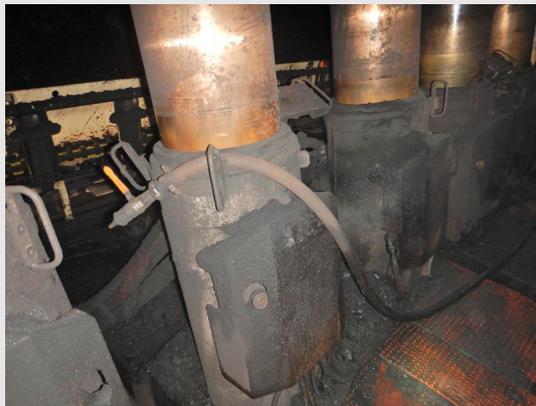
Dangerous incident
IncNot0039838
Underground coal
mine

While retrieving a wash down hose on the longwall face an operator was sprayed on the side of the head with 1200 kilopascals of water pressure when the ball valve inadvertently opened.

Mine operators should consider using gate valves in place of ball valves to prevent inadvertent operation of water hoses.

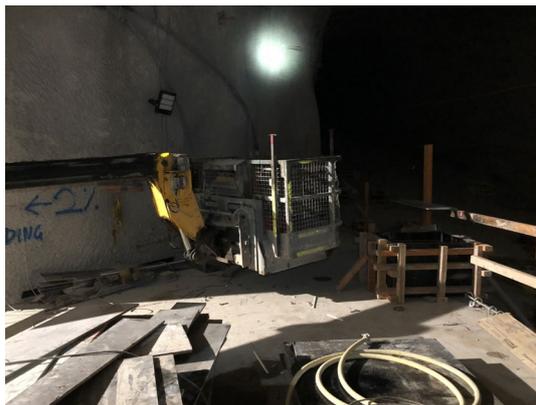
Dangerous incident
IncNot0039872
Underground
metals mine

Two electricians were in a man basket attached to the extended boom of a telehandler when the basket dropped to the ground. When the boom was extended, the telehandler overbalanced causing the basket to drop to the ground and the rear of the telehandler to lift. The basket dropped approximately 3.5

metres at a slow rate. The outriggers of the telehandler had not been extended due to the tight working location.

Before completing a task, a risk assessment tool must be used, and control measures put in place for identified risks. If identified controls such as outriggers are installed and cannot be used, Additional control measures must be identified and implemented through a risk management process.

Operators must be trained in identifying when a risk is present and how to control the risk. OEM recommendations must be taken into account when developing procedures for tasks.
