MINE SAFETY INVESTIGATION UNIT

Serious incident involving an inrush of water and cuttings in an underground mine

21 February 2010

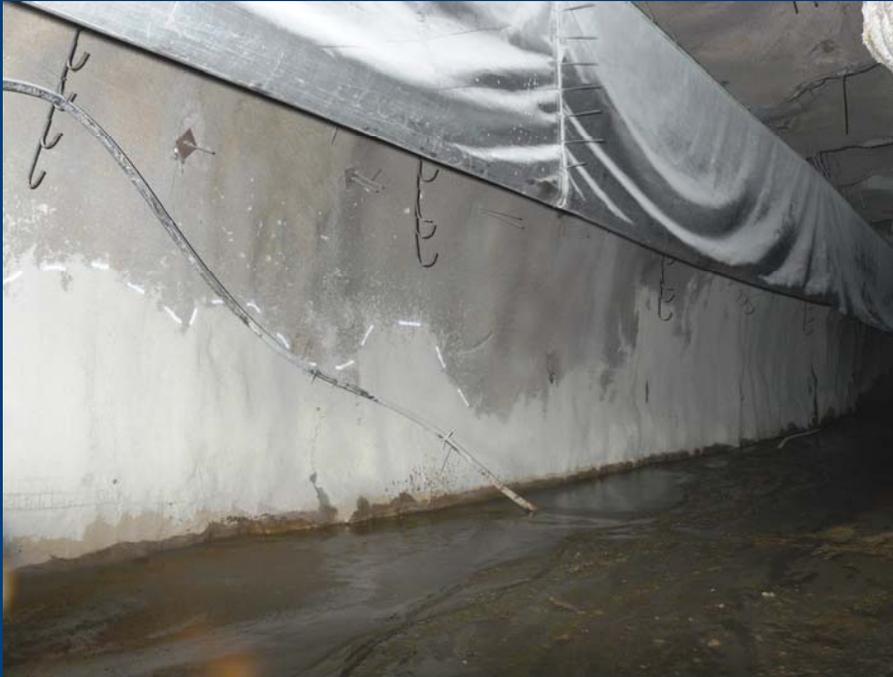
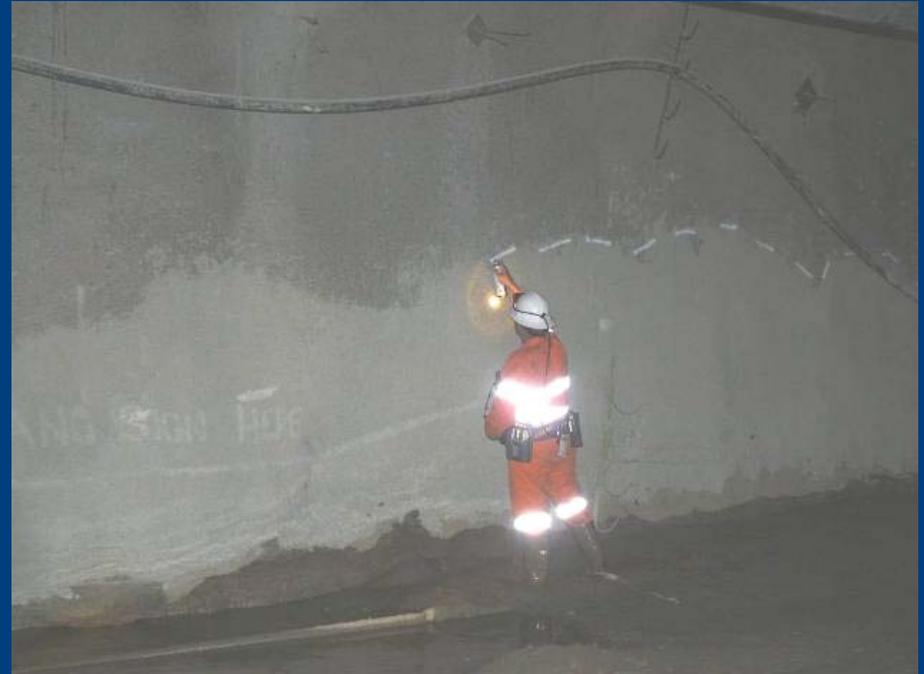
Inrush Flow

1. Inrush path commencing at the base of the ventilation shaft.
2. Height of inrush a short distance from the base of the ventilation shaft

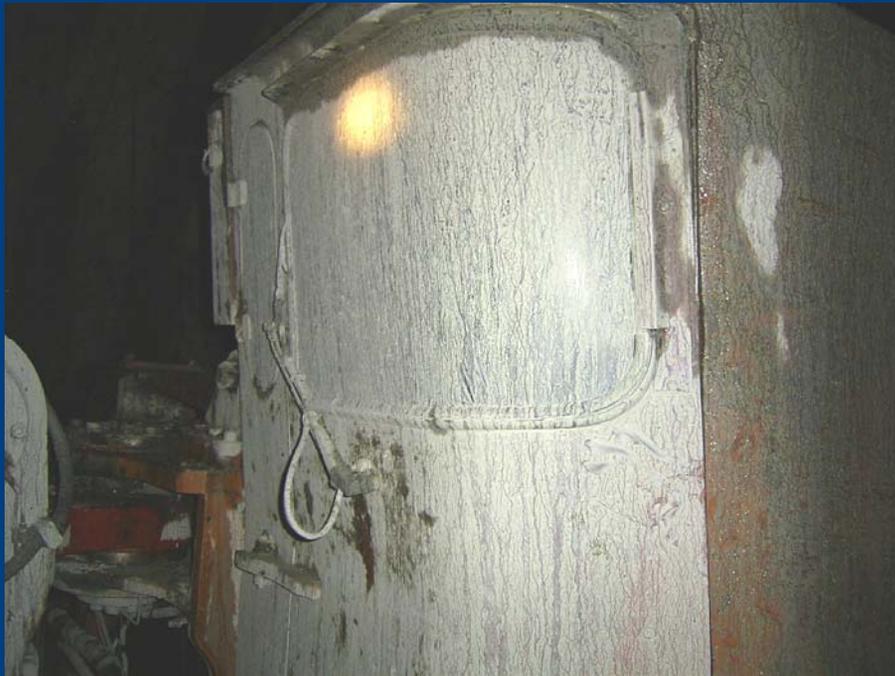
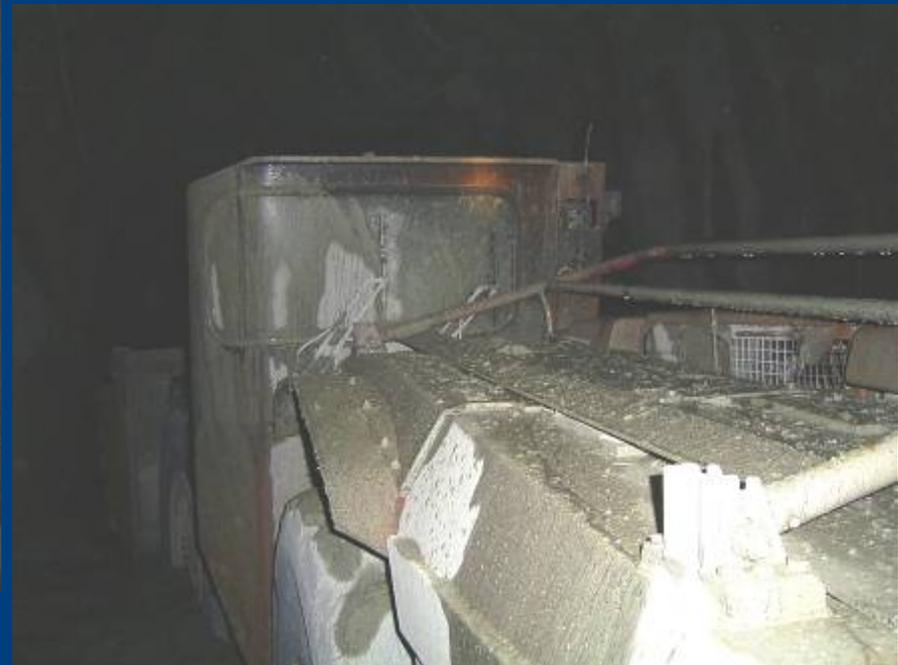
Bogger pushed 30-40 metres along drive

1. Mud material coating the front windscreen
2. Mud material coating bogger up to cabin level – rear view.

Height to top of cabin 2.99m

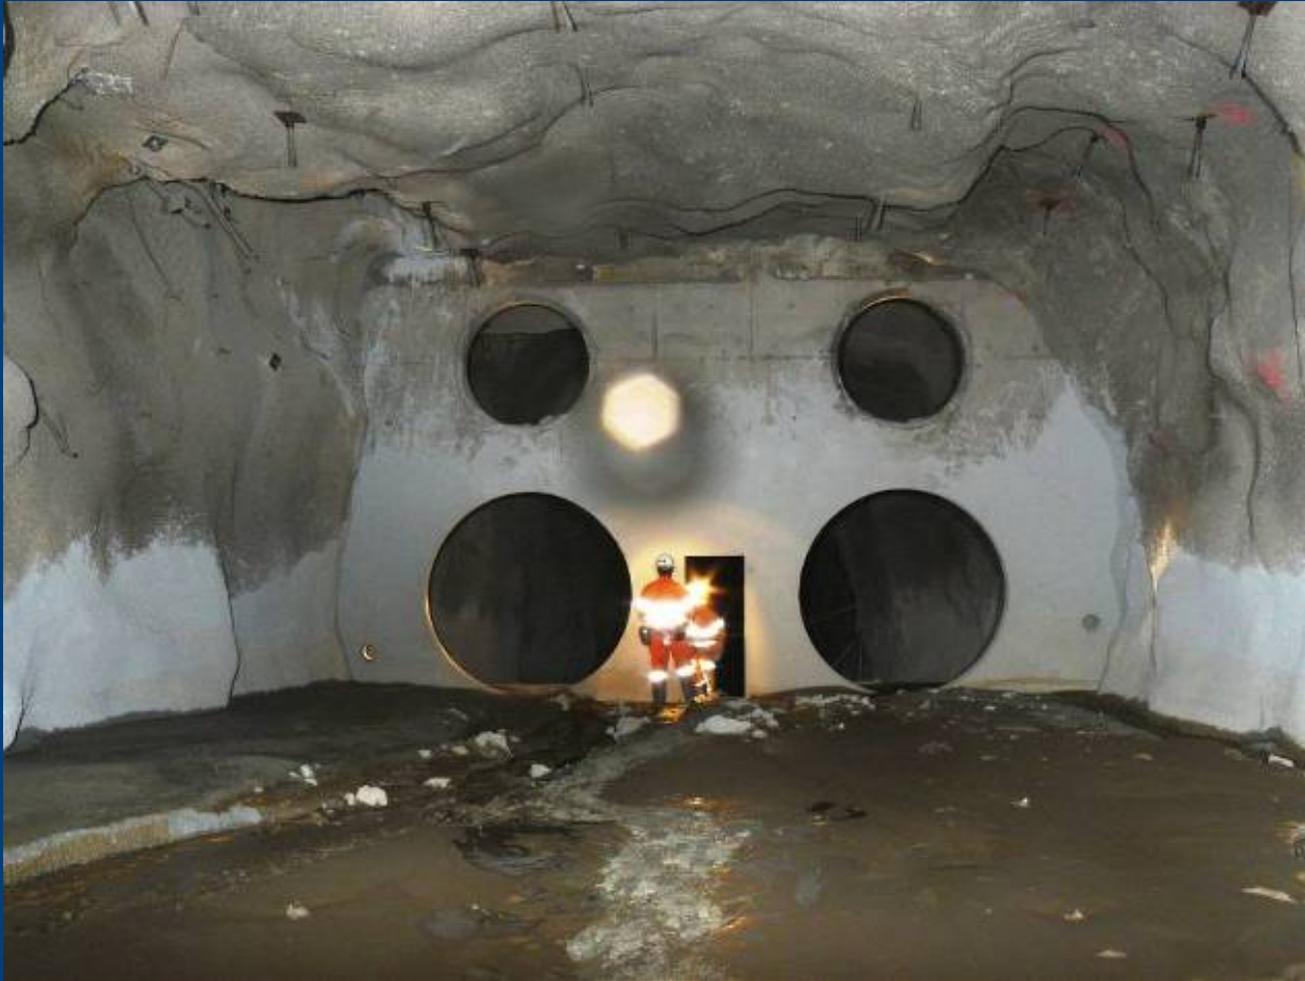
Inrush impacts ventilation structure

Note height of inrush material relative to persons standing in doorway

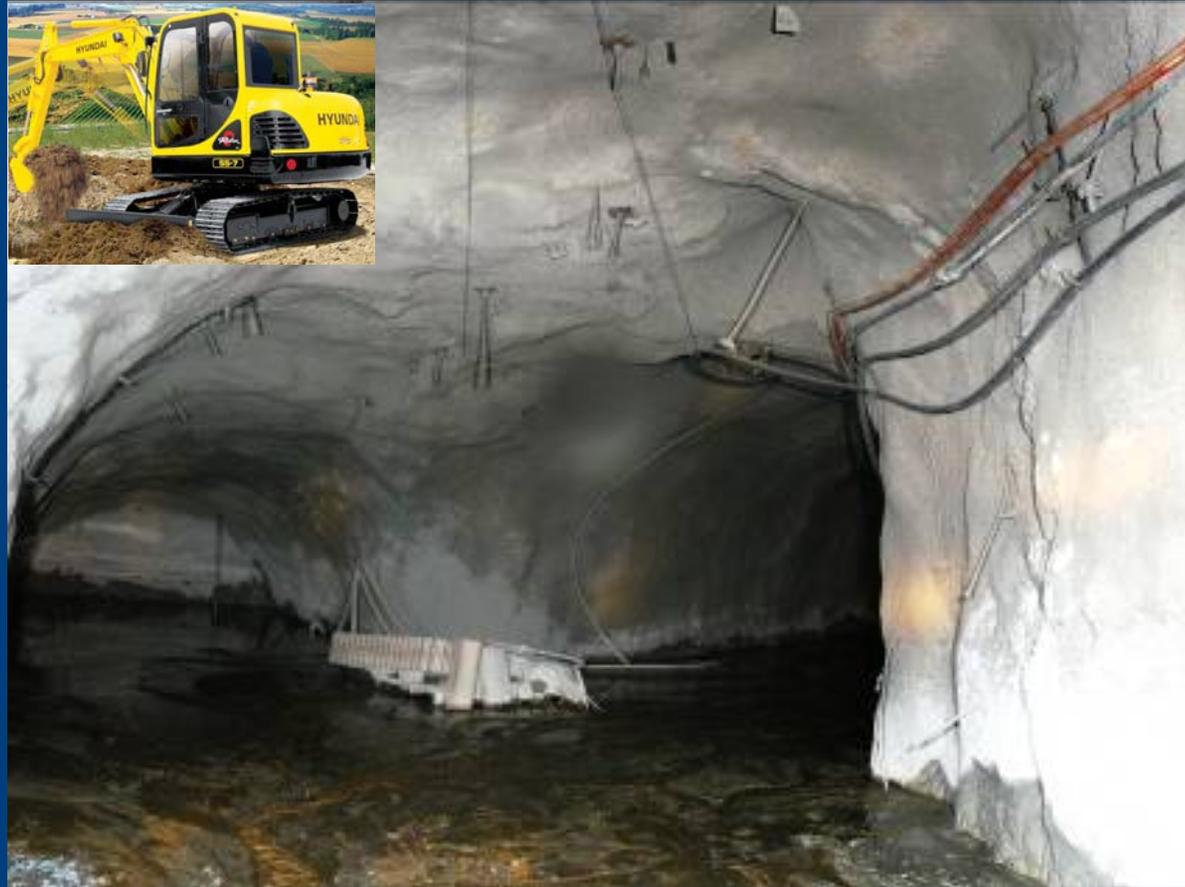
Top of second ventilation shaft

(814 metres from inrush site)

Six tonne excavator that was swept approx. 300 metres to the vicinity of the top of the second shaft is on its side with tracks exposed

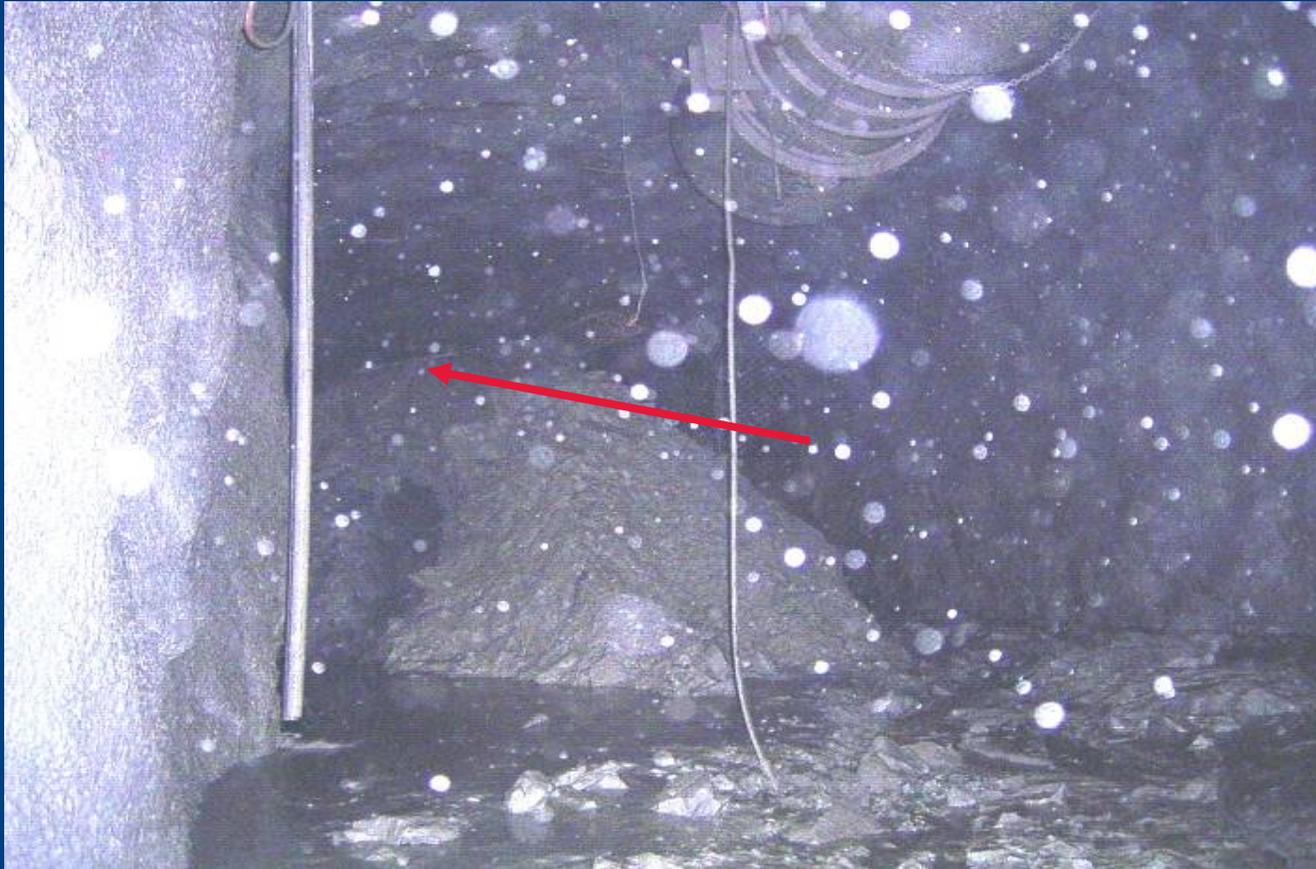
Bottom of second shaft

Red arrow points to vicinity where a mound of material and the brattice was located for ventilation purposes. Inrush material fell 375 metres to base of this shaft

The inrush washed away part of the mound of material and the brattice and consequently changed the ventilation in the mine.

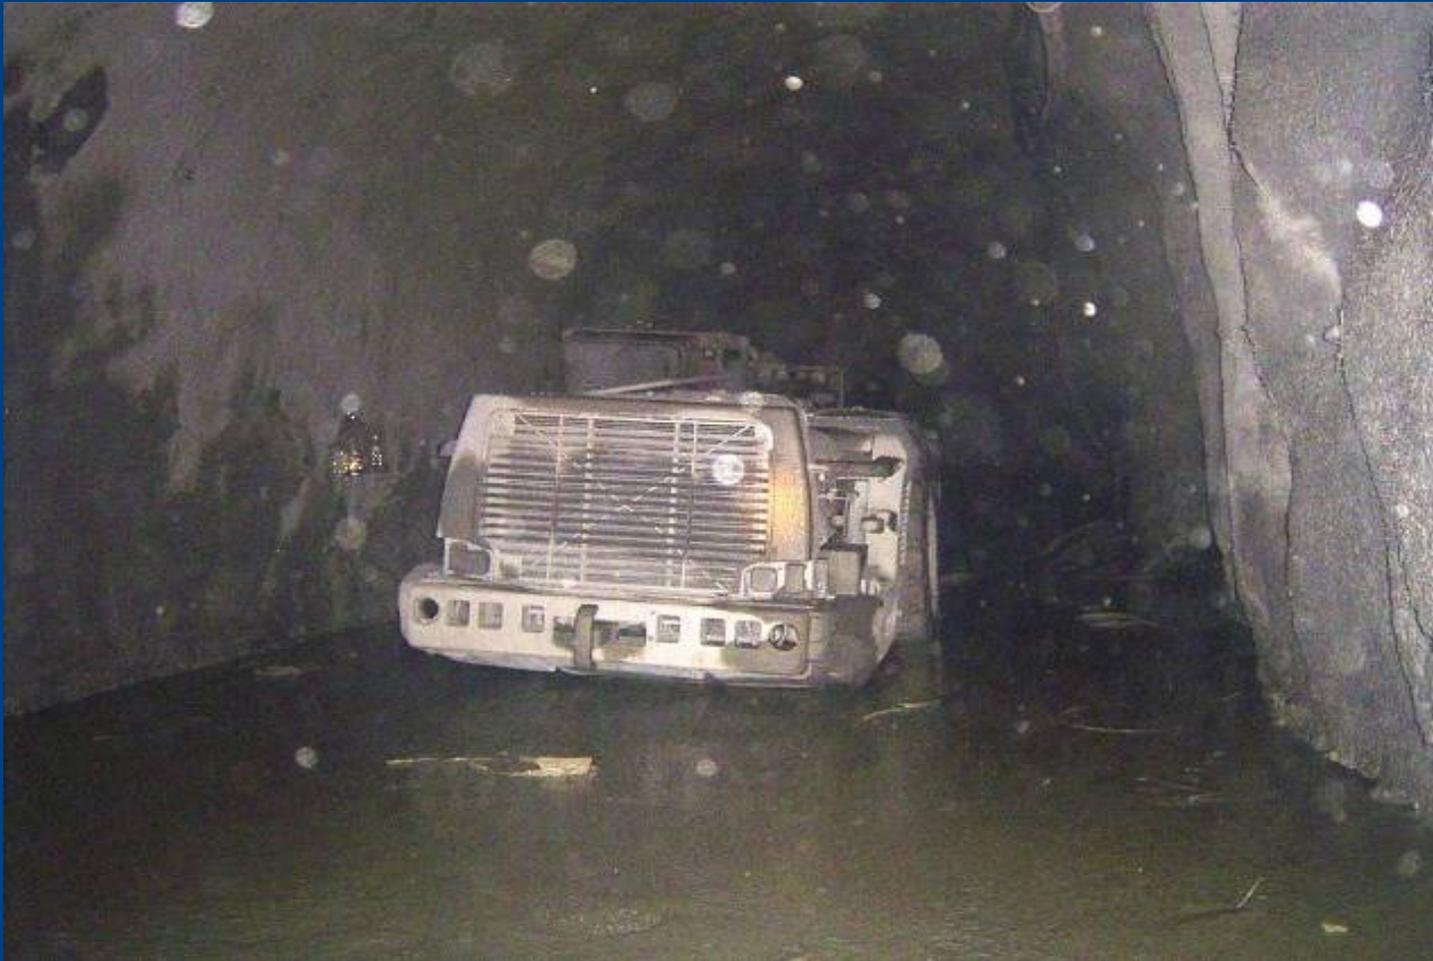
The second bogger impacted by inrush

This bogger was located nearby to the base of the 2nd shaft, it was struck by wet material and subject to a higher than normal wind velocity

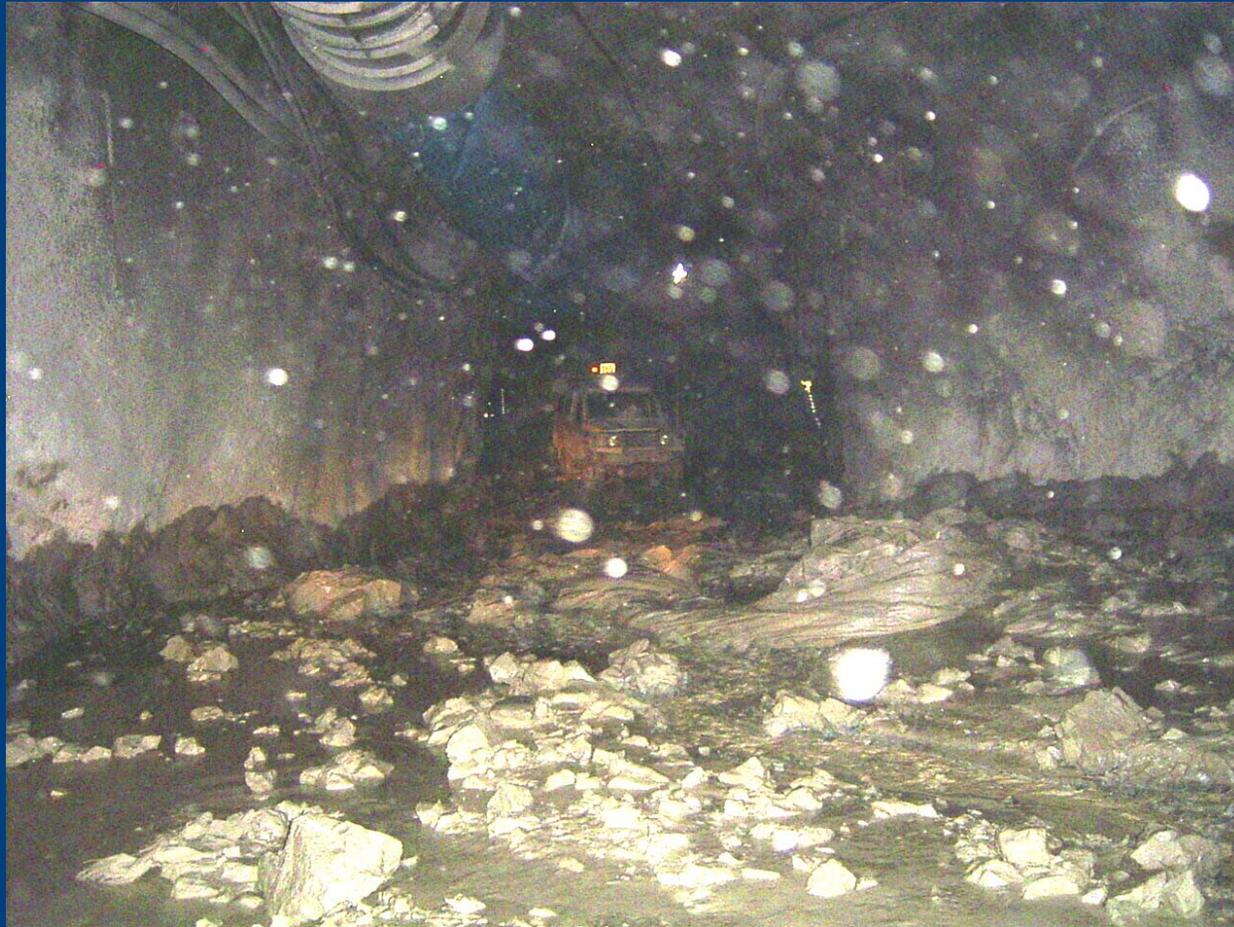
Light vehicle bogged by inrush material

Three persons in “bogged” light vehicle unable to drive through inrush material to exit the area.
