# MINE SAFETY INSPECTORATE

INVESTIGATION INFORMATION RELEASE

## High potential incident

**Event** Komatsu 730E dump truck crushes light vehicle

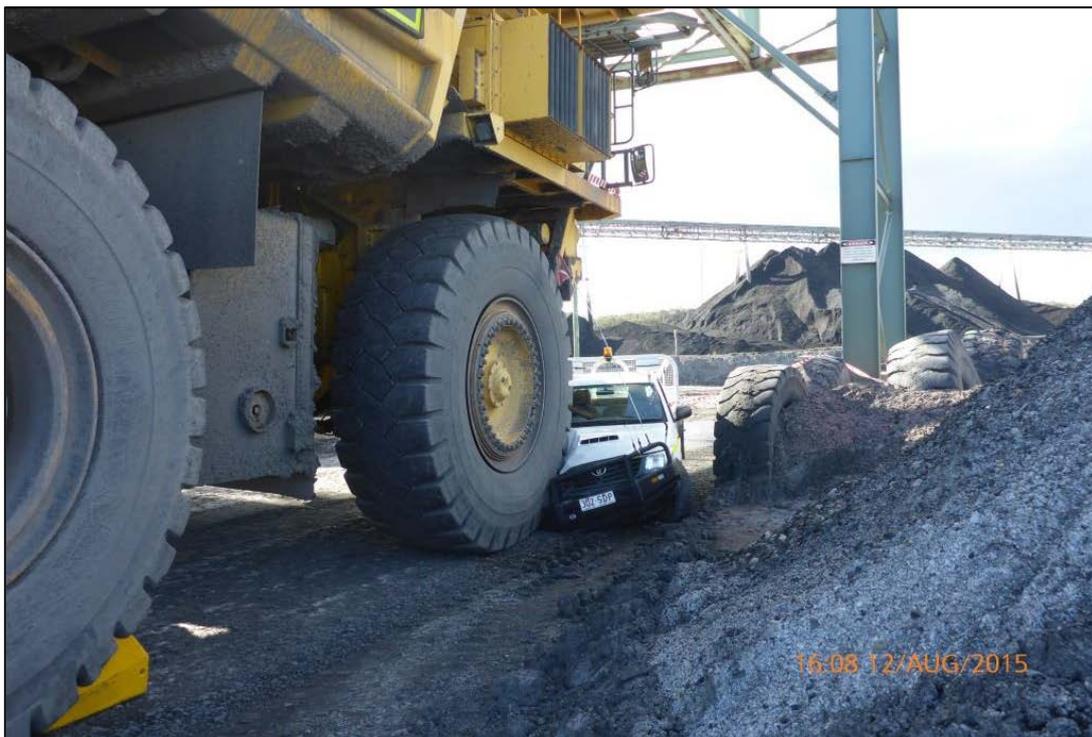
A 180 tonne Komatsu 730E dump truck rolled onto a light vehicle. A person sitting in the passenger seat exited the light vehicle via the passenger door window as the truck rolled forward.

Figure 1: Photograph of incident scene - photograph by Mine Safety inspector.

The starter motor test circuit was examined, and it was identified this circuit bypassed all interlocks required to be healthy to start the truck normally, including the park brake switch interlock. A level of protection was afforded by the use of a timer relay to limit the amount of time the engine would crank during a starter motor test to two seconds. This circuit was installed by the mine in 2005 after the truck was bought in 2004.

The consequence of bypassing the park brake switch interlock in this event was critical. When starting the engine via the starter motor test switch, if the park brake switch was in the off position, hydraulic pressure would have been developed in the park brake circuit disengaging the park brakes and allowing the truck to roll forward.

These procedures were in place at the mine, however were not adhered to in this incident. In reversing the truck out from under the bin, it was left parked on a grade without the wheels being chocked. The vehicle was not isolated when the wheel inspection was undertaken. The light vehicle was also parked under the bin, which was also not in accordance with site procedures and warning signs.
