SAFETY ALERT

Electric shock and arcing results from ineffective earthing

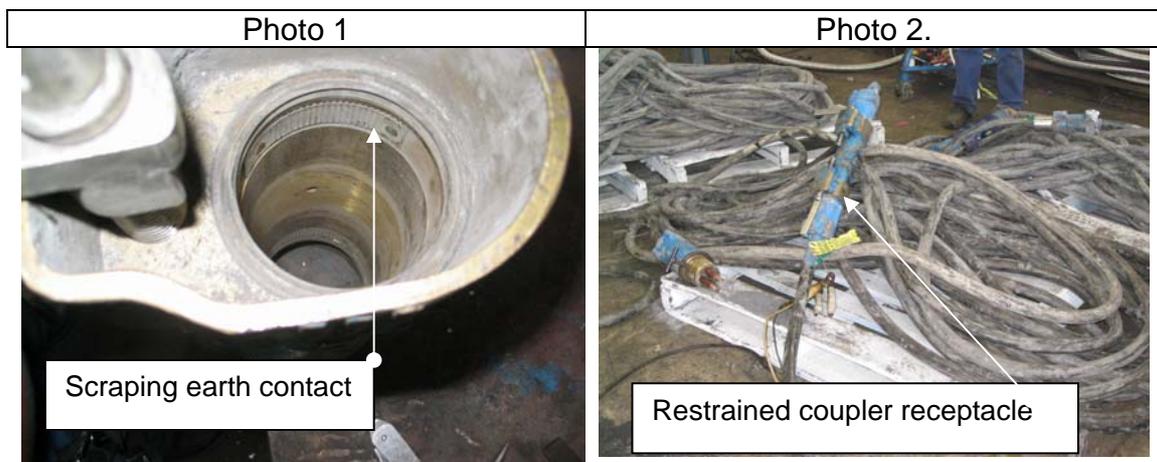
Incident 1: Power supply to an electrically powered hydraulic pump tripped on earth leakage and an operator found the handle of a jacking screw on a Restrained Coupler Receptacle (Back to Back) 'tack' welded to steel rib support mesh.

Incident 1: The scraping earth connection between the plug earth sleeve and receptacle body was not continuously effective.

- 1) The back-to-back coupler (photos 1 and 2) was examined and the scraping earth did not comply with Australian Standard AS1299. (Other receptacles utilising this scraping earth design may potentially have similar non-conformance.)

- 1) Mines should immediately inspect equipment in service to confirm integrity of earth connections.
- 2) Mines must ensure that tripping times for earth leakage relays and earth continuity relays are set to minimum values to achieve adequate prospective touch voltage/operating time characteristics.

- 5) Cable Repair Workshops and Approved Workshops receiving receptacles and cables of these types for repair should apply information from the product manufacturers to assess the compliance of product and mechanical integrity of scraping and internal earth connections.

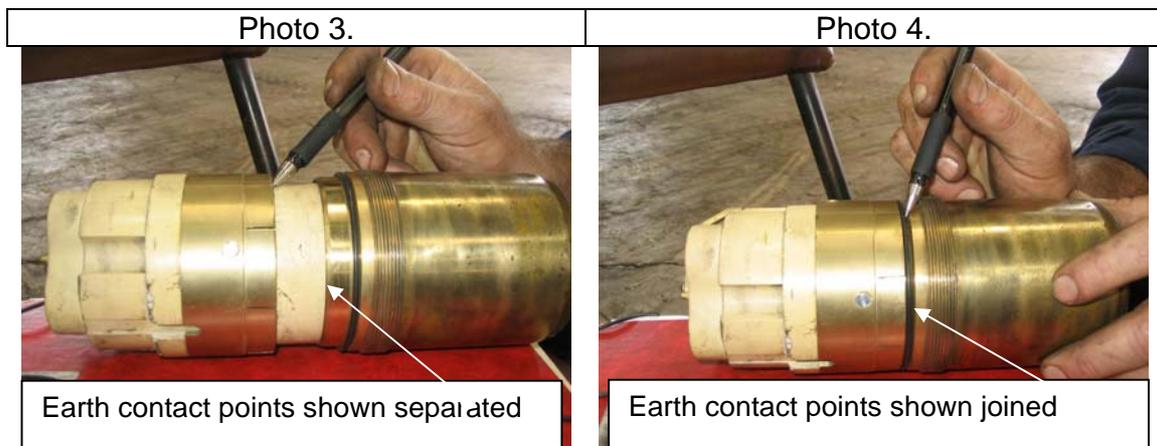
Incident 2: A trailing cable plug was found to have an ineffective earth connection inside the plug body between the earth sleeve and the earth attachment ring mounted on the moulded interior. Earth leakage trip times had an intentional and unauthorised delay. The earth continuity relay was set for pilot control however the external circuit was not wired for pilot control. (Drop-out resistance is increased approximately 300 per cent).

- 2) The cable plug (photos 3 and 4) was disassembled and the earth sleeve was found to have an unreliable contact with the earth ring attached to the moulded interior. (Other plugs utilising sliding or butt internal earthing connections may potentially have poor electrical integrity).

- b. Earth fault currents and earth leakage currents will be carried without danger to persons from electric shock, effects of arcing or fire.
- 4) Manufacturers should immediately investigate the effectiveness of earthing arrangements used on plug and receptacle products and arrange for the provision of adequate information to recipients of the product, to ensure safe use. In particular, information on tests and inspections to assess ongoing compliance with AS1299.
