SAFETY BULLETIN

Rocks breach catch bund

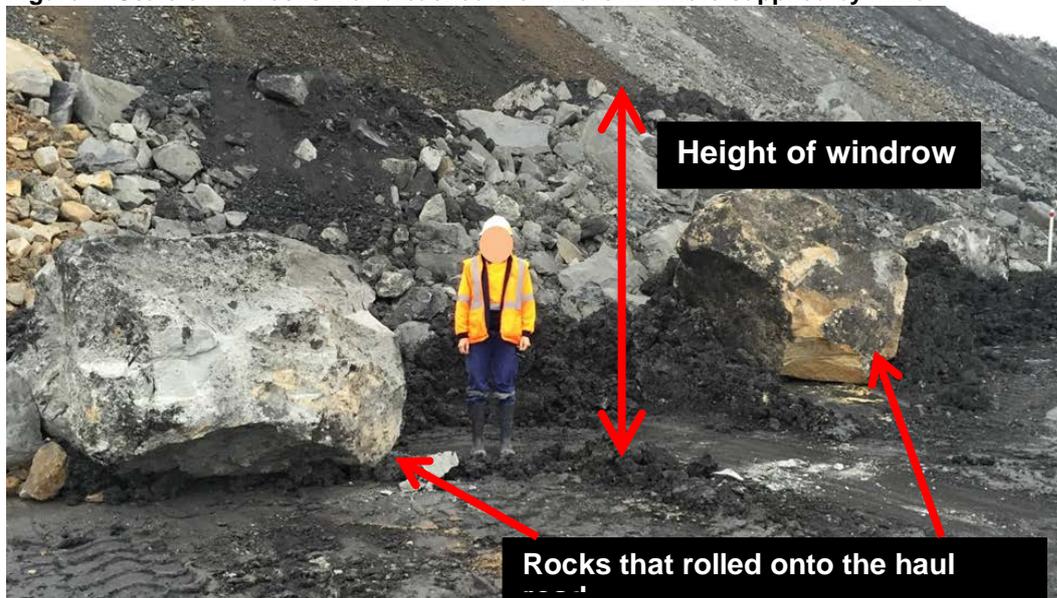
A recent incident involving rocks breaching bunding at the base of a dump occurred at a Hunter Valley mine, while dumping was taking place above an active haul road. The dump was about 40 m high and a substantial catch bund had been established at its base. The dozer operator checked the bund from the dump and believed it had sufficient capacity. During the shift, a truck stopped on the haul road below the dump, waiting for some spillage that was blocking the road to be removed. At that time, a number of rocks breached the windrow and came to rest about 15 m from the stopped truck.

Figure 1: Scale of the rocks that breached the windrow. Photo supplied by mine.

- It is poor practice to have any operations occurring below an active dump. Operations below an active dump should be avoided where possible.
- If it is unavoidable to exclude operations from below an active dump, an appropriate risk assessment of the hazard should be completed. The risk assessment should have input from those potentially at risk from the hazard.
- Additional controls must also be implemented to minimise the risk to those operating below a dump. These controls should include:
 - dumping in daylight only
 - dumping at a different location when traffic is below the dump
 - managing the size of the material so that oversized material is placed separately on the dump
 - increasing the size of the catch bund, both in terms of height and thickness

- reducing traffic, equipment and exposure levels in the work area below
- increasing inspection frequency based on the increased risk
- increasing supervision of the work being undertaken at both locations
- stopping access during the time of dumping a load.

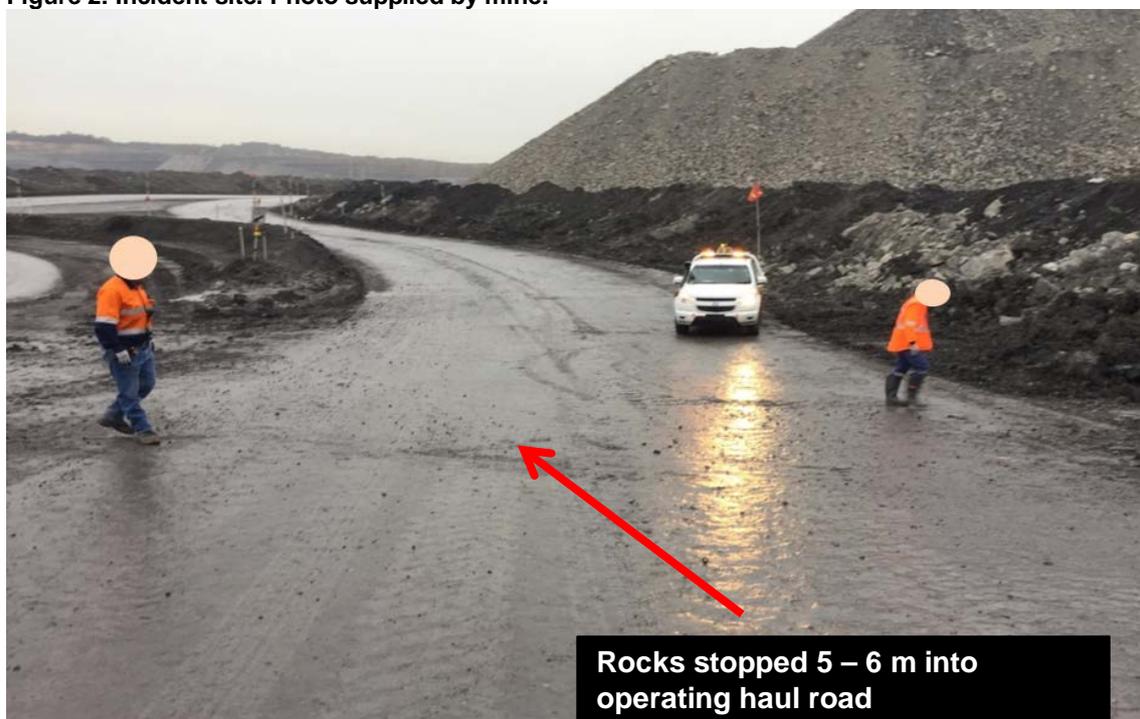
Another truck was observed dumping their load just prior to the breach. Rocks from this load have rolled out of the tray and continued down the dump slope. They have reached the bund and, with a combination of a partially filled bund and excess momentum, they have breached the bund and come to rest near the stopped truck.

The investigation conducted by the Resources Regulator established that the dozer operator did not identify that the catch bund was filling up. The dozer operator had only inspected the dump from the top of the dump, about 40 m from the breach point. Up until the breach, no supervisor inspections of the dump had been conducted during the shift.

Figure 2: Incident site. Photo supplied by mine.
