COMPLIANCE AUDIT PROGRAM

PERILYA BROKEN HILL OPERATIONS

Perilya Broken Hill Limited

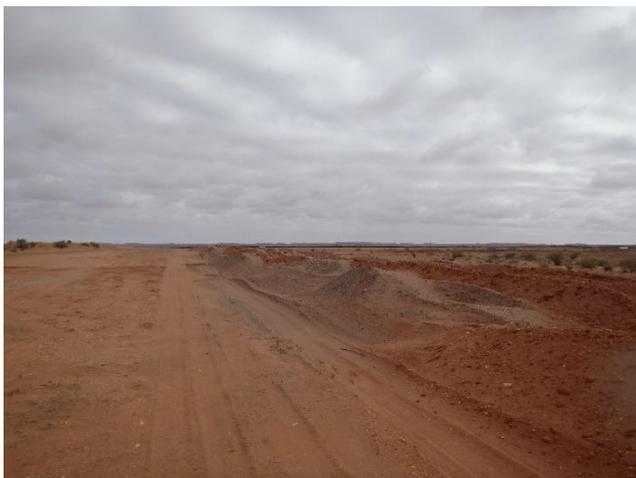
approved MOP. During the site inspection, it was observed that Perilya had stockpiled topsoil on the top of cell 1 at Site D TSF (refer to Figure 1) that is not consistent with the activities described in the MOP. This issue was raised as observation of concern no. 1. Perilya staff advised that an opportunity arose to recover some excess topsoil from a water pipeline project (unrelated to the mining activities). Given Perilya was forecasted to have a topsoil deficit in the long term, the opportunistic recovery of this topsoil was seen to benefit rehabilitation outcomes.

Figure 1 Windrowed topsoil stockpiles on cell 1 Site D TSF

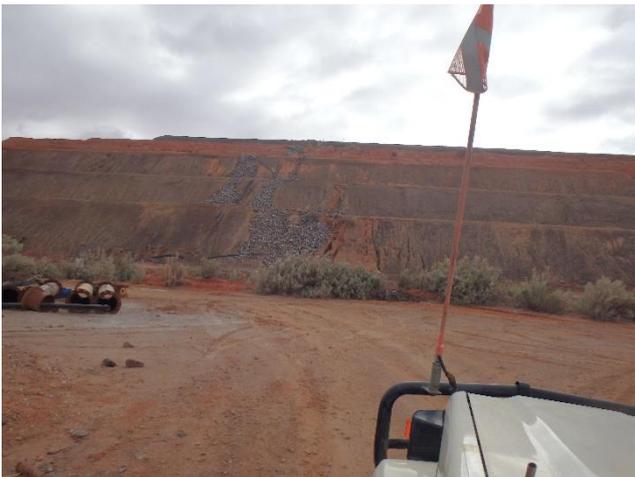
Erosion was observed at several sites within the Southern Operations area. For example, the embankments of the former tailings storage facility, Site A-B and the operational facility, Site D, had some deep erosion scours and rilling as shown in Figure 2 and Figure 3. Waste rock was being used as rock armouring to fill the erosion scours and stabilise the embankments (refer to Figure 4).

Figure 2 Erosion scours on the embankments of cell 1 Site D TSF

raised as non-compliance no. 1. Perilya should undertake a chemical characterisation of waste rock to be used for armouring of embankments and assess and manage any risks that arise from this use.

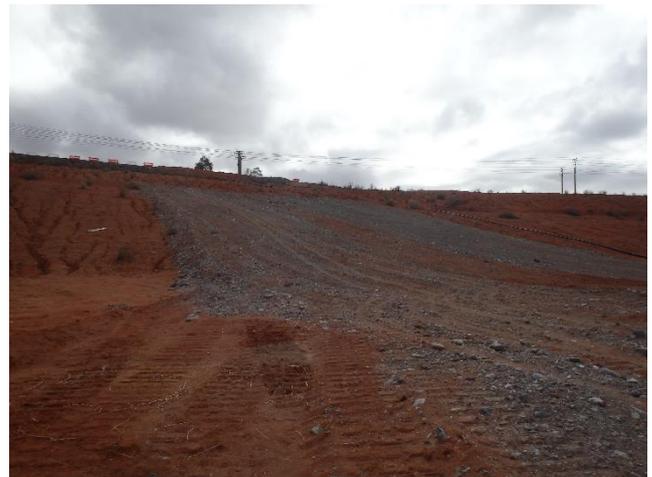
Figure 3 Waste rock being used to rock armour the TSF embankment

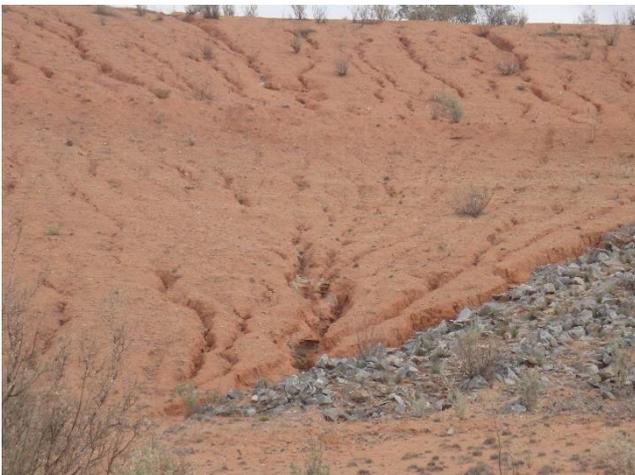
Figure 4 Erosion on the embankments of former TSF Site A-B

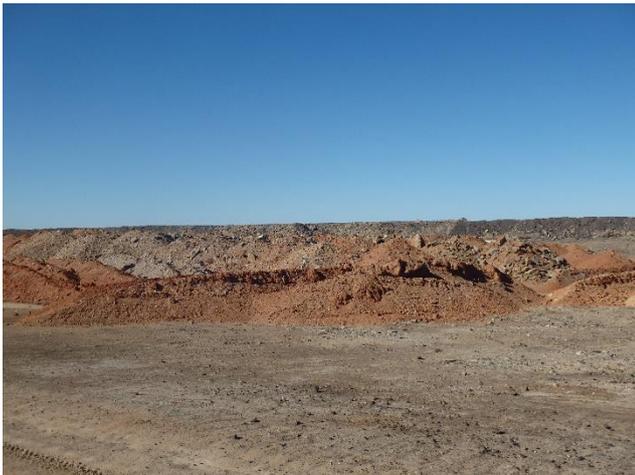
Sections 3 and 4 of the approved North Mine MOP provide a description of proposed activities over the MOP term. Condition 3 of the mining lease requires that operations are carried out in accordance with an approved MOP. During the site inspection, it was observed that Perilya had stockpiled topsoil on the top of a waste emplacement at North Mine (refer to Figure 5). This was not consistent with the description of activities provided in the MOP and was raised as observation of concern no. 4.

Discussions with Perilya staff identified that the topsoil was recovered during the recent construction of the evaporation ponds and was stockpiled on the waste emplacement awaiting reuse in rehabilitation. As with the Southern Operations site, the North Mine is forecast to have a topsoil deficit in the long term, so recovering available topsoil during construction activities is seen as beneficial to rehabilitation outcomes.

Figure 5 Topsoil stockpiled on the top of a waste emplacement at North Mine

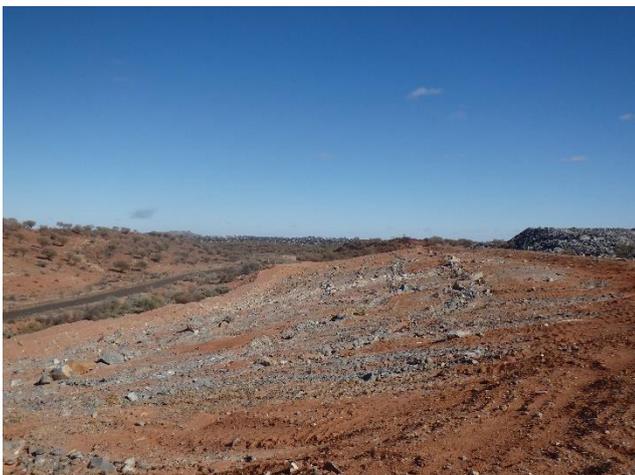
Inspections of the Potosi Mine by the Regulator in 2017 identified significant erosion on the batters of the Potosi WRE. The waste emplacement was inspected during the audit and it was observed that Perilya had undertaken significant remedial works to address the erosion issues on the WRE batters. Generally, the batters were reshaped and ripped along the contour (refer to Figure 6). This work stabilised the batters and no further evidence of erosion was observed.

Figure 6 Batters of the Potosi WRE reshaped and ripped

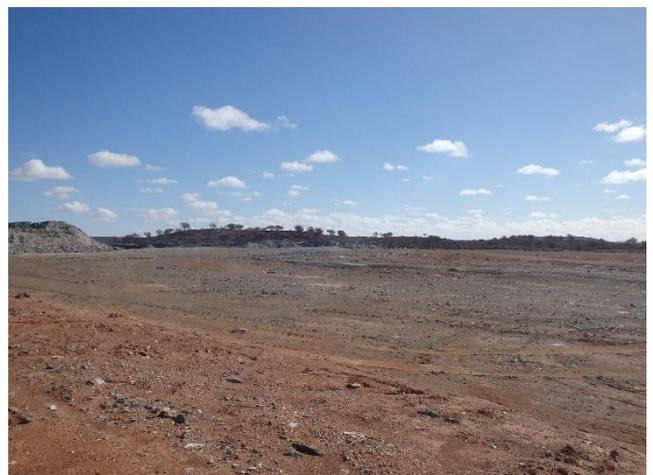
Figure 7 Storage of waste rock on top of the Potosi WRE

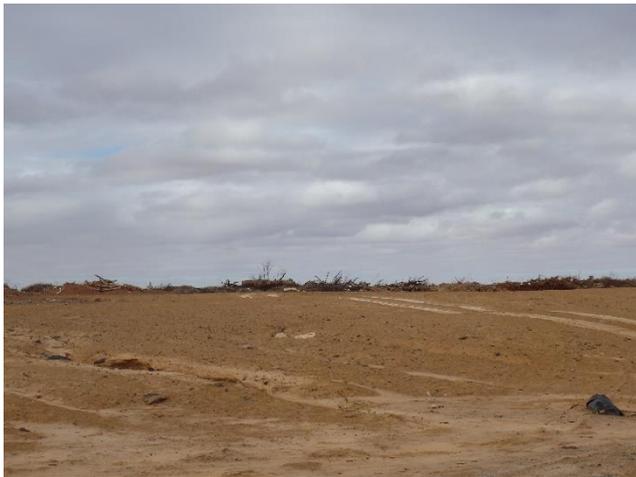
Figure 8 Part of Site C top surface - reshaped and used for storage of rehabilitation resources

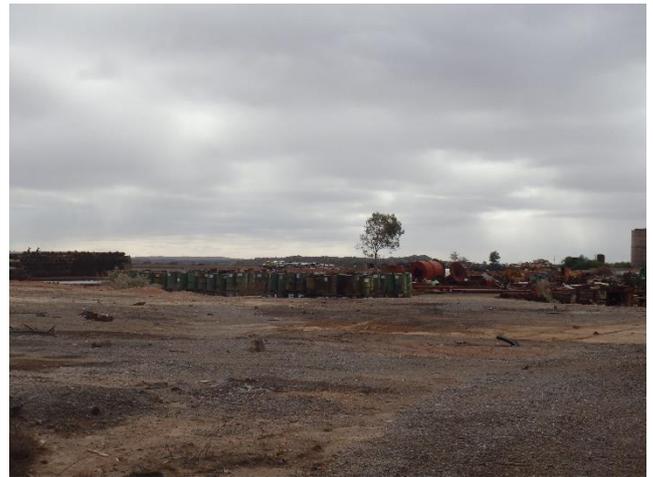
Table 15 in the Southern Operations MOP indicates that the Site C top surface would be in a decommissioning phase by 2018, with an indicator of completion being that the area was no longer in use and was recognised as a rehabilitation area. During the site inspection, it was observed that some areas of the Site C top surface were reshaped and being used for the storage of rehabilitation resources (refer to Figure 8). The remaining area of Site C top surface was still in use as a laydown area (refer to

Figure 9) and was not on track for land establishment by 2019 as indicated in the MOP. This is raised as non-compliance no.2.

Figure 9 Remainder of Site C top surface used as a laydown area

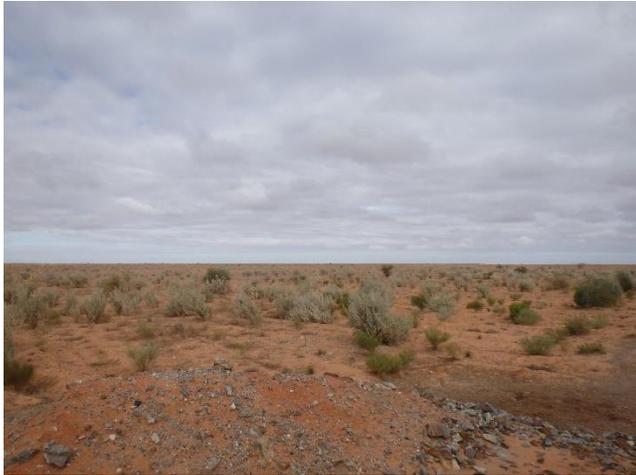
An inspection of the rehabilitation completed on the top of cells 1 and 2 at Site D showed that there were marked differences in rehabilitation success between the two sites. Vegetation establishment on cell 2 was reasonably good (refer to Figure 10), while vegetation establishment on cell 1 was poor (refer to Figure 11). No records of rehabilitation methodologies or monitoring data were available for review to determine why there was such a marked difference in rehabilitation between the two adjacent sites (for example, differences in topsoil depth, ameliorants applied, seeds mixes used etc).

Figure 10 Revegetation on cell 2 of Site D TSF

The lack of rehabilitation monitoring strategies and lack of rehabilitation records was raised as observation of concern no. 7. Perilya should review the rehabilitation monitoring strategies and develop and implement more effective strategies for monitoring the success of rehabilitation.

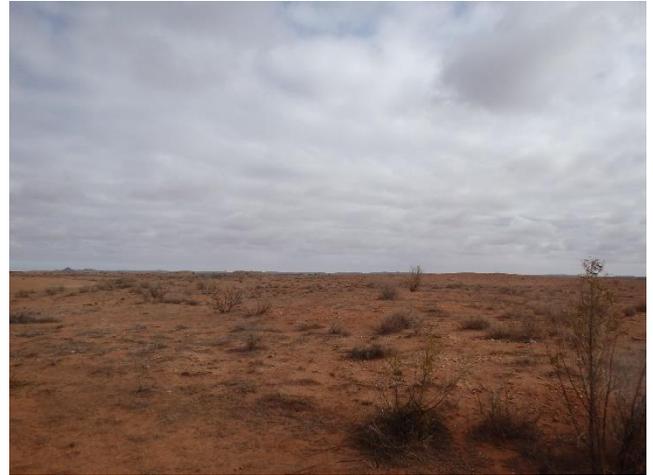
Figure 11 Revegetation on cell 1 of Site D TSF

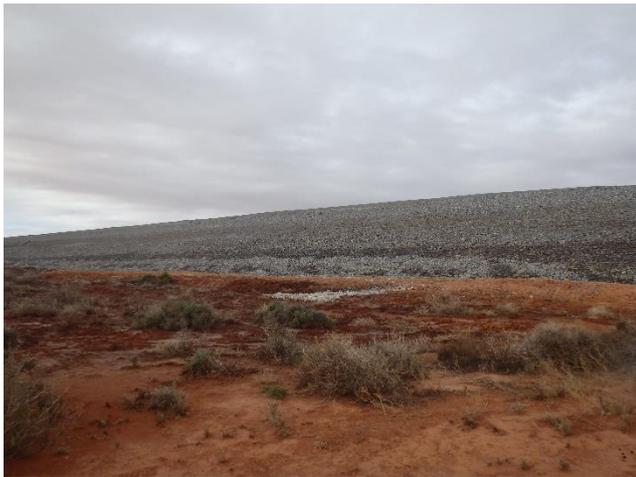
In September 2018, the Regulator’s inspectors identified a possible leak from the Site D TSF, which was impacting the area to the north of cell 3 (refer to Figure 12 and Figure 13). The Regulator referred the incident to the Environment Protection Authority (EPA) which issued a pollution reduction program to Perilya to contain and manage the surface and groundwater impacts.

Figure 12 Seepage from possible TSF leak

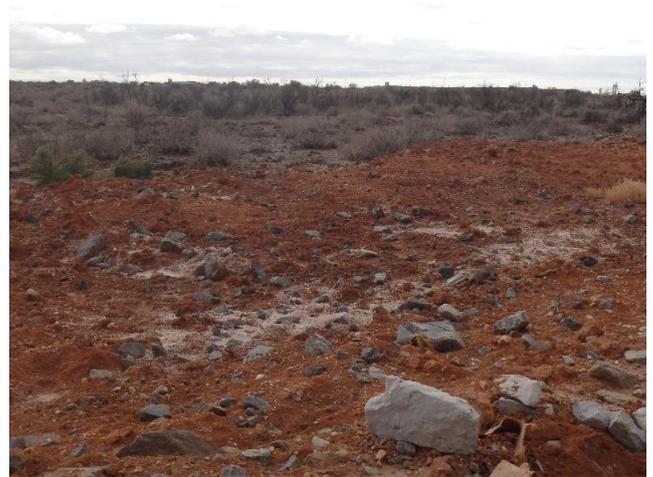
Figure 13 Salt scalding from possible leakage from Cell 3

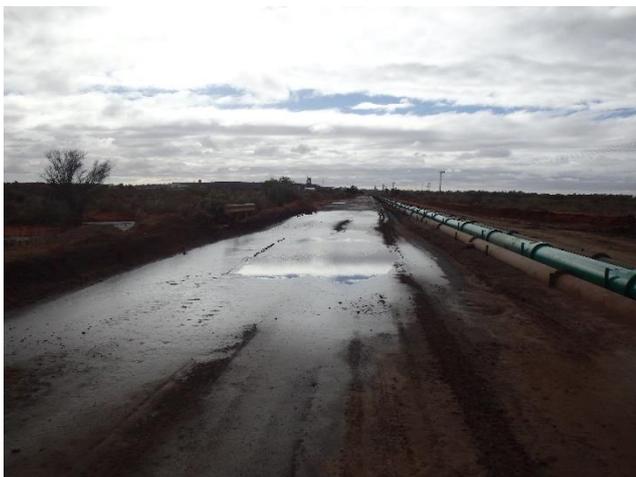
On 15 June 2019, Perilya notified a tailings line break to the EPA. Notification of the incident was made to the Regulator on 17 June 2019, which is compliant with the requirements of condition 5 of CML9. The area of the tailings line spill was inspected during the audit (refer to Figure 14 and Figure 15). The EPA is the lead regulator for this incident, but the Regulator will be reviewing the site remediation to monitor any risks to successful rehabilitation outcomes. Further testing and analysis, such as a sampling validation report, may be required to demonstrate that any contamination risks have been mitigated.

Figure 14 Site of tailings line leak at Site D TSF

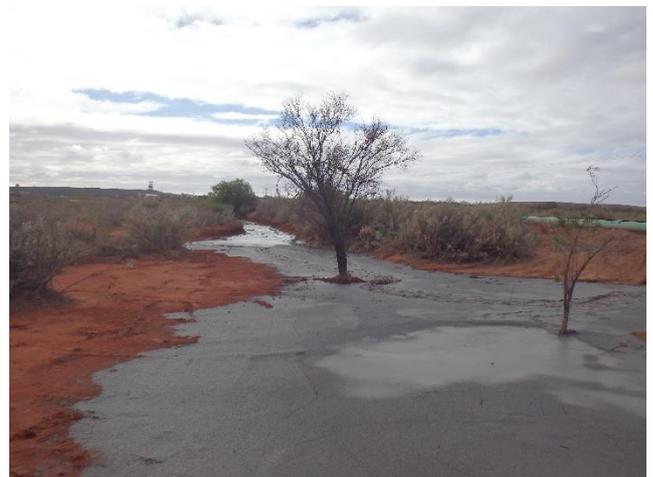
Figure 15 Tailings spillage at Site D TSF

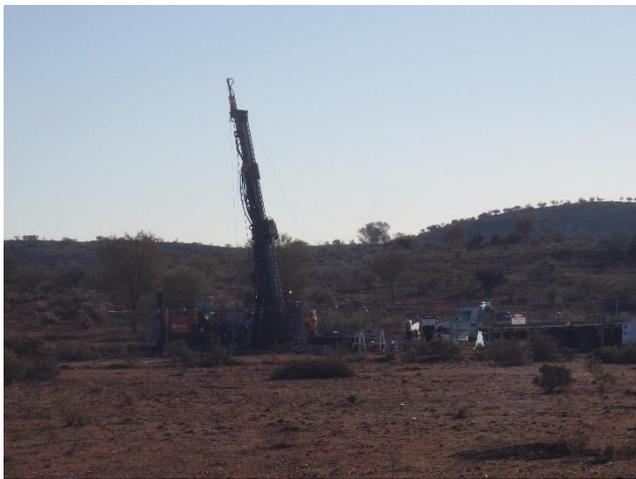
Drilling was in progress on CML5 (refer to Figure 16) and was inspected during the audit. Neither the conditions of title for CML5, nor the approved MOP specify requirements for environmental management of exploration drilling within the mining lease. Given there were no specific compliance requirements, the audit focussed on the environmental performance of the drilling activities.

Figure 16 Longstar Drilling exploration drill site in CML5

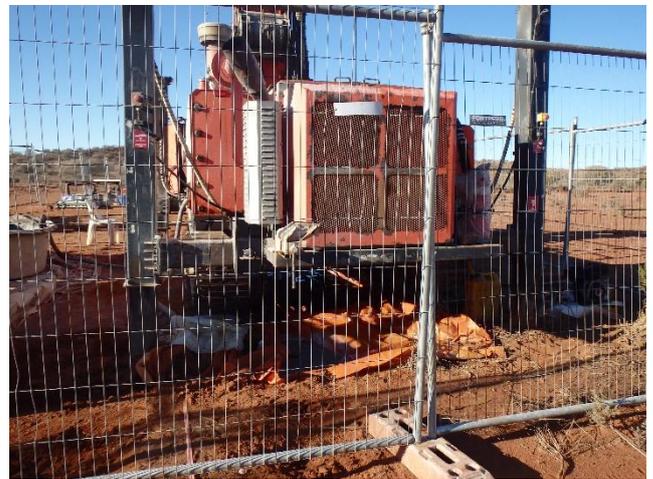
Figure 18 Use of spill control matting under the drill rig

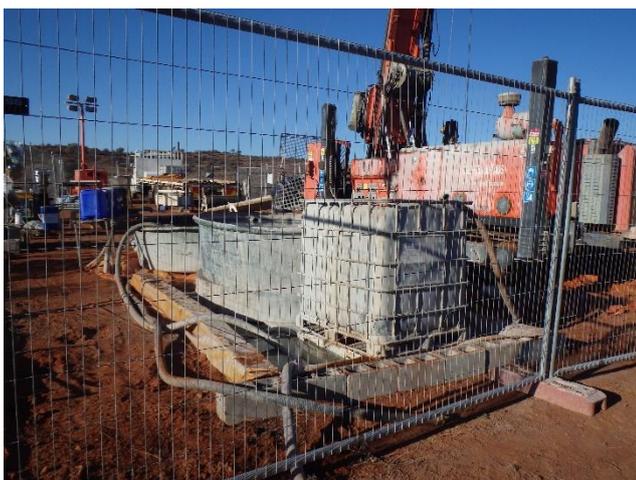
Figure 17 Use of bunded aboveground sumps

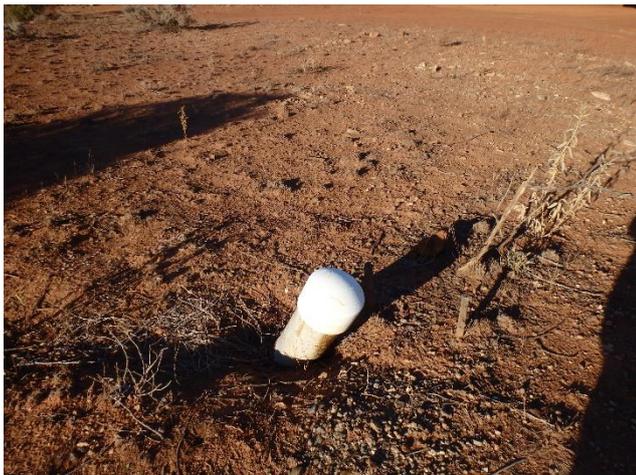
Section 2.3 of the approved MOP for the Potosi Mine identified that rehabilitation of exploration drill sites would be undertaken as soon as reasonably practical after completion of the drilling activities. Commencement of works to rehabilitate historic drill sites on CML5 was also proposed to be undertaken during the term of the MOP, with this rehabilitation to include cutting casing below ground level. During the site inspection, the auditors observed several historic drill collars (drilled about 2008) that were capped but had casing extending above the surface (refer to Figure 19). Given that some of those drill collars were within the Wilyama Common, casing above ground level could represent a public safety hazard. It was noted that the titleholder maintains a list of all drill holes that were capped or require further rehabilitation. A program is in place to progressively review the rehabilitation status of historic drill holes and complete outstanding works.

Figure 19 Hole drilled in 2008, casing still extending above ground level

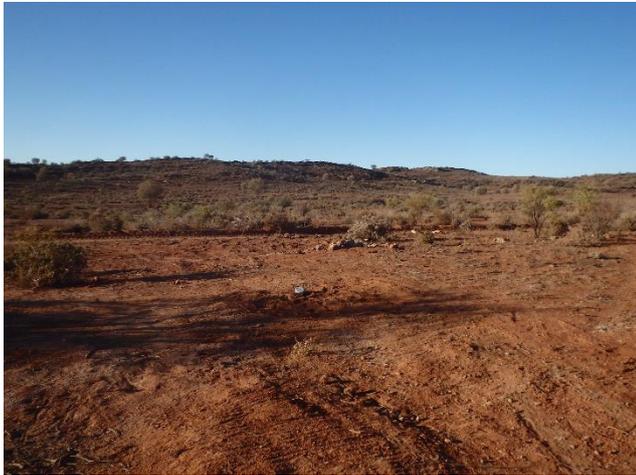
The holes drilled as part of the 2019 drilling program have been capped but have not had rehabilitation completed (refer to Figure 20 and Figure 21).

Figure 20 Hole PD515142, drilled 2019, capped but not yet rehabilitated

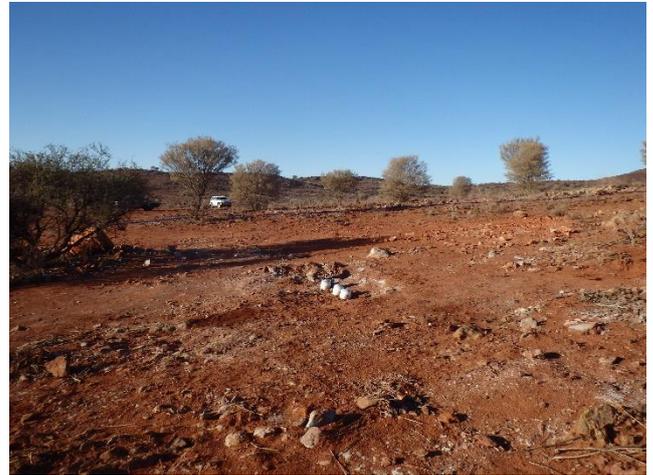
Figure 21 Holes PD515143 to PD515145, drilled 2019, capped

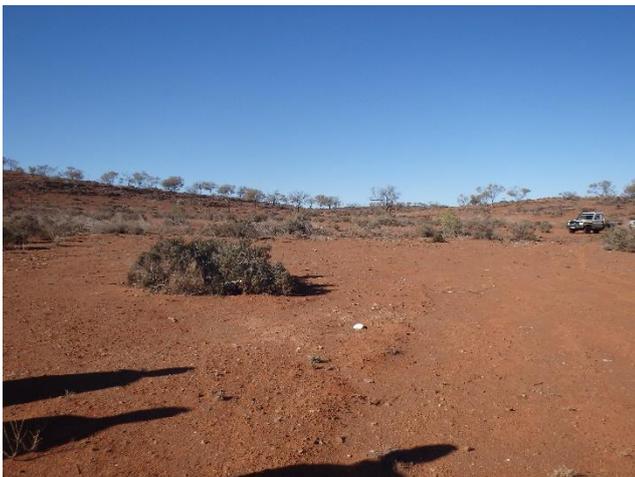
The holes drilled in 2016 were inspected and found to be capped but not grouted. The exploration manager advised that further downhole logging and other investigations may still be undertaken from these holes. Preliminary rehabilitation has been carried out, including removal of all drilling infrastructure and wastes and raking of the ground around each hole (refer to Figure 22 and Figure 23).

Figure 22 Hole LBH-111, drilled 2016 and capped

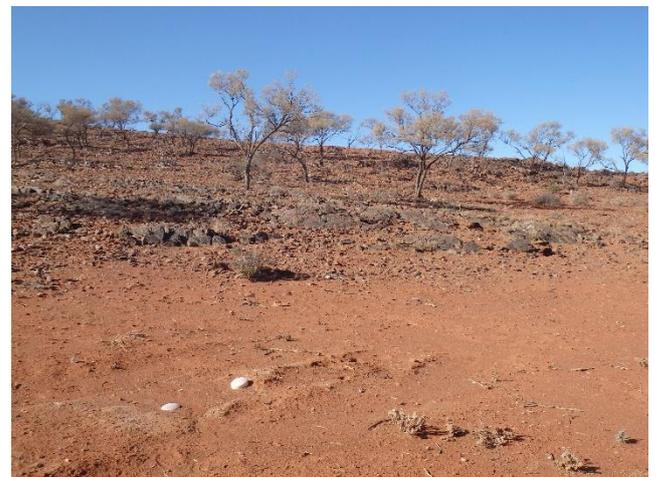
Figure 23 Holes LBH-109 and LBH-110, drilled 2019 and capped
