INVESTIGATION INFORMATION RELEASE

DATE: 4 JANUARY 2021

Worker pinned by falling loader cab

Location: Attunga Limestone Mine, near Tamworth, NSW

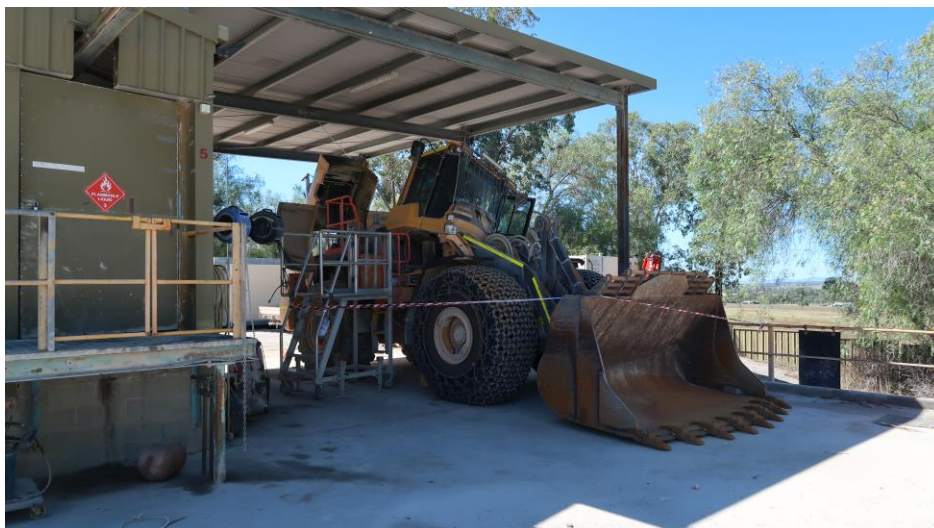
Figure 1 Volvo L220H loader with the cab in the raised tilted position

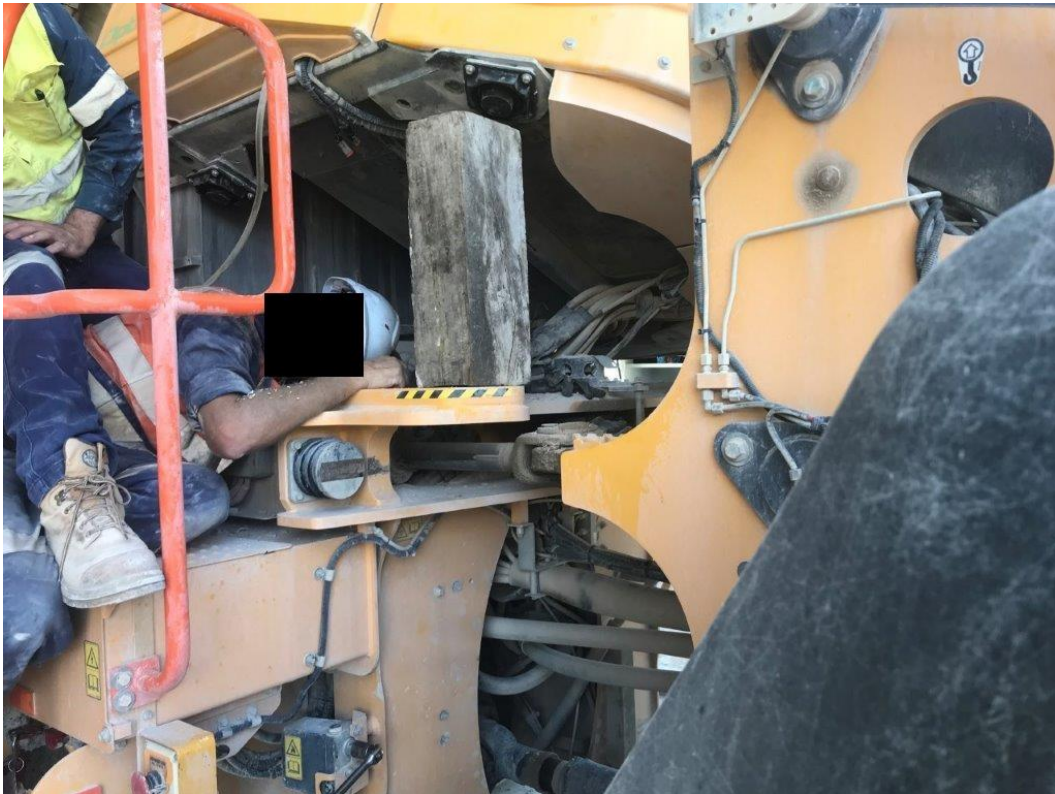
Figure 2 Position of the worker after the cabin was raised and a wooden chock provided by mine workers during the release of the worker

Thereafter, when the work was complete, the worker partially lowered the cab in order to reconnect harnessing and straps. The worker again relied upon the single hydraulic ram to hold the cab structure in position while he entered the crush point under the cab to reconnect a strap without using a secondary cab support device. The hydraulic ram suddenly released causing the cab to lower onto the worker's upper body and trap him between the cab and the chassis.

Mine workers and contractors should never place a body part in a crush point under a suspended load without secondary support devices, such as locking pins, support bars and timber chocks, being provided.

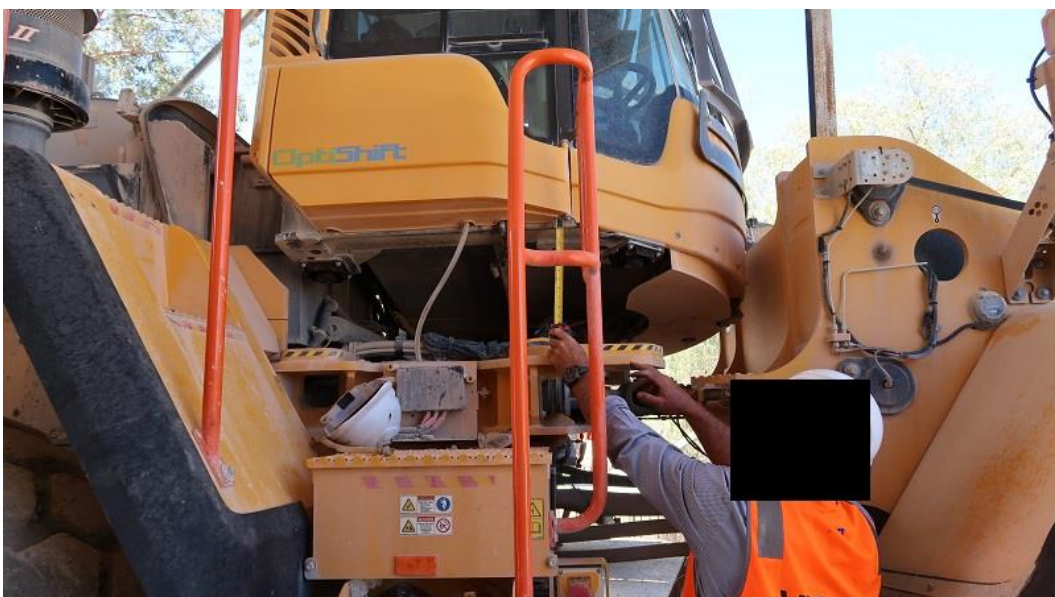
Figure 3 Simulation of the crush point height and the cab position just prior to the incident

Post-incident testing identified that the hydraulic control system would release unexpectedly and allow the cab to descend if the cab structure was bumped with adequate force while in the near lowered position (when raised approximately 350mm).

- review cabin tilt designs so that the position of tilt cylinder floats are not in a range that will allow access for a person to position or reach under the cabin.
