INVESTIGATION INFORMATION RELEASE

Worker pinned by falling loader cab

Incident date: 30 November 2020

Location: Attunga Limestone Mine, near Tamworth, NSW

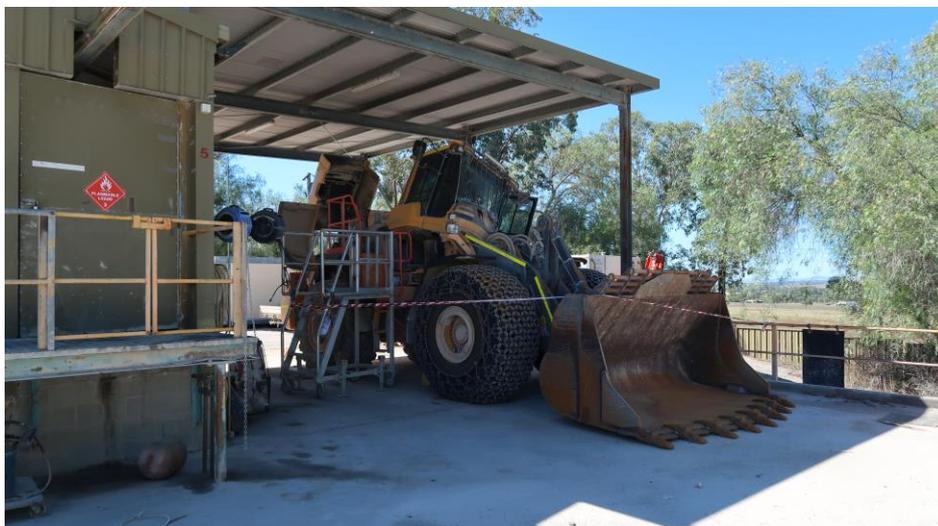
Figure 1 Volvo L220H loader with the cab in the raised tilted position

A contract maintenance worker attended the site to service a Volvo L220H loader in the mine's service bay. The worker was tasked with changing cab mounts on the loader and needed to raise the cab to access components underneath it.

The worker consulted Volvo's procedure for raising the cab which required the worker to utilise a manual hydraulic pump to raise the cab to a level where it could be secured with a purpose-built locking pin fitted to the frame of the loader. However, because the wiring harness and straps of an aftermarket device fitted under the cab structure were too short, the maintenance worker needed to disconnect the harness and straps to enable the cab to be raised. Despite disconnecting the harness and straps, the worker did not raise the cab to its normal lock out position due to his perception that further harnessing and hoses were interfering with the cab being raised. He conducted the servicing work with the cab supported only by the hydraulic ram with no locking pin in place. There was otherwise no procedure that took account of any inability to raise the cab to the level of the locking pin by mandating, for example, the use of a secondary cabin support device.

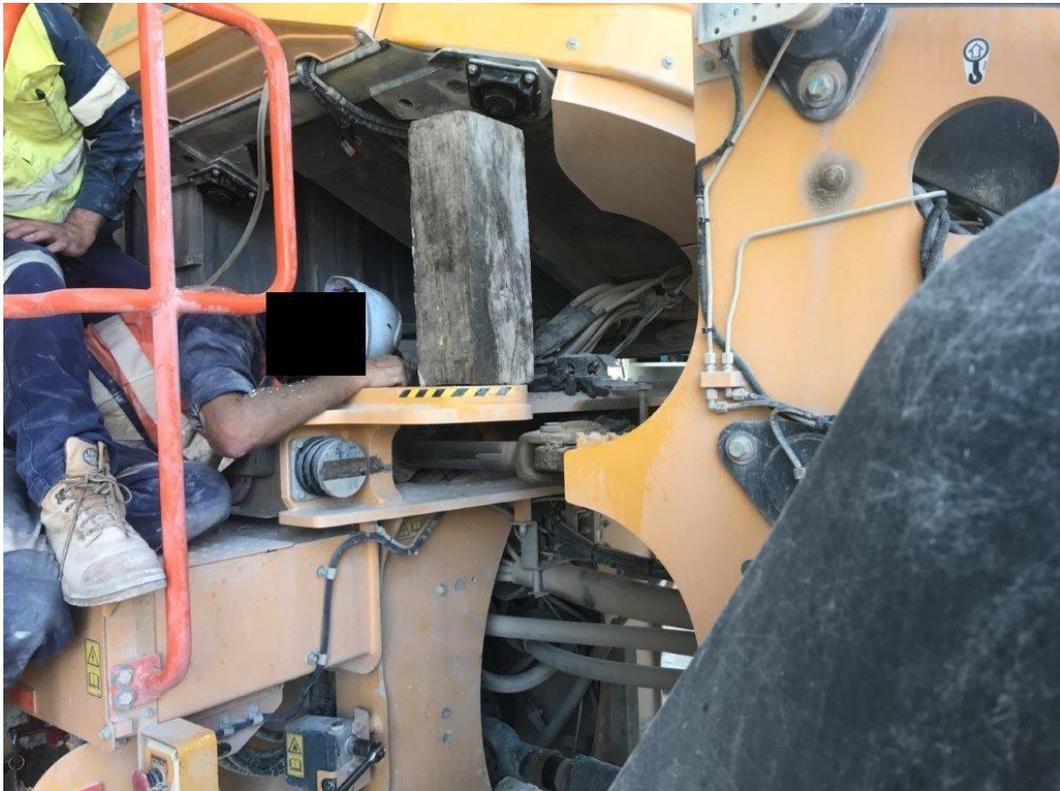
Figure 2 Position of the worker after the cabin was raised and a wooden chock provided by mine workers during the release of the worker

Thereafter, when the work was complete, the worker partially lowered the cab in order to reconnect harnessing and straps. The worker again relied upon the single hydraulic ram to hold the cab structure in position while he entered the crush point under the cab to reconnect a strap without using a secondary cab support device. The hydraulic ram suddenly released causing the cab to lower onto the worker's upper body and trap him between the cab and the chassis.

The worker was freed from underneath the cab with the assistance of nearby mine workers. He sustained soft tissue injuries and was transported to hospital for medical review.

- ensure that maintenance workers do not enter crush points under suspended loads which are not adequately supported
- ensure that maintenance workers use a secondary support device while working under suspended loads
- ensure that procedures are risk assessed and accurately reflect tasks performed by workers
- provide adequate supervision of maintenance workers to ensure that, when task procedures have changed from those originally planned, adequate new risk control measures are put in place
- provide adequate supervision and observation of contract maintenance workers who are required to work alone in areas of the mine that are not regularly attended by other workers
- review aftermarket wiring harnesses and hydraulic hosing installed on mobile plant to ensure they are installed and operate to prevent unintended risks arising from changes to the original operating design

Mine workers and contractors should never place a body part in a crush point under a suspended load without secondary support devices, such as locking pins, support bars and timber chocks, being provided.

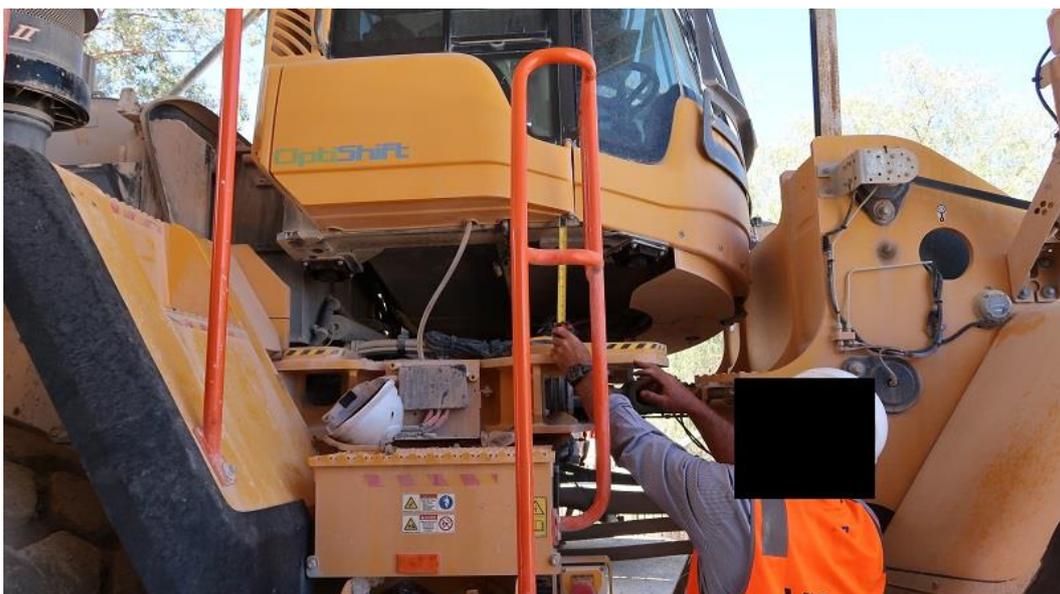
Figure 3 Simulation of the crush point height and the cab position just prior to the incident

Post-incident testing identified that the hydraulic control system would release unexpectedly and allow the cab to descend if the cab structure was bumped with adequate force while in the near lowered position (when raised approximately 350mm).

- review cabin tilt designs so that the position of tilt cylinder floats are not in a range that will allow access for a person to position or reach under the cabin.
