WEEKLY INCIDENT SUMMARY

Week ending Friday 19 February 2021

This incident summary provides information on reportable incidents and safety advice for the NSW mining industry. To report an incident to the NSW Resources Regulator: phone 1300 814 609 24 hours a day, 7 days a week.

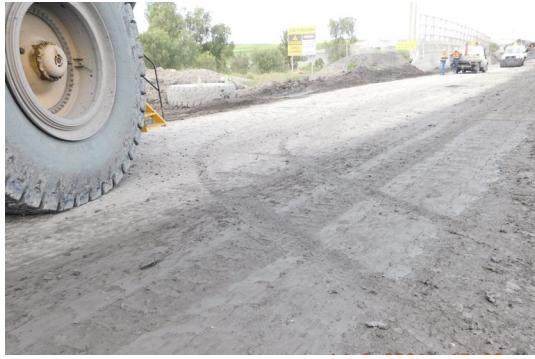
| INCIDENT TYPE | SUMMARY | COMMENTS TO INDUSTRY |
|---|--|---|
| Dangerous incident IncNot0039232 Open cut coal mine | The drivers of a light vehicle and a haul truck had to take evasive action to avoid colliding at an intersection. The light vehicle driver stated that he did not see the truck. | Principal hazard management plans for roads or other vehicle operating areas should consider factors that may affect operator visibility or ability to control a vehicle. Fog, sunlight, storms or dust obstructions can affect lines of sight. Drivers should be reminded to travel at speeds suitable for the conditions. Vehicle operators need to ensure that windscreens are kept clean to aid visibility. Collision detection and avoidance systems, visual aids and segregation should be implemented before relying on procedural controls. |

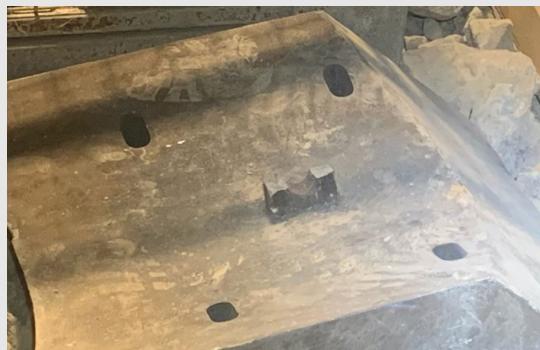
An underground worker sustained two fractures to his leg when he was hit by a chute liner, that fell to the ground, when a lifting lug on the liner failed. The liner weighed about 205 kilograms.

Mine operators must provide safe systems of work. The work methods and controls used must consider the risk of falling material, the positioning of workers, and the use of mechanical aids. Whenever there is a possibility that objects can fall, appropriate no-go zones should be established to protect workers. No-go zones should be clearly delineated and communicated to all workers in the vicinity. When establishing a no-go zone, as a control for falling objects, bouncing or ricochetting must be considered.

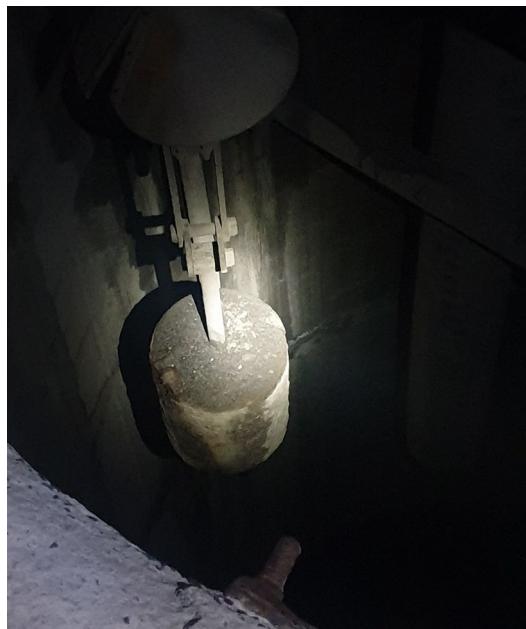
A loader operator who was cleaning the bottom of a shaft discovered a cheese weight had fallen from a friction winder. Approximately 80% of the cheese weight fell from a cage guide rope.

Mine operators must ensure that stringent monitoring and quality control of maintenance and repair activities is undertaken on winders. Enough time and resourcing must be allocated for maintenance and repair tasks.

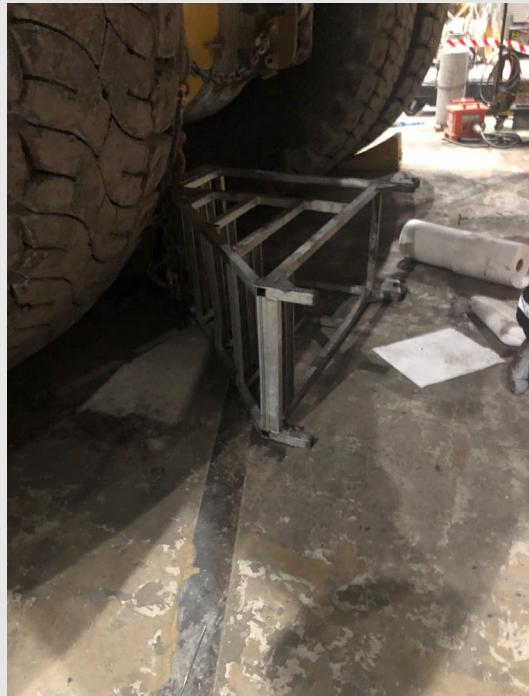
A worker who was removing a sling from a haul truck was found unconscious on the floor of the workshop.

Mines should have documented procedures for the installation and removal of body slings.

When a risk of falling is present, mine operators must assess the risk and minimise the risk of fall by providing adequate protection against falls.

Work platforms must be fit for purpose with handrails in place as appropriate. In-house design of work platforms should be done in consultation with the mobile equipment OEM.
