SAFETY ALERT

DATE: FEBRUARY 2021

Underground loader makes contact with development drill rig (jumbo)

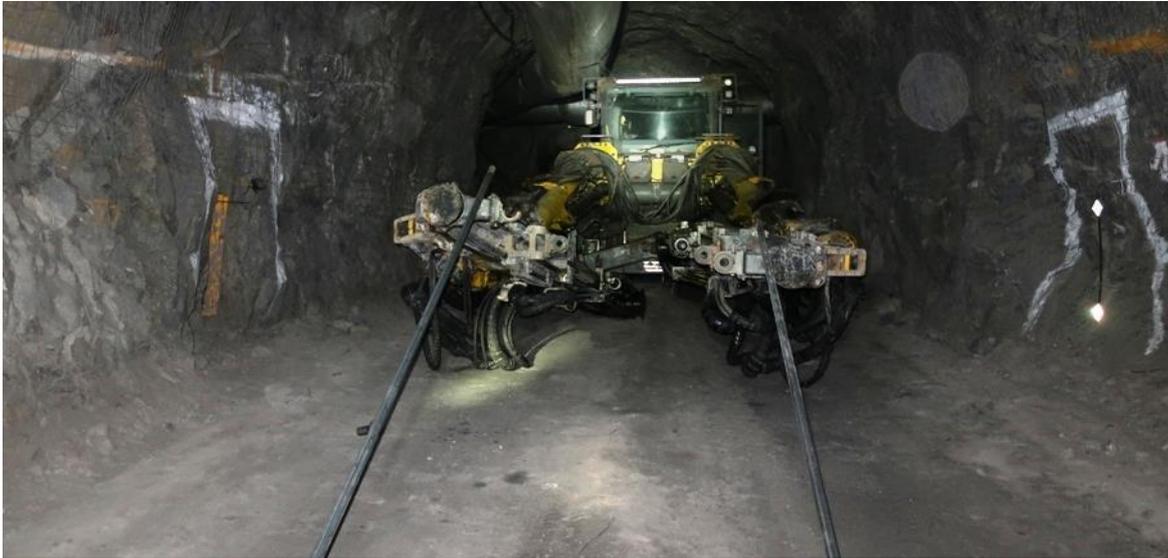
Figure 1. Atlas Copco jumbo parked in the access drive with booms lowered to change drill steels.

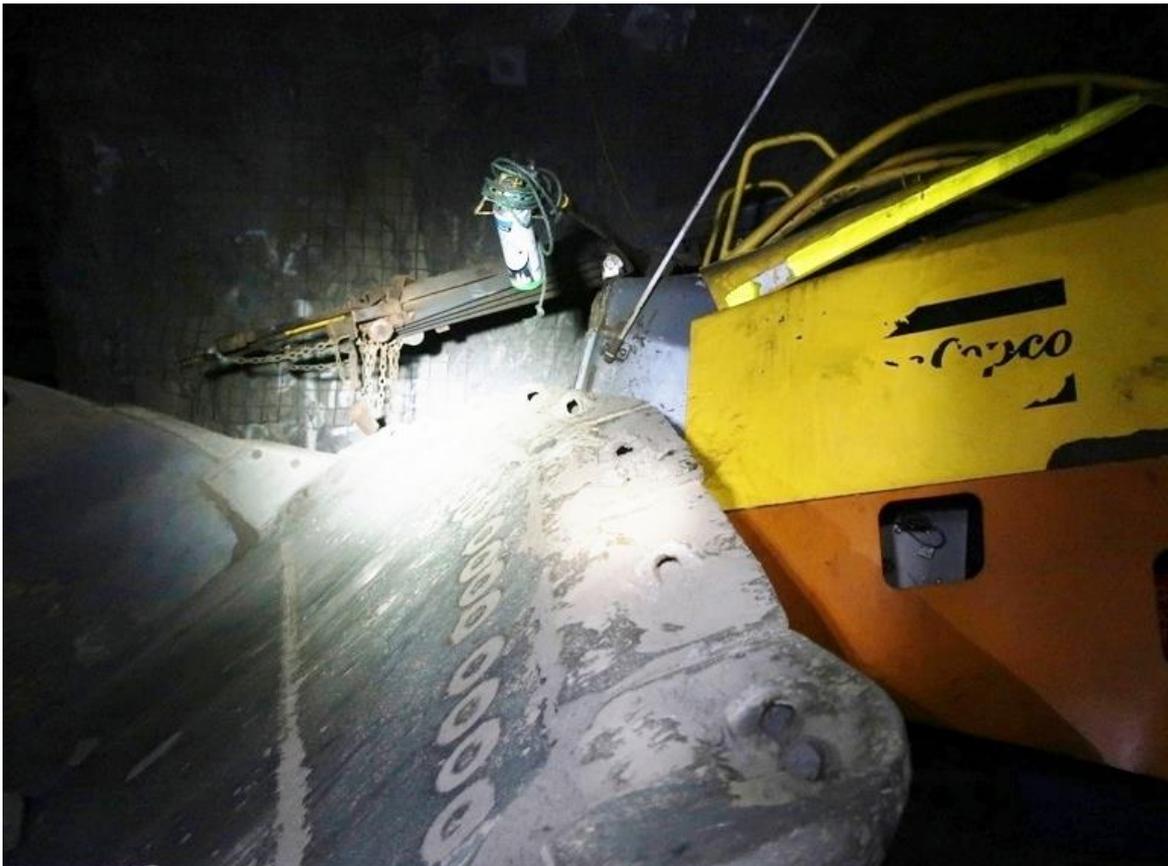
A Caterpillar R2900G underground loader contacted the rear of a stationary Atlas Copco jumbo while turning into an access drive. There were no injuries sustained by either worker. Damage was caused to the rear of the jumbo and it was taken out of service for inspection and repairs.

Figure 2. Impact point of the loader and jumbo

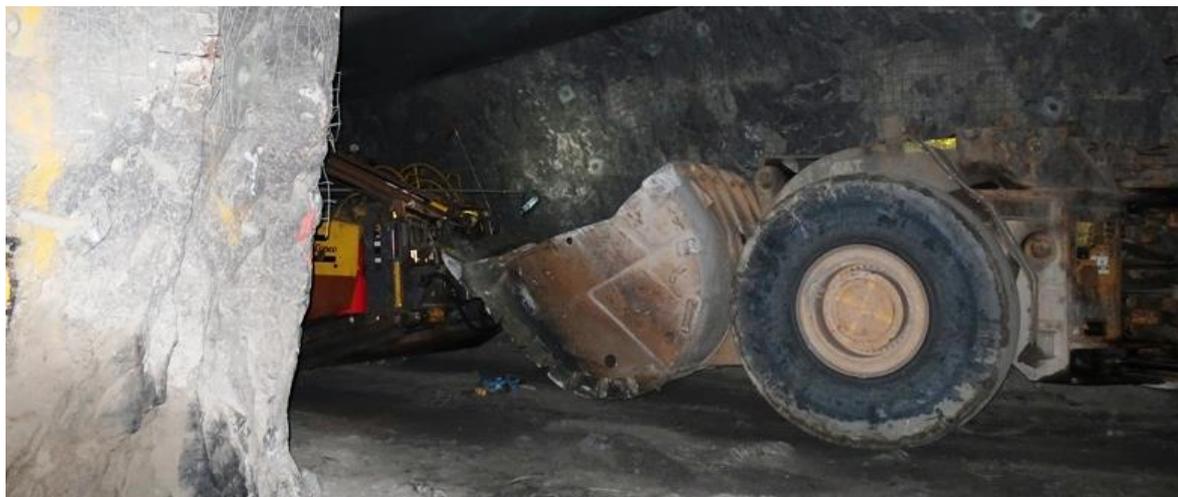
Figure 3. Access drive and impact point of the loader and jumbo

- The jumbo did not have a beacon/flashing light fitted to visually alert the loader operator of its presence in the drive.
- There was no demarcation or restriction of access to the drive implemented prior to carrying out the drill steel change over process.
- Minimum parking distances from access drive corners had not been identified in any documented procedure.
- The jumbo operator was using an impact wrench and could not hear the loader approaching.

- ensure control measures that are implemented at the mine, such as beacon/flashing lights, are installed, maintained, and operational
- review the appropriateness of the location and type of beacon/flashing lights used on underground mobile equipment
- develop, review and update procedures that manage the interaction of all mobile plant operating on site, including requirements for proximity detection, demarcation and

- implement engineering controls to control vehicle and mobile plant interactions such as proximity detection, collision avoidance and proximity lockout systems
- ensure information, instruction and training is provided to and implemented by workers to manage vehicle interactions on the mine
- have systems in place for supervisors to monitor compliance with site vehicle interaction procedures
- ensure mine supervisors monitor and enforce compliance with nominated procedures and controls regarding vehicle interactions in all underground work areas.
