WEEKLY INCIDENT SUMMARY

Week ending Friday 19 March 2021

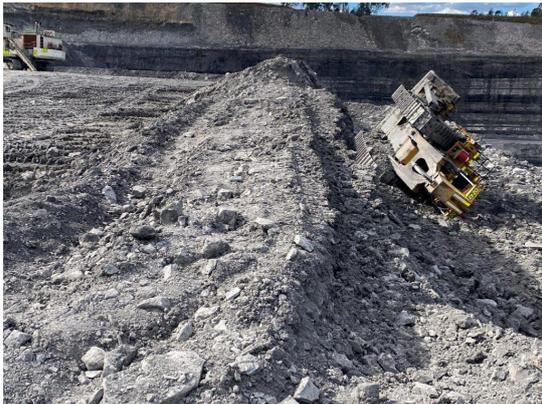
INCIDENT TYPE	SUMMARY	COMMENTS TO INDUSTRY
Dangerous incident IncNot0039443 Open cut coal mine

Roads or other vehicle operating areas	A dozer tipped on its side while in the process of levelling a windrow. The operator was able to exit the machine and sustained no injuries.

Workers have a legislative duty to care for their own health and safety and that of others (s28 <i>Work Health and Safety Act 2011</i>). One of the duties is to cooperate with any reasonable policy or procedure. Failure to comply with a duty is an offence for which penalties apply. Site procedures are developed to help protect workers from injury or illness. Where a procedure exists for a particular task, workers should follow the procedure. Any deviation from a procedure should first be discussed with a supervisor and

Refer to safety bulletin [SB19-01 Rise in dozer incidents putting operators at risk.](#)

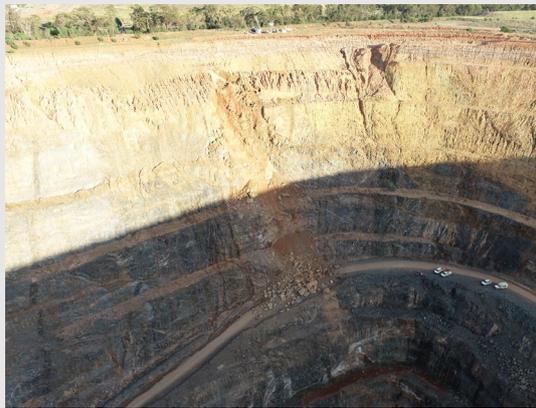
Dangerous incident
IncNot0039450
Underground
metals mine

Ground or strata
failure

A fall of ground occurred across a haul road approximately 300 metres above the mine portal. Two operators were unable to drive out of the pit due to the ramp being blocked. There were no injuries.

The fall of ground is currently being investigated and further information may be published at a later date.

The mine’s emergency plan must identify triggers for activation of the plan, actions to be taken and appropriate rescue equipment must be available.

For recommendations in relation to highwall failures, refer to safety bulletin:

[SB20-01 Failure of highwalls, low walls and dumps](#)

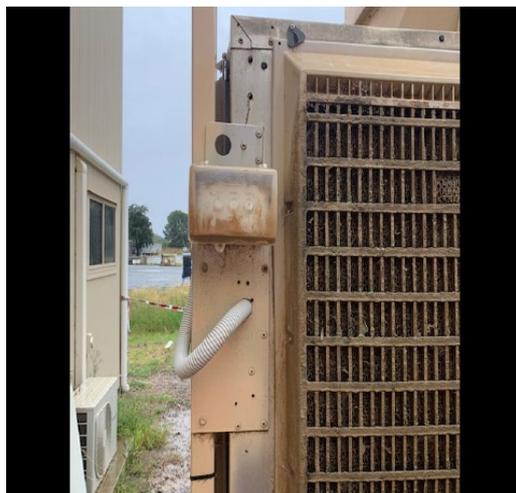
Dangerous incident
IncNot0039477
Underground
metals mine

A worker received an electric shock from an air conditioner controller switch that was housed in a weather-proof enclosure. The subsequent investigation found that the IP rating of the switch did not meet the site standards.

Mine operators are reminded of the need to follow introduction to site procedures to ensure second-hand equipment meets the required standards. The [Electrical Engineering Control Plan Code of Practice](#), (1.6.8 Acquisition of Plant) states that “the EECPP should provide systems to ensure the acquisition of plant includes the processes to verify that any plant, new to the mine, is fit for the intended purpose in the intended operating environment and is safe to use (introduction to mine site).”
