FIRES ON MOBILE PLANT

January – March 2021

Title: Fires on mobile plant, January – March 2021

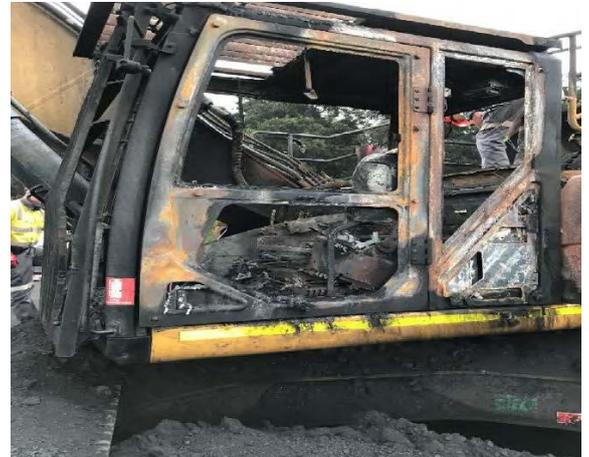
Figure 1: Excavator fire damage

A worker was backfilling a chute on the surface part of the mine's stockpile area using a Caterpillar 336D excavator when they heard a loud bang. The worker observed a flash of light as the engine bay exploded into flames.

The fire brigade was called and the excavator was extinguished.

The excavator was extensively damaged, however, the investigation identified sufficient evidence to support the cause of the fire as a failure of the hydraulic system.

This incident is a reminder of the importance of quality maintenance and inspection work in the prevention of premature failure of components.

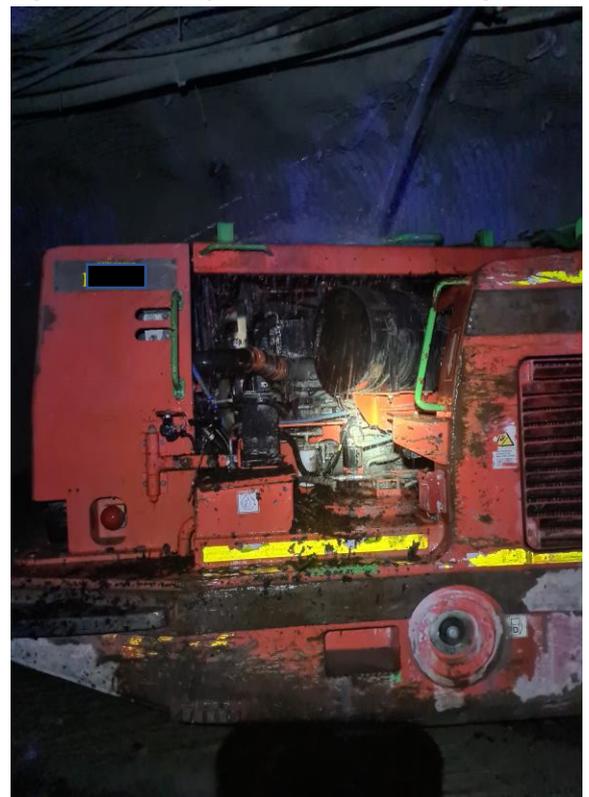
Figure 2: Loader fire location and damage

A worker was operating a Sandvik LHD loader in the underground production level of a metalliferous mine when the worker observed flames coming from the engine bay. The worker stopped the machine and used the onboard fire suppression system and a hand-held fire extinguisher to put out the fire.

The mine identified that a brake cooling hose had been rubbing on the adjacent steel pipe causing the hose to fail and spray oil into the engine bay compartment.

This incident is a reminder of the importance of quality maintenance and inspection work in the prevention of premature failure of components.

Additionally, for this type of incident where a fuel source is sprayed over the engine, hot surface protection or fire-resistant fluids are the only preventative controls available.
