TECHNICAL REPORT

Subject: Analysis of Blakefield South Mine (BSM)
Explosion

Date: First Draft 16 Feb 2012
Revised 20 Feb 2012; 29 Feb 2012

Report Prepared By: Drs Hsin Wei Wu and Stewart Gillies

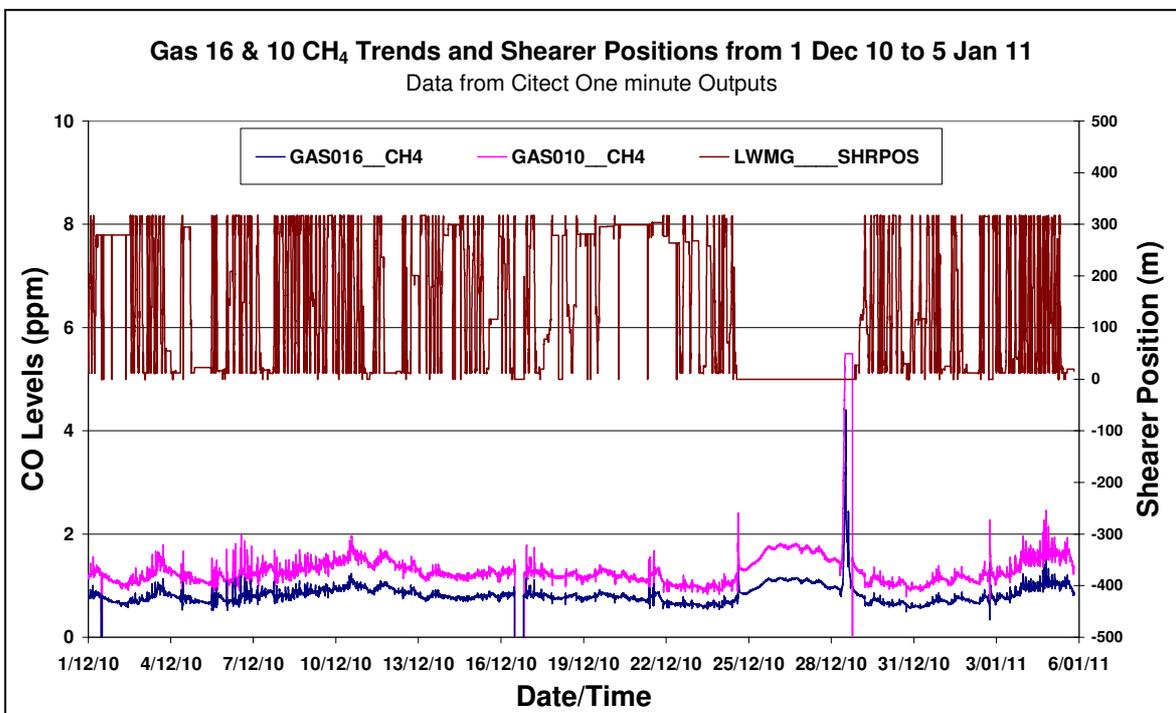
Figure 2.1 Methane gas trend recorded at Gas 16 & 10 Stations (1/12/10 – 05/01/11) and position of LW Shearer.

During the non production period from 24/12/10 to 28/12/10, CH₄ readings recorded at Gas Stations 16 and 10 gradually increased and stabilised. CH₄ readings shot up during the planned fan shut down on 28/12/10 but CH₄ levels decreased very quickly when fans were turned back on and the general trends of CH₄ levels were downward.

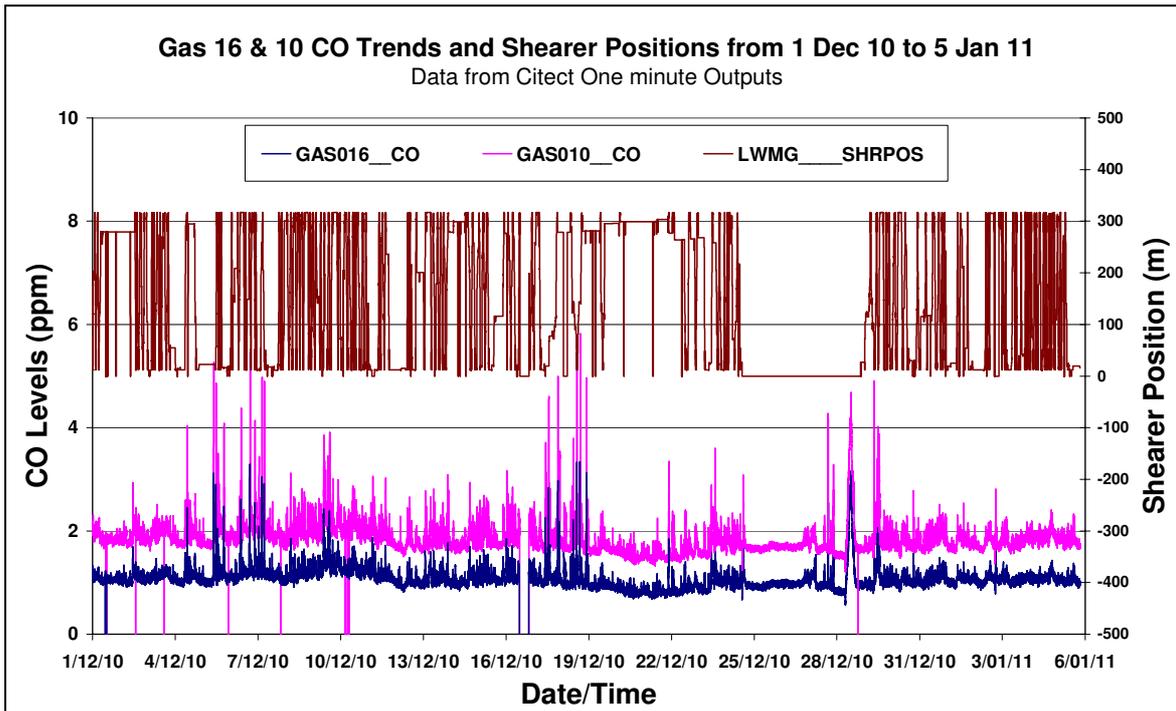
CO levels at both stations on the other hand remained steady during the Christmas shut down period. Correlation between CO levels at both stations and LW production was not as obviously as CH₄. However, the general trends of CO levels from 1 Dec 2010 to 5 January 2011 were steady and slightly downward in the second half the period.

Figure 2.2 CO gas trend recorded at Gas 16 & 10 Stations (1/12/10 – 05/01/11) and position of LW Shearer.

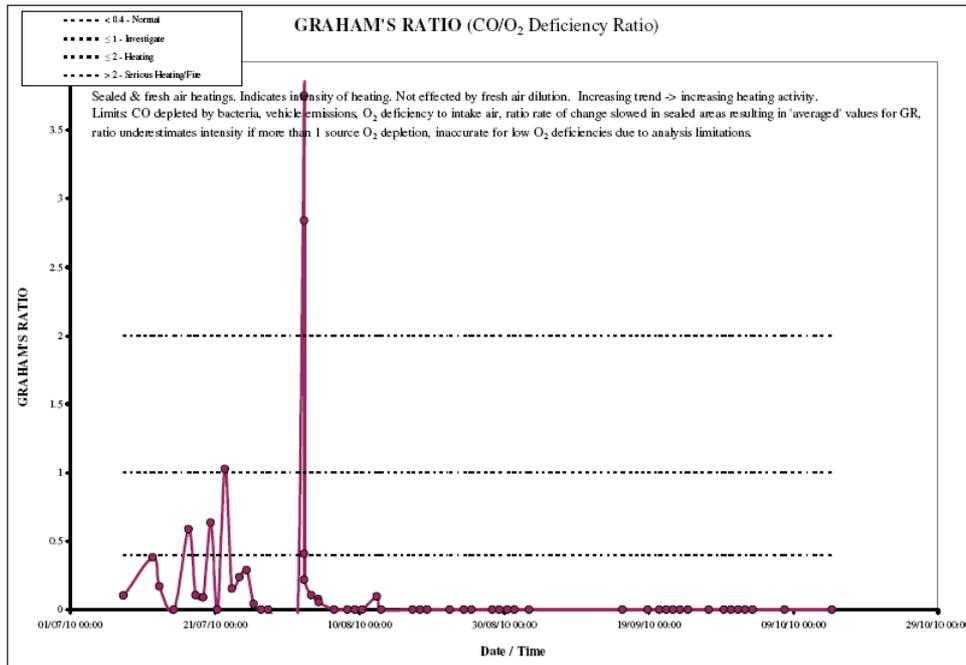
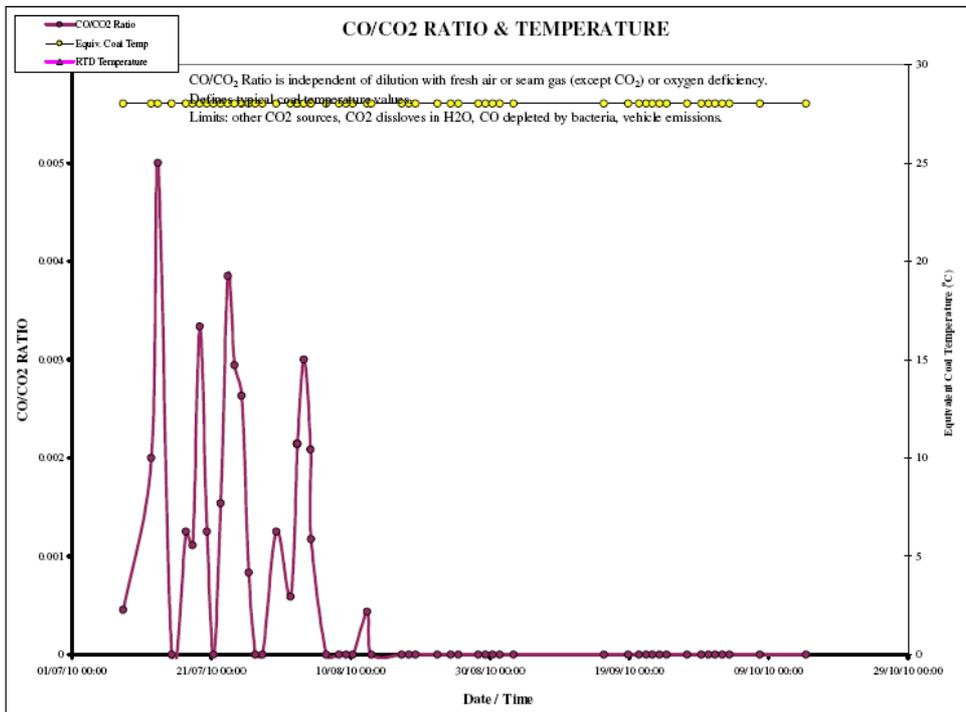
Figure 2.3 Graham's ratio trend from LW goaf bag samples.

Figure 2.4 CO/CO₂ ratio and temperature trends from LW goaf bag samples.

It can be seen that from these two figures that LW goaf gas environment after initial unstable period in July 2010 and by early August 2010 LW goaf gas environment had settled and stabilized.

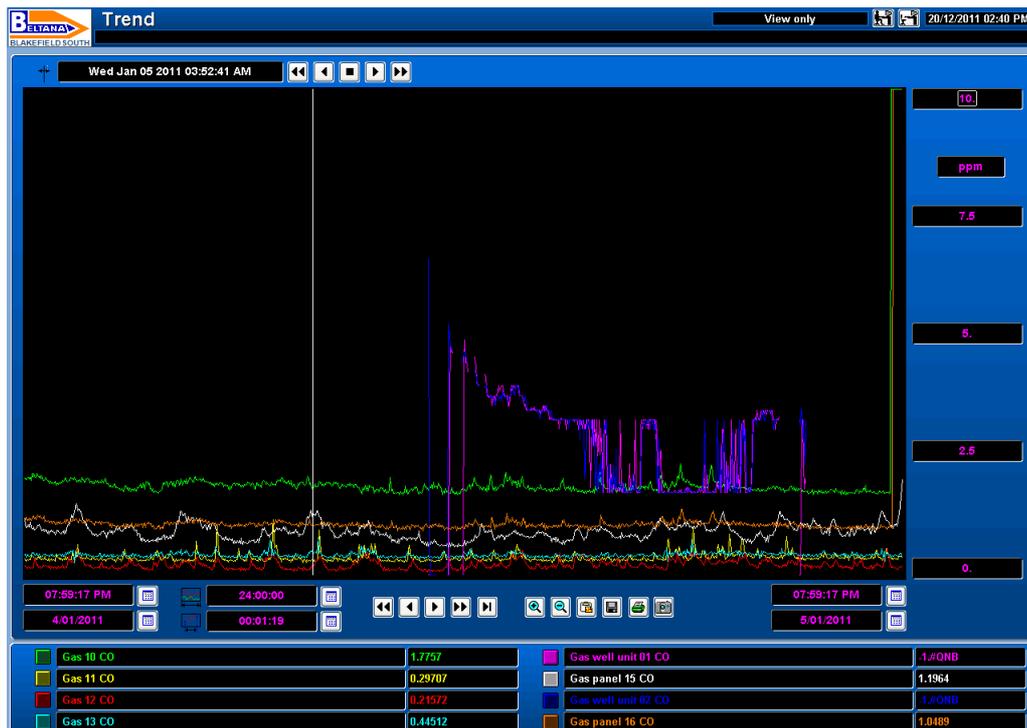
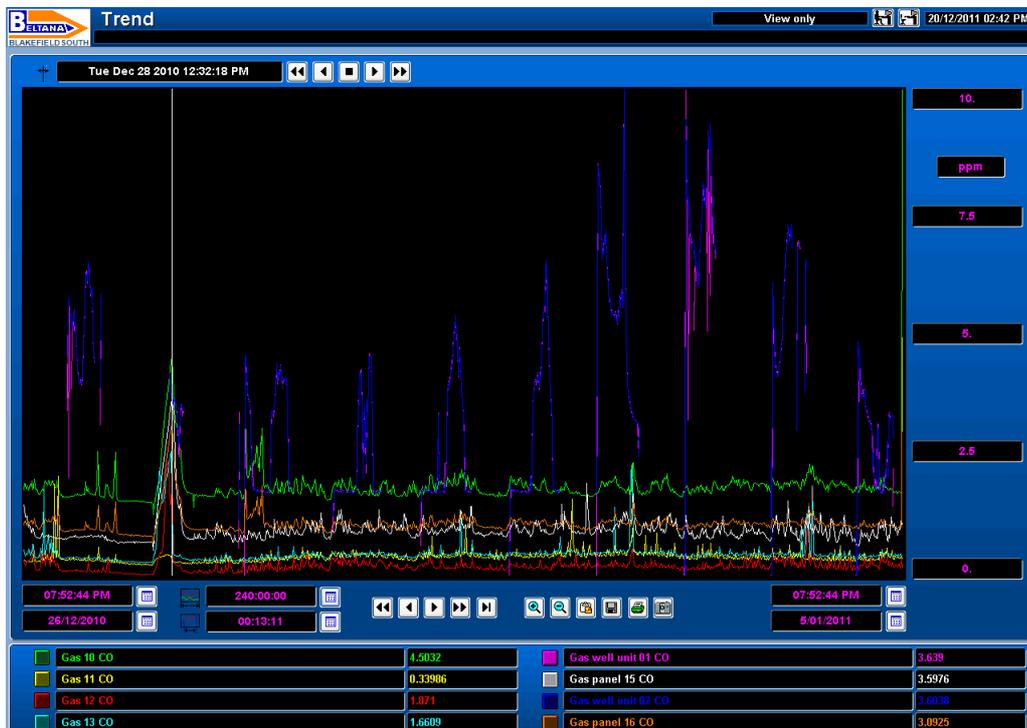
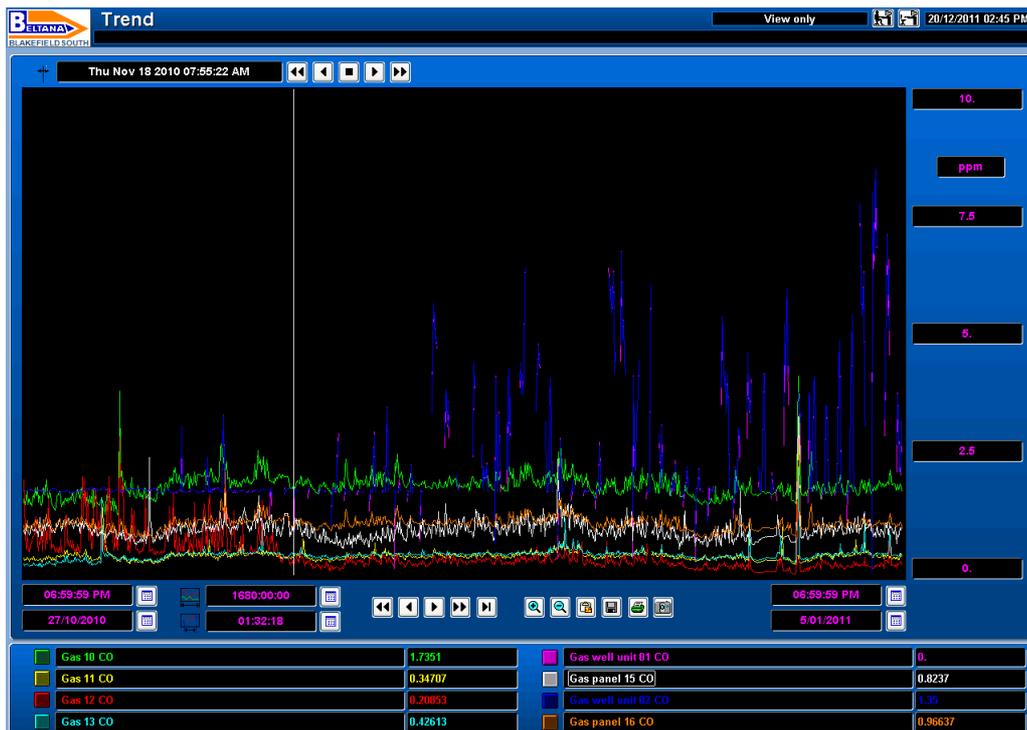
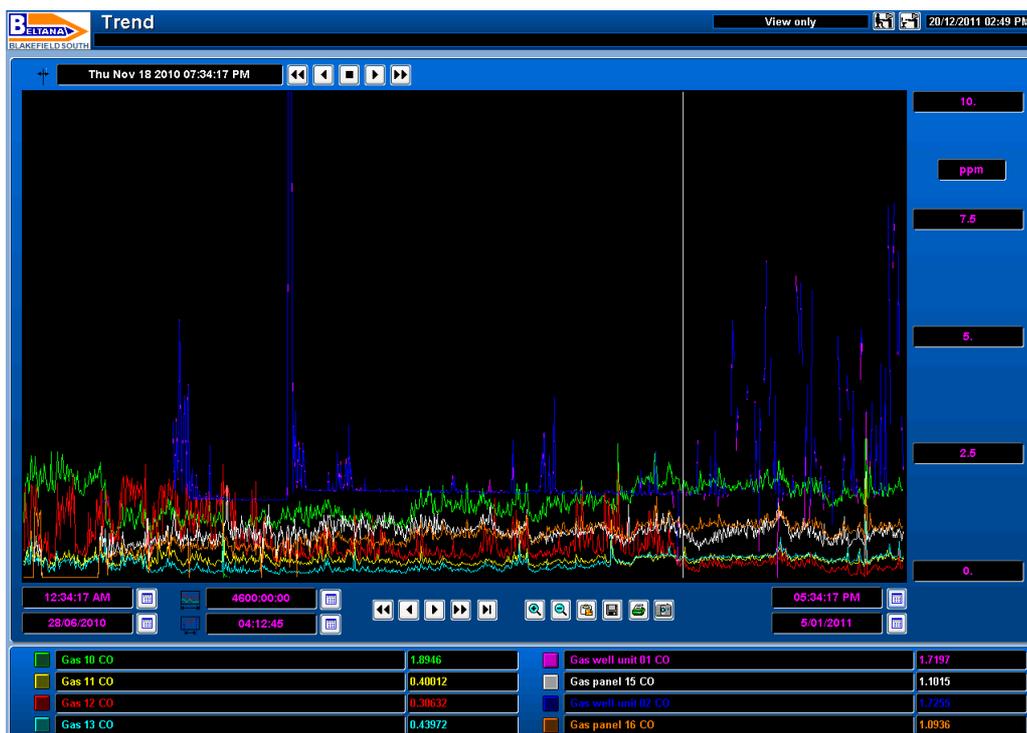
The indications of "high" CO levels in the range of 7 to 10 ppm from gas drainage wells recorded by the Citect gas monitoring system could come from a number of sources.

- Vehicular traffic working hard sporadically in the Main Gate that ventilated across the face and around the goaf to the TG could have been the cause.

- Also slow oxidation of coal in the goaf will cause some low level CO. As the goaf forming roof fell air would have pushed into the face area and across CO sensors. These wind blasts would have altered the normal air gas concentration near the sensor for a short period (an inrush possibly followed by a suck back).

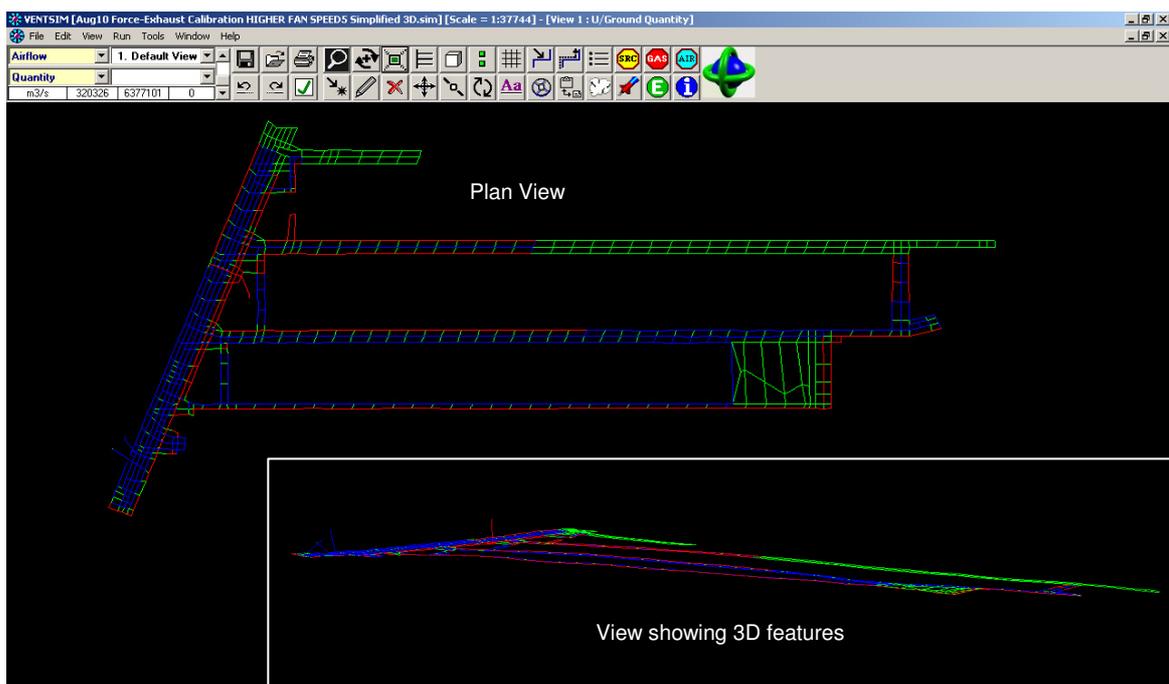
Mines typically keep Ventsim models updated monthly after the statutory ventilation survey. It can only be assumed that the mine was not maintaining an up-to-date Ventsim model for the short term planning of their ventilation system. The mine does not appear to have the capability to do so possibly due to the complexity of the push and pull ventilation system used at BSM.

Figure 6.1 Screen snapshots of the 3D Ventsim converted based on 2D model supplied.

The model supplied also does not include the attributes of the actual forcing fans and exhaust fans operating at the time. Instead, fixed quantities had been incorporated in the model at the locations of the fans at the intake and exhaust shafts to simulate the total mine airflows. This means that the model is not able to reflect/predict the effects from all changes made to the ventilation system in the model. It only represents a static snapshot of a particular time phase. This supports the recent interview statement obtained by the Investigation Unit from the former BSM ventilation officer that it was not possible to maintain a valid ventilation model for the push/pull ventilation system used.

These circumstances indicate that BSM's mine ventilation management system needs improvement when compared with the standards of current Australian underground coal mine ventilation accepted practice.

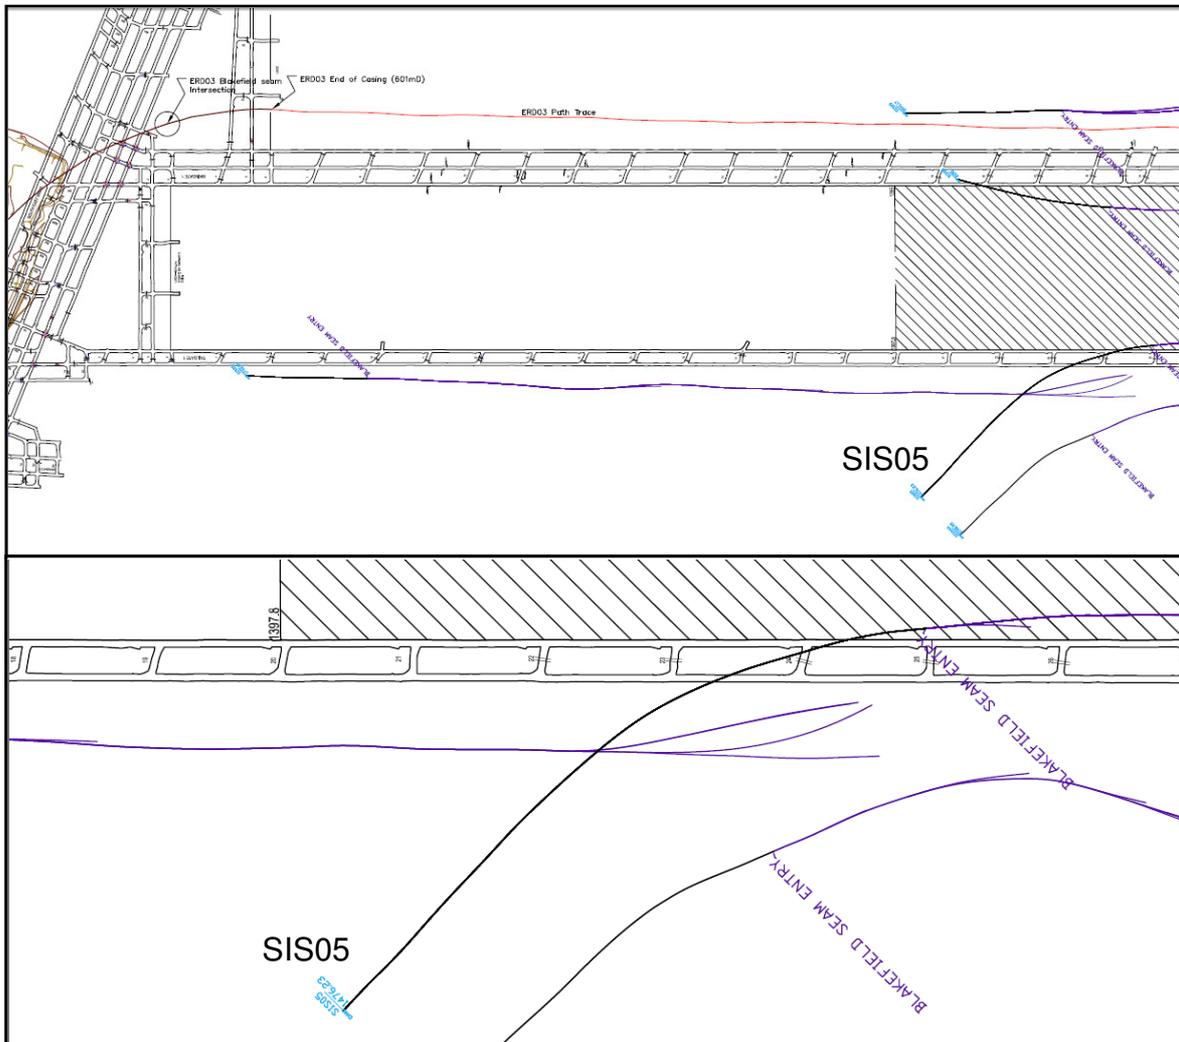
Figure 7.1 Extract from mine plan showing SIS 05 hole intercept LW TG at about 4 to 5 CTs inbye of the LW face line at the time of incident.

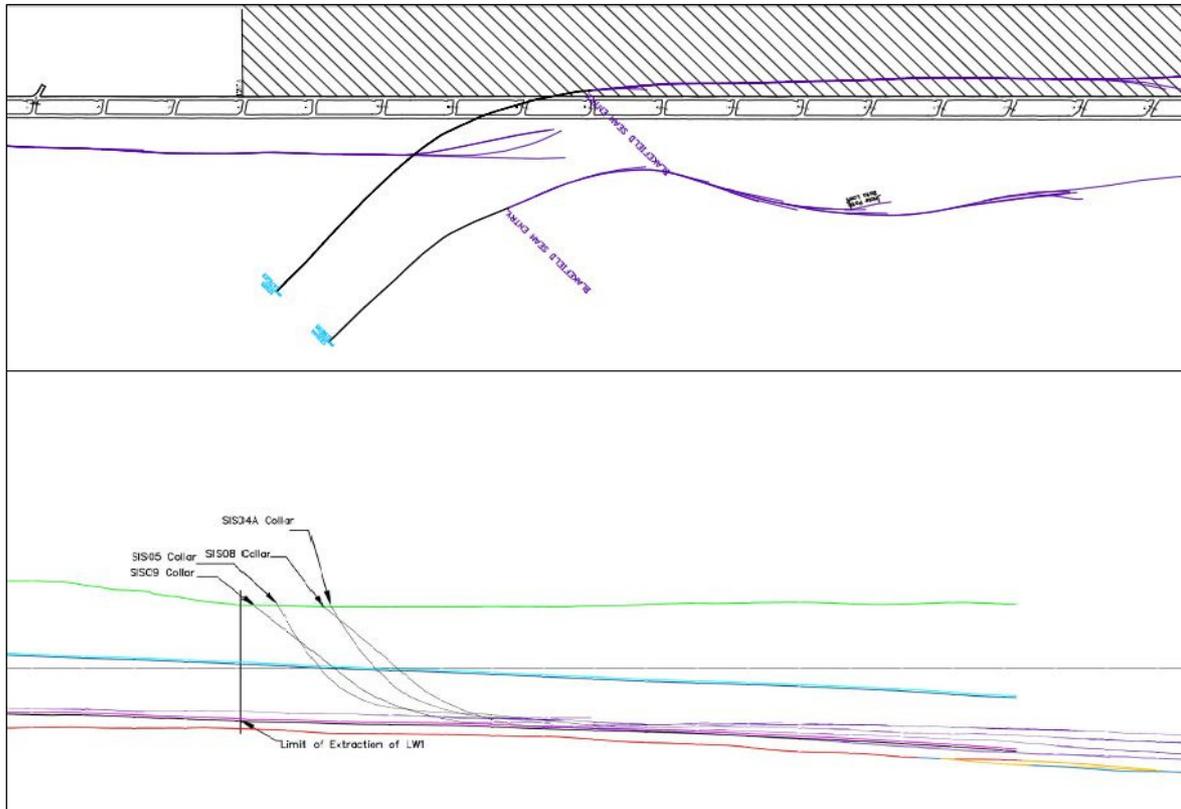
Figure 7.2 shows a plan and elevation view of the boreholes intersecting the upper and lower seams being worked in the vicinity of the TG on 5 January 2011. These demonstrate that there were a number of borehole connections between upper Wybrow and lower Blakefield South coal seams that could have held gassy atmospheres that possibly played a part in allowing CH₄ to pass from the upper seam to replenish CH₄ gas concentration levels immediately after dilution with ventilation as the longwall mined through a particular part of the coal seam being worked and goaf formation occurred.

Figure 7.2 Plan and Elevation view of the boreholes intersecting the upper and lower seams being worked in the vicinity of the TG on 5 January 2011.

- (iv) Undertake Ventgraph modelling with an ignition assumed to originate where a borehole intersects the worked seam in the TG about 4 CT back or inbye the LW face. In this modelling assume that ignition is caused by lightening and model to parallel the observations and re-actions of the LW shift Deputy and the Maintenance Supervisor from the moment of lightening strike recorded on the surface above the borehole position.

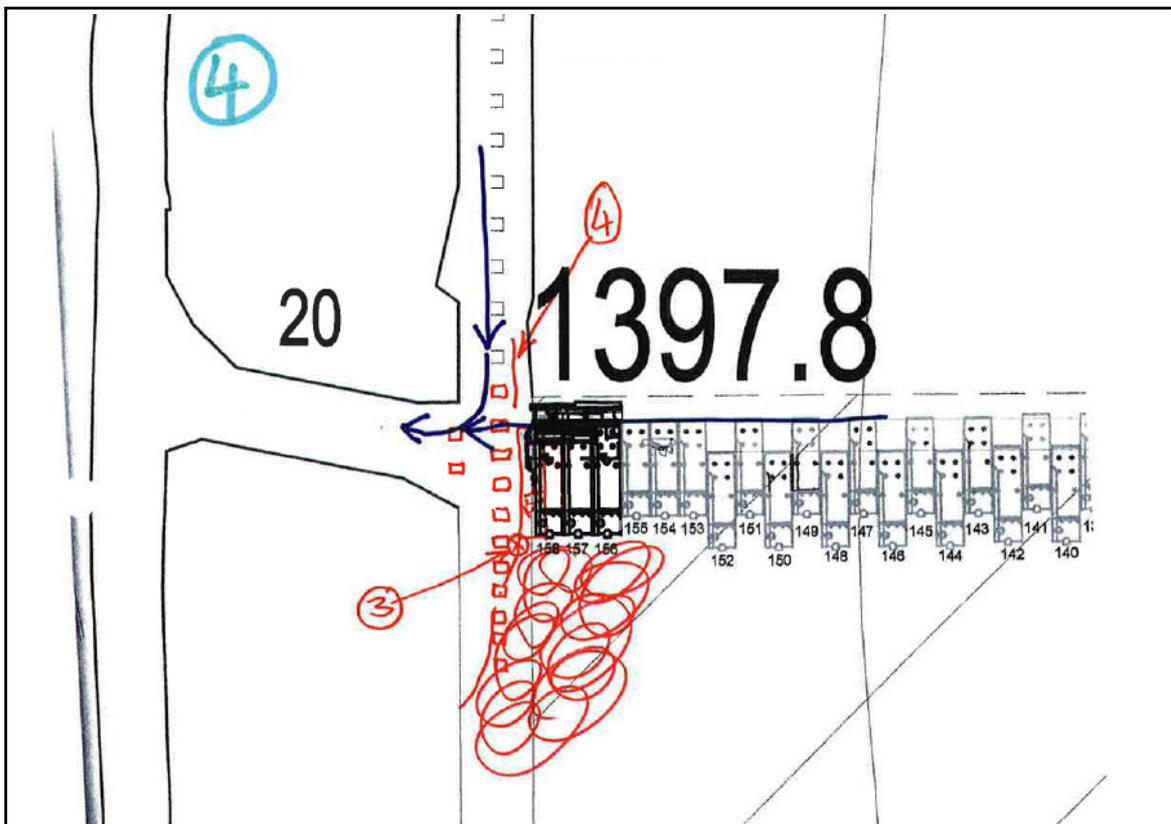
Figure 8.2 LW Crew Deputy, ██████████ hand drawing indicating the locations of the flames he saw at TG end of LW.

Therefore, [REDACTED] observations indicate that a goaf fire burning gases and solid coal was occurring on the edge of the broken material forming the goaf and possible further inside the goaf. He was seeing a progression from the colder part of a diffusion (incomplete combustion) flame which is red, transitioning to orange, yellow, and white as the temperature increased as evidenced by changes in the blackbody radiation spectrum. In terms of the “fire triangle” oxygen was abundant from the mine ventilation airways surrounding the goaf, fuel was coal and seam gases and an ignition source existed (there
