# MINE SAFETY INVESTIGATION UNIT

INFORMATION RELEASE

## Fatality

<b>Date</b>	7 March 2013
<b>Event</b>	Body found at bottom of a blind shaft
<b>Location</b>	Lightning Ridge, NSW

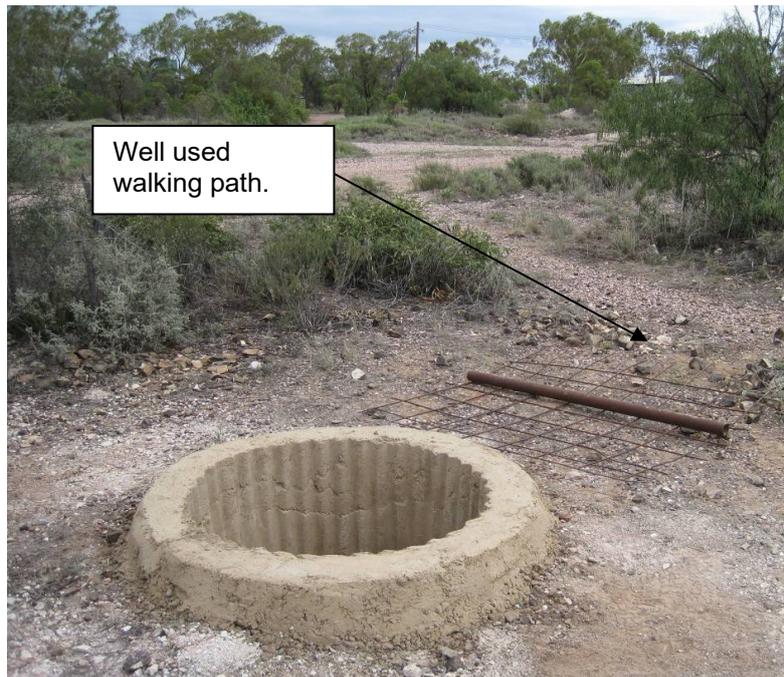
The following morning a person living on the mineral claim noticed that the shaft cover was off the shaft, and replaced it. After doing so he saw the deceased at the bottom of the shaft.

The shaft was 13.6 metres deep and was a blind shaft, i.e. no workings had been developed from it. It had been drilled about six months prior to the incident. The collar of the shaft was raised approximately 0.1m above the ground and lined the top of the hole. It was 1.05m in diameter at the top.

The shaft had a cover constructed of a piece of steel reinforcing mesh and steel pipe.

**The shaft and cover as described by a witness**
