MINE SAFETY INSPECTORATE

INVESTIGATION INFORMATION RELEASE

Event Open cut highwall failure adjacent to a public road

Location Moolarben Coal Operations – Open Cut, adjacent to Ulan-Wollar Road, Mudgee

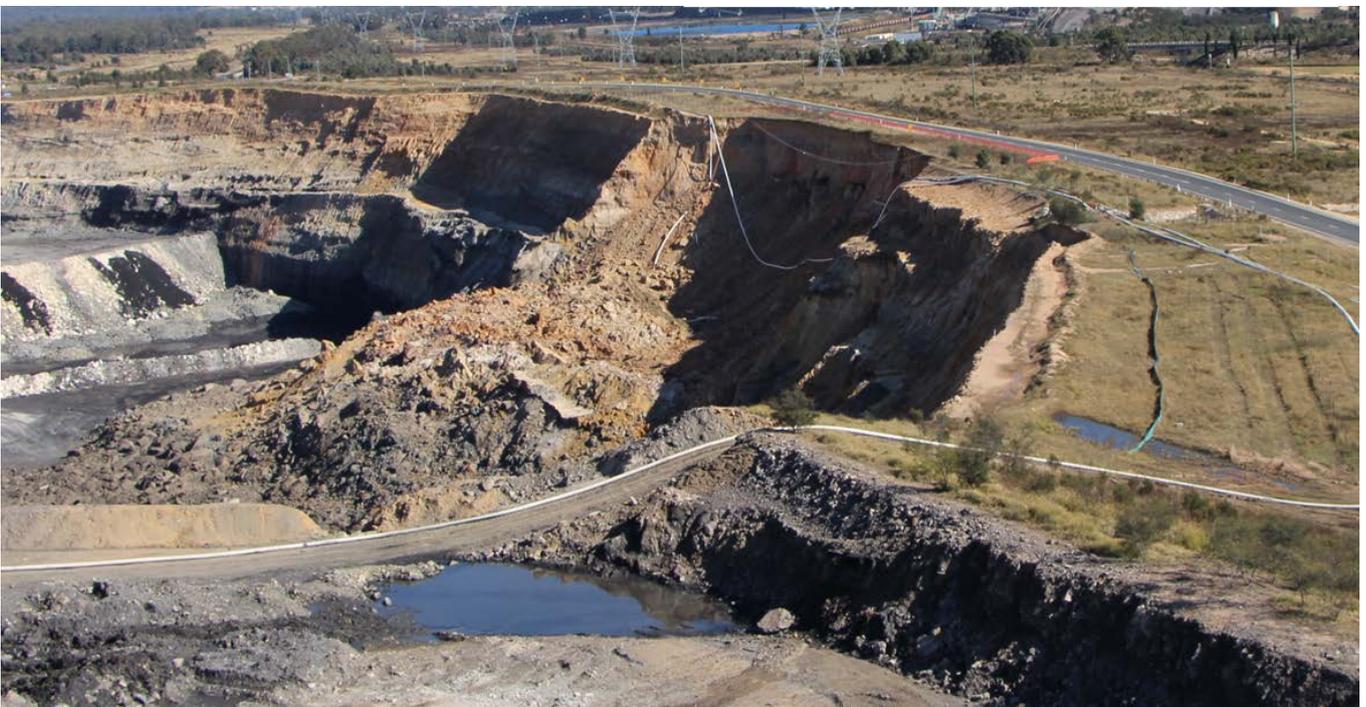
Figure 1: Northern highwall adjacent to Ulan-Wollar Road showing the failure and barricading after the incident. Photographs taken by Moolarben Coal Operations.

The failure was about 160 m wide and approximately 55 m high. The highwall edge before the failure was 40 m from a public road and 12 m after the failure.

A palaeochannel infill sequence of materials had been exposed during recent mining operations. It included materials that had not been identified in geological modelling. A palaeochannel is a remnant of an inactive river or stream that has been filled or buried by younger sediment.

This palaeochannel was locally deeper than previously exposed and comprised of differing lower level sediments. The increased thickness of the channel consisted of relatively loose silty sands and weaker clays which were at the base of the palaeochannel infill at the top of the coal seam. The

upper 25 m of materials were stiffer and stronger and it is believed these have caused overstressing of the clays and infill sands. Undrained pore pressure is believed to have triggered localised liquefaction and lubricated the fissures within the clays.

- fencing to secure the area in consultation with the local council
- buttressing of the immediate slip area
- backfilling of the area
- increased monitoring including continuous radar scanning of the area.

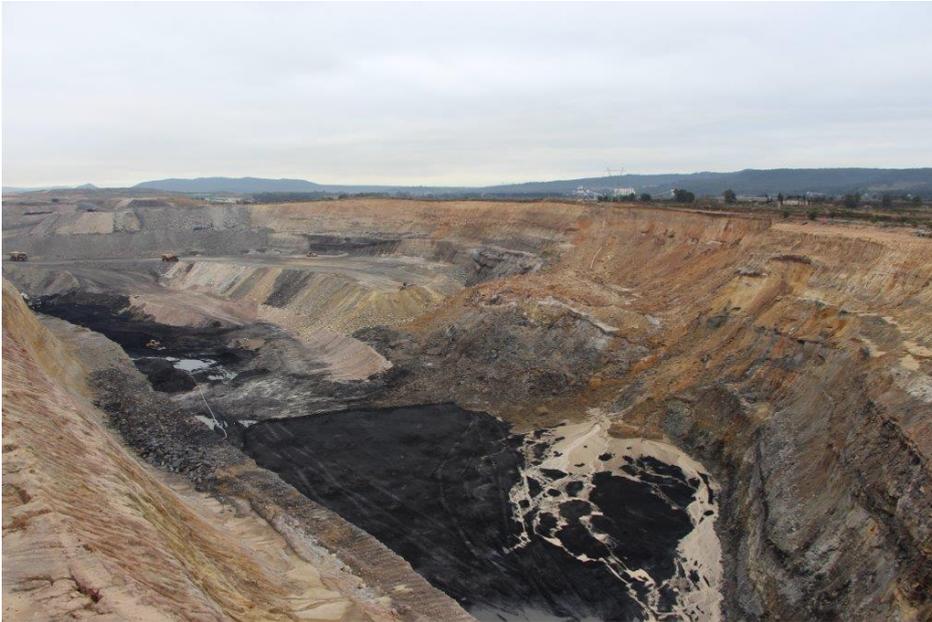
Figure 2: Northern highwall failure remedial works 15 June 2015.

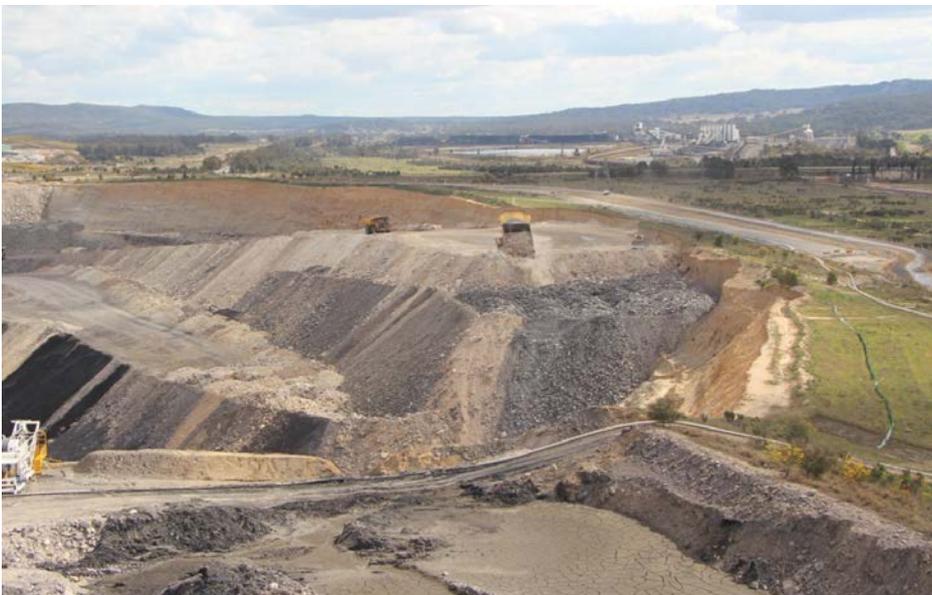
Figure 3: Northern highwall failure remedial works 18 September 2015.

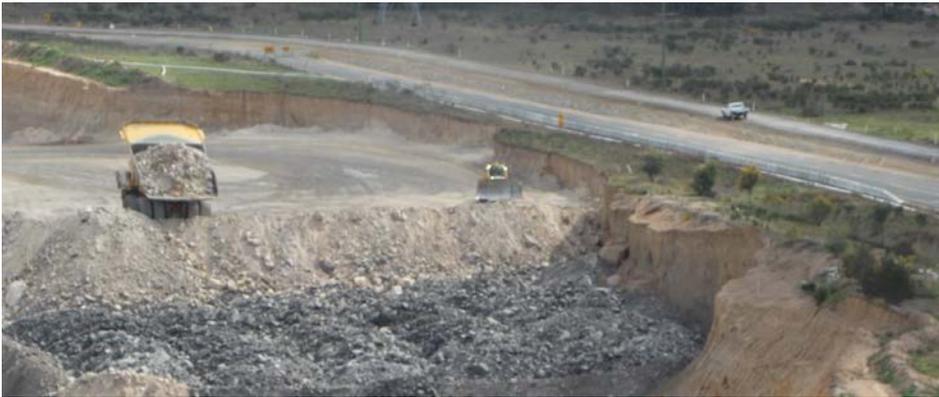
Figure 4: Northern highwall failure remedial works on 18 September 2015 showing failed area almost backfilled.

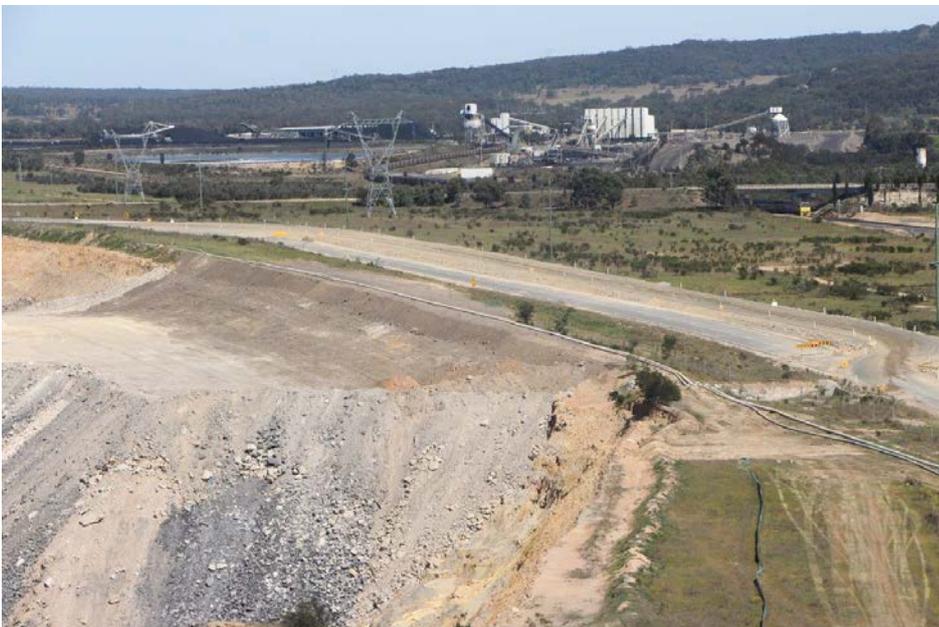
Figure 5: Northern highwall failure remedial works at 5 October 2015 showing failed area backfill completed.
