## Week ending 22 November 2017

This incident summary provides information on reportable incidents and safety advice for the NSW mining industry. To report an incident to the NSW Resources Regulator: phone 1300 814 609 24 hours a day, 7 days a week.

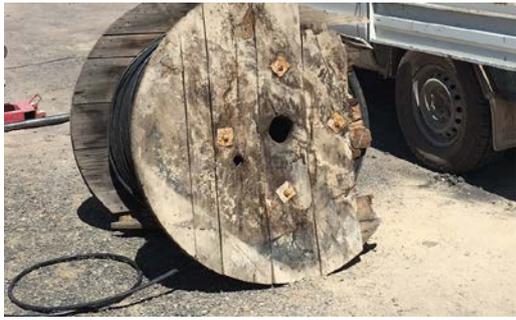
Incident type	Summary	Recommendations to industry
<p>Serious injury SinNot-2017/01849</p>	<p>An electrician involved in the installation of a water treatment plant was rolling cable off a drum and wedged his left arm between the rear of the ute tray and the drum. His arm was broken and he was taken to hospital for treatment.</p>

<p>Mine operators should have systems in place that allow for recognition of changes to tasks resulting from damaged or defective equipment</p> <p>Supervisors should continually review hazard awareness of all workers, especially when equipment is damaged and how this can change its normal performance.</p> <p>Workers should always consider if they are placing parts of their body in a place of potential harm.</p>
<p>Dangerous incident SinNot-2017/01836</p>	<p>An operator was using a front end loader to clean up around a haul truck when he reversed into a truck. A cover was damaged on the loader, which then moved forward and cracked the back window.</p>

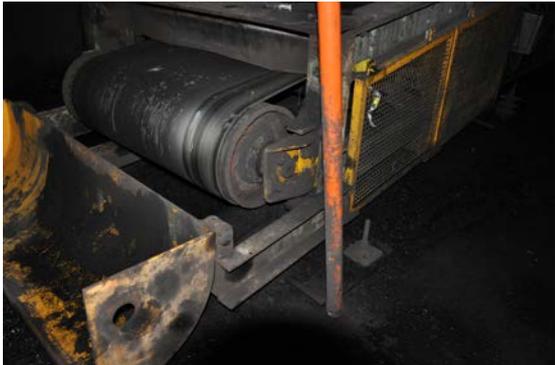
<p>performed by supervisors to ensure compliance with site procedures.</p> <p>When reversing mobile plant, operators should check down both sides as well as to the rear of the equipment. The use of proximity awareness systems such as cameras and alarms may assist vehicle operators.</p> <p><b>Refer to:</b></p> <p><a href="#">MDG 2007 - Guideline for the selection and implementation of collision management systems for mining</a></p>
<p>Dangerous incident SinNot-2017/01833</p>	<p>An operator stopped at a diesel tag board and smelled something unusual and discovered flames coming from under a steel cover at a conveyor boot end. The operator hosed the area with water and removed the cover to make an inspection to ensure the fire was fully extinguished.</p>

<p>Mine operators should ensure the following are in place for conveyor systems at their mine:</p> <ul style="list-style-type: none"> <li>• Conveyor pulleys are designed with the appropriate life for the intended duty.</li> <li>• Carbon monoxide monitoring or particulates of combustion sensors are be installed in appropriate locations to assist in the early detection of fire and heatings</li> <li>• Alarm set points and trigger action response plans should be developed that suit each installation</li> <li>• A water source is readily available to quickly extinguish a fire at any place along a conveyor belt</li> <li>• Conveyor inspections are undertaken regularly</li> <li>• Temperature for head and tail pulley bearings.</li> </ul> <p>Consider the applicable recommendations in <a href="#">MDG 1032 Prevention of coal mine fires</a> and AS/NZS 4024.3611</p> <p><b>Refer to:</b></p> <ul style="list-style-type: none"> <li>• <a href="#">Mechanical engineering control plan code of practice</a></li> <li>• <a href="#">MDG 1032 Guideline for the prevention, early detection and suppression of fires in coal mines</a></li> <li>• AS/NZS 4024.3611 Safety of machinery, Conveyors – Belt conveyors for bulk material handling is incorporated into the mechanical engineering control plan code.</li> </ul>

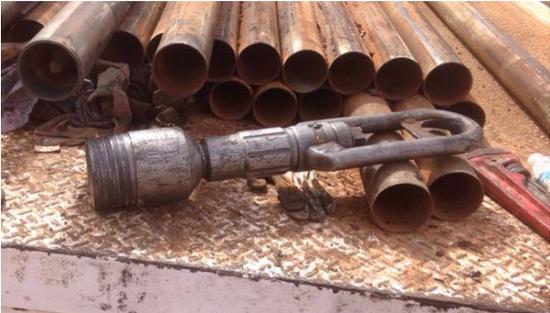
<p>Serious injury SinNot-2017/01831</p>	<p>A drill rig off-sider was hit in the face by a haul plug resulting in a fractured cheek bone and broken nose. He was taken to hospital for medical attention.</p>

<p>Mine operators should review the safe standing zones associated with drilling tasks.</p>
<p>Dangerous incident SinNot-2017/01829</p>	<p>A shaft winder tripped a limit, stopping it approximately 5 m below the No 9 level plat. One worker was in the man cage at the time. He was not injured. The site's mines rescue team was activated. A ladder was used to extricate the worker from the man cage.</p>	<p>Mine operators should review the preventive maintenance strategies relating to winder controls, including all field devices. This should include regular testing of all equipment and safety devices.</p> <p>Before resetting winder faults, a thorough investigation should be completed by a competent person.</p> <p>Mines should review winder risk assessment and operating procedures to ensure emergency scenarios are adequately addressed. This is especially important for scenarios where workers are in the cage when there is a failure of the winder control systems.</p> <p>Mines should review their emergency management plans to include if and when external rescue resources are notified and mobilised for different scenarios.</p>

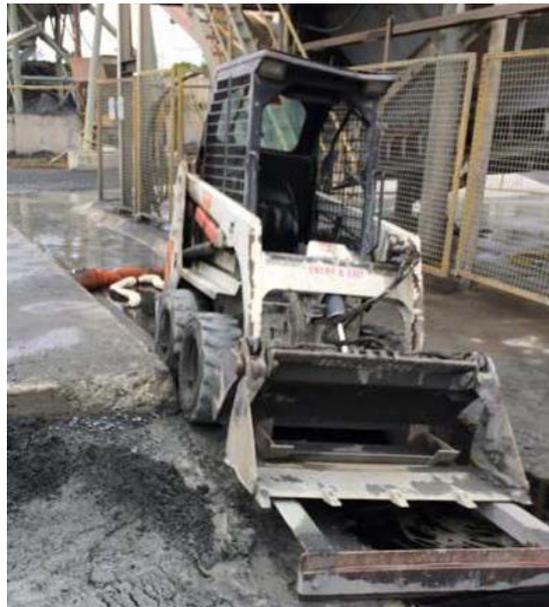
<p>Dangerous incident SinNot-2017/01825</p>	<p>A trained worker doing routine clean-up of plant on a stable, concrete surface misjudged the corner of the concrete edge when backing up. In the process of turning the bobcat, the back right wheel rode up onto the concrete curb putting him at an imbalance point. As he tried to correct and drive off he overbalanced and the bobcat and rolled onto its side.</p> <p>Other workers righted the bobcat to stop and contain further oil spills.</p>	<p>All mine operators should consider how they train workers on positional awareness and the potential hazards associated with lapses in concentration.</p>

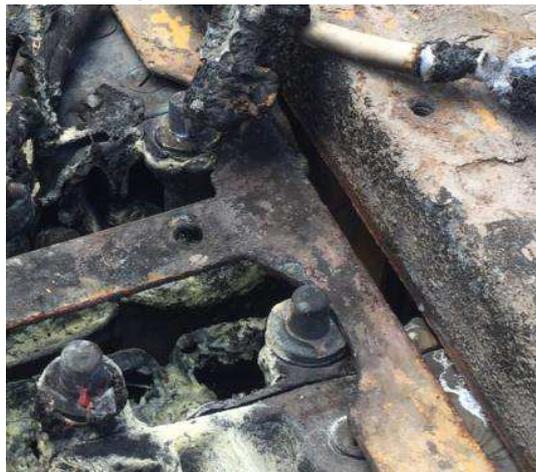
The operator of a water truck was operating the truck when she smelled something unusual. The operator pulled the truck over on the go line, applied the park brake and turned the machine off. At this time she heard a 'pop/bang' sound, as did a plant mechanic who was in the vicinity of the area at the time.

The hold-down cover was not an original equipment manufacturer-supplied part and did not have provision to prevent the movement of the battery under the plate. This has resulted in the battery terminals shorting to the cover plate and overheating two of the batteries.

Mine operators should review their preventive maintenance inspection plans for machinery that has a battery system on board as to the standard of how the battery or batteries are retained.

The potential hazards associated with electrical faults associated with batteries should be clearly conveyed to the workforce.
