FIRES ON MOBILE PLANT

January-March 2019

Mobile plant fires present safety and production losses

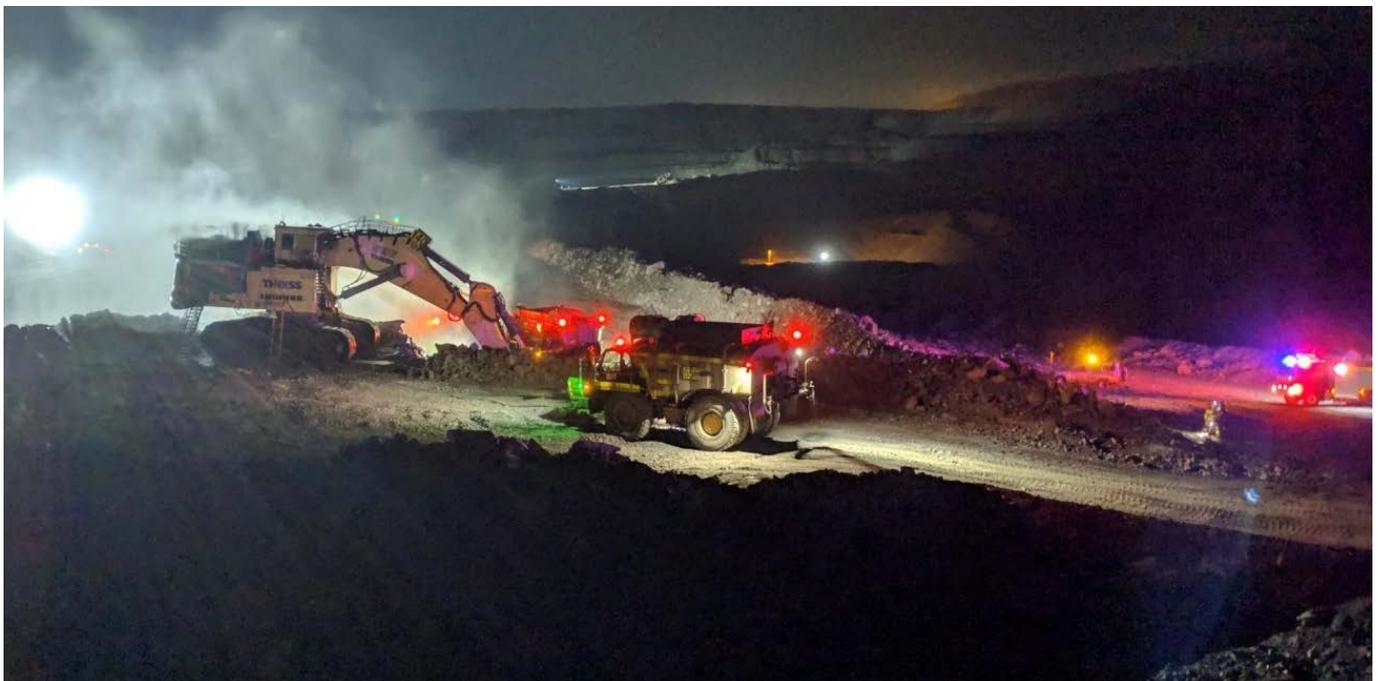
Figure 1 Excavator fire

Major mine operators started the first quarter of 2019 with several fires on large critical equipment. Five machines experienced fires including four large excavators and a large loader.

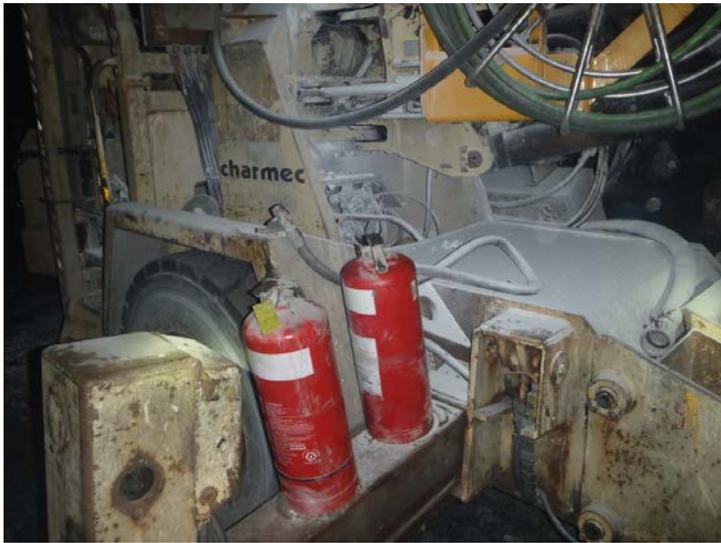
Figure 8 Murrawombie Copper mine incident

January 2019 - Murrawombie Copper mine IncNot 0033495

A solenoid failure on a Normet charge rig allowed a build-up of enough heat to ignite the plastic coating of the solenoid. The automatic fire suppression system was activated however did not extinguish the fire. It is believed this was due the area not being covered by any nozzles.

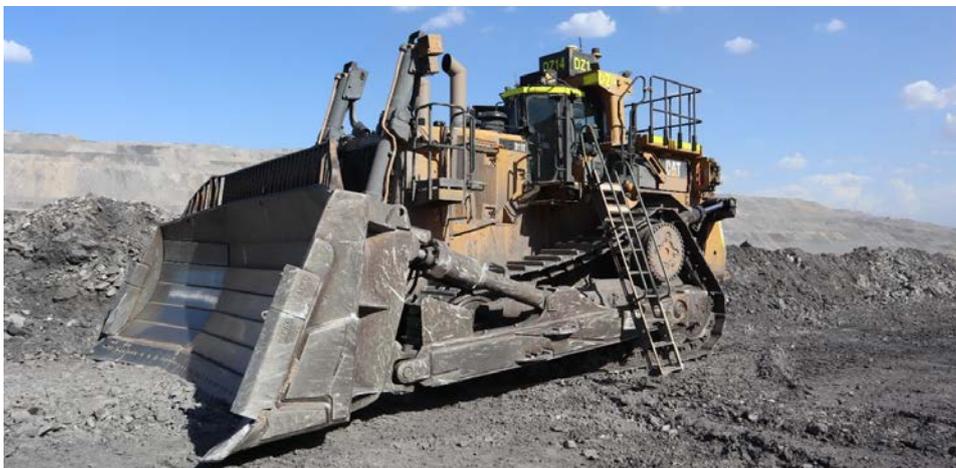
Figure 98 Bengalla incident

January 2019 - Bengalla IncNot0033522- An investigation into the incident at Bengalla found that the ladder valve supply hose, from the transmission filter to the ladder valve, rubbed through an adjacent hose and sprayed oil into the hell hole area. The engine fan drew oil into the engine bay. The oil made contact with hot surfaces of exhaust/turbo components and ignited.

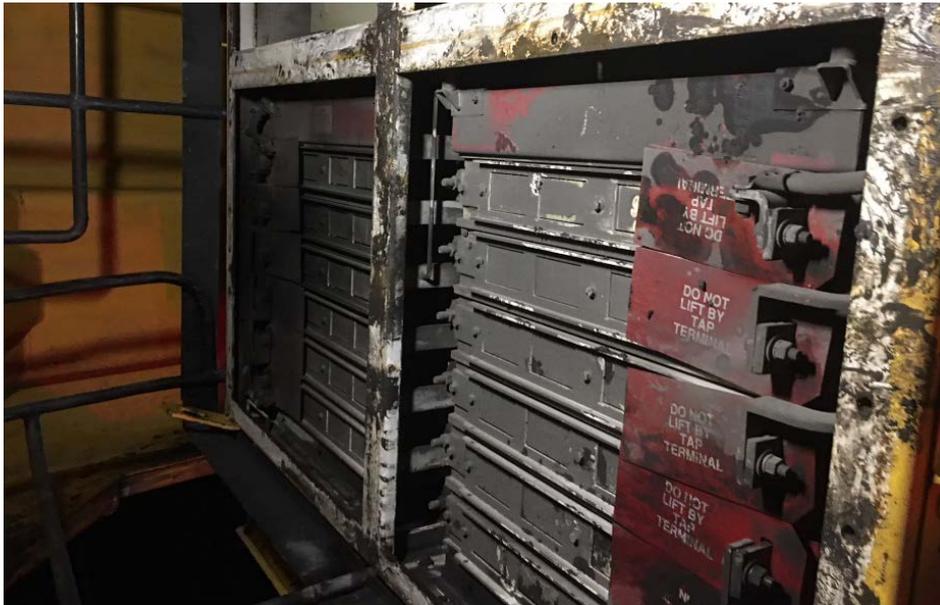
Figure 10 Hunter Valley Operations incident

January 2019 - Hunter Valley Operations IncNot0033564

An operator was made aware by another operator of a fire coming from a resistor grid box on a haul truck, while descending the ramp.

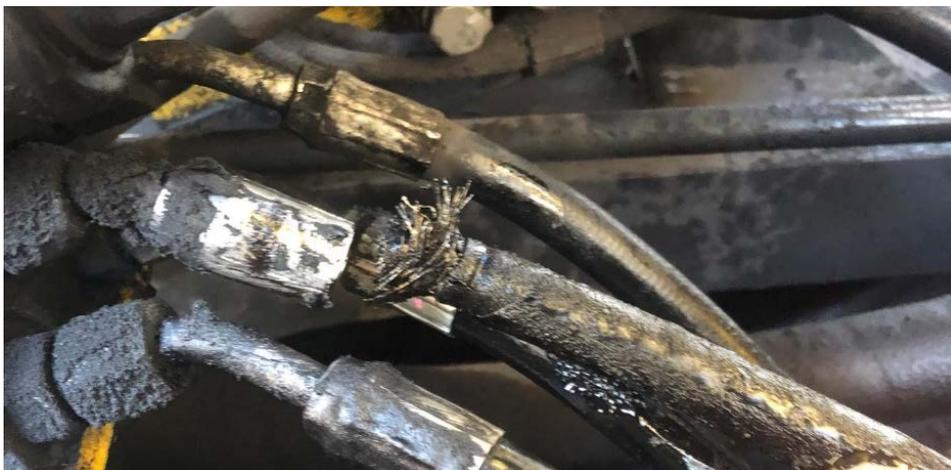
Figure 11 Moolarben incident

January 2019 - Moolarben IncNot0033553

On a Komatsu WA1200 loader, a hydraulic pilot control circuit hose failed at the point where it connected to the hydraulic pilot control solenoid, releasing hydraulic oil. This ignited on hot engine components.

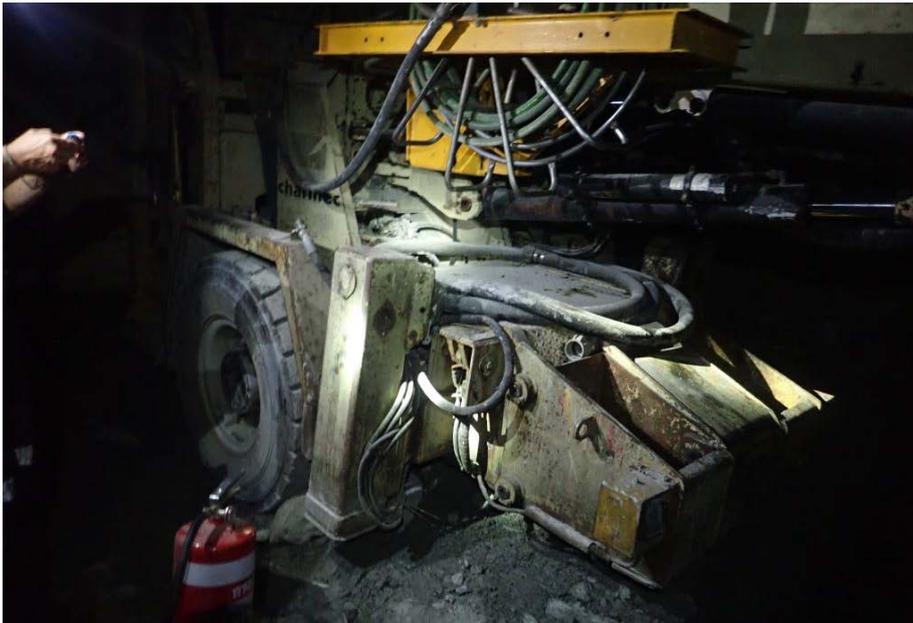
Figure 12 Murrawombie incident

January 2019 - Murrawombie Copper mine IncNot0033599

A Normet, on the bottom of the decline, was stationary and being derigged when the boom solenoid caught fire.

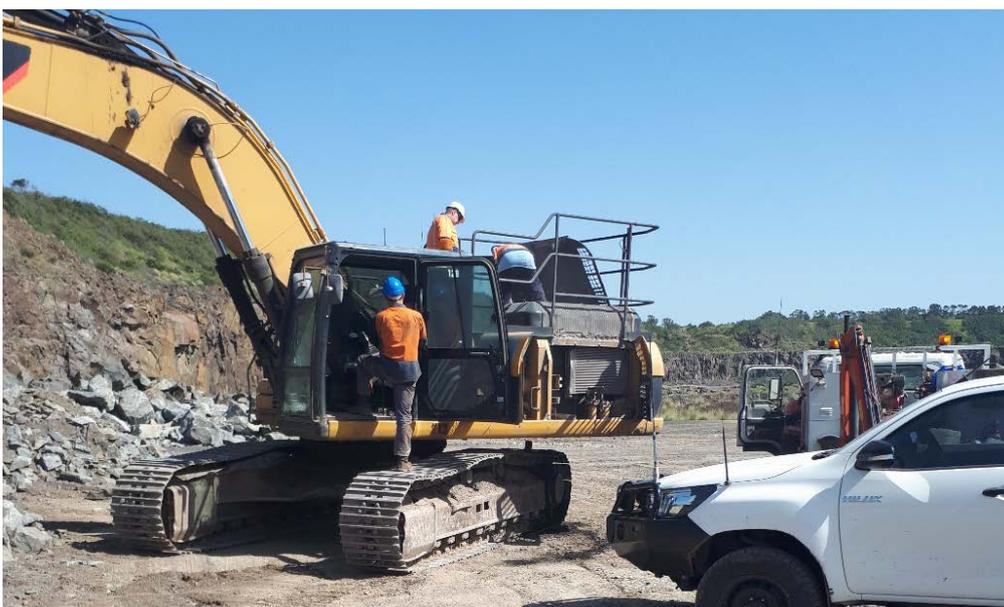
Figure 13 Hanson Bass Point Quarry incident

January 2019 - Hanson Bass Point Quarry IncNot0033615

The battery cable rubbed through on an engine oil supply hose.

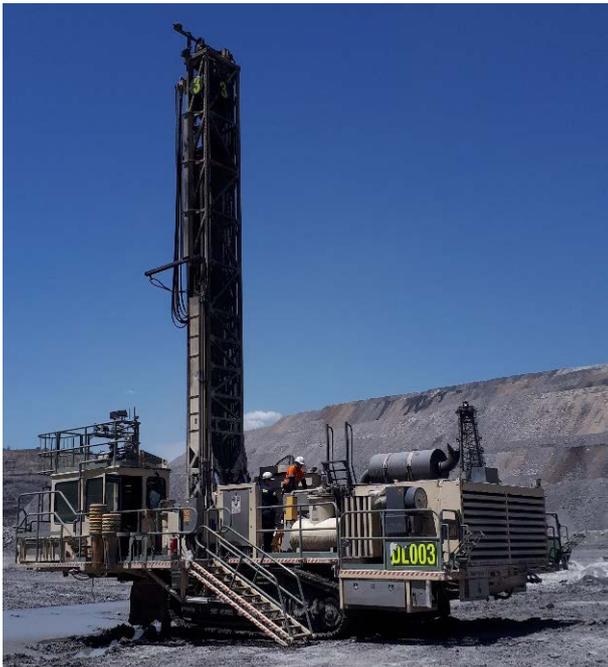
Figure 9 Bengalla incident

January 2019 - Bengalla IncNot0033626

Failure of turbo oil feed line.

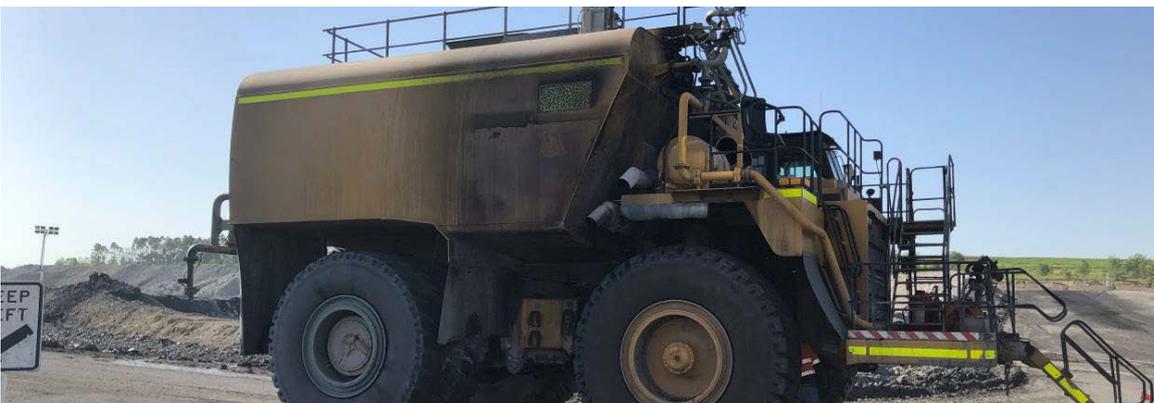
Figure 15 Hunter Valley Operations incident

January 2019 - Hunter Valley Operations IncNot0033652

The cause of a fire on a water cart was found to be a hoist/water pump system hydraulic hose failure, between the chassis rails under the water tank, which sprayed hydraulic oil into the engine bay. This hose was identified as leaking on 29 December 2018 and marked as a 'high' priority. However, it was only scheduled to be replaced on 9 February 2019.

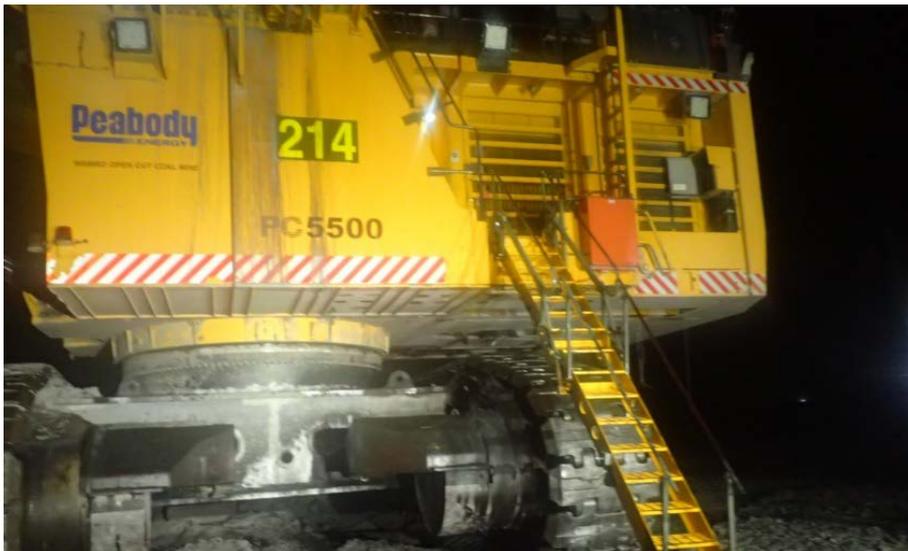
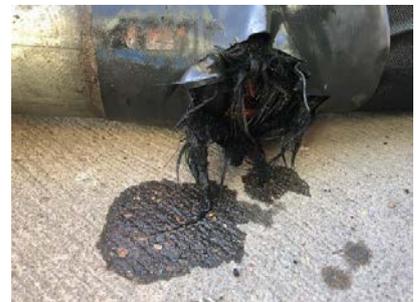
Figure 16 and 1710 Wambo incident

January 2019 - Wambo Open Cut IncNot0033641

On an excavator, the main hydraulic supply hose from the high-pressure screen to control valve #3, suffered from a rupture. Flames were seen around the turbo of engine #2.

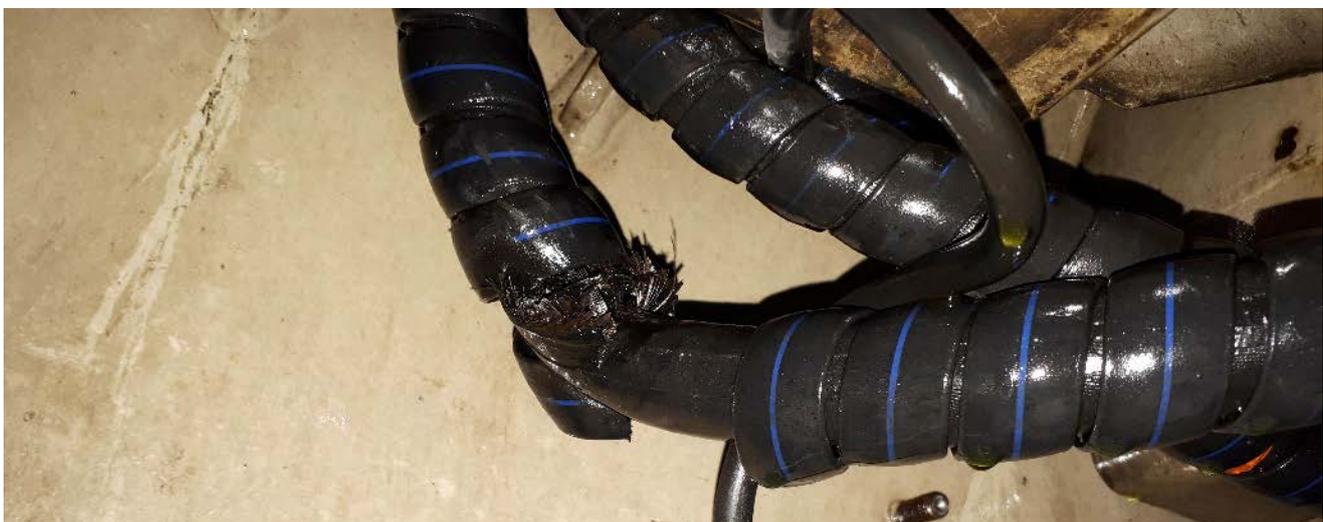
Figure 11 Bengalla fire incident

January 2019 - Bengalla IncNot0033643

There was a fire on a Hitachi EH4500 truck which came from the engine bay. The driver could see flames outside the passenger door coming from the engine bay. A burst hose was rubbing on the deck structure. The investigation identified that the hydraulic hose failed and a mist burst from beside the cab, outside the passenger door. Within a few seconds, flames appeared behind the cab at the height of the cab itself.

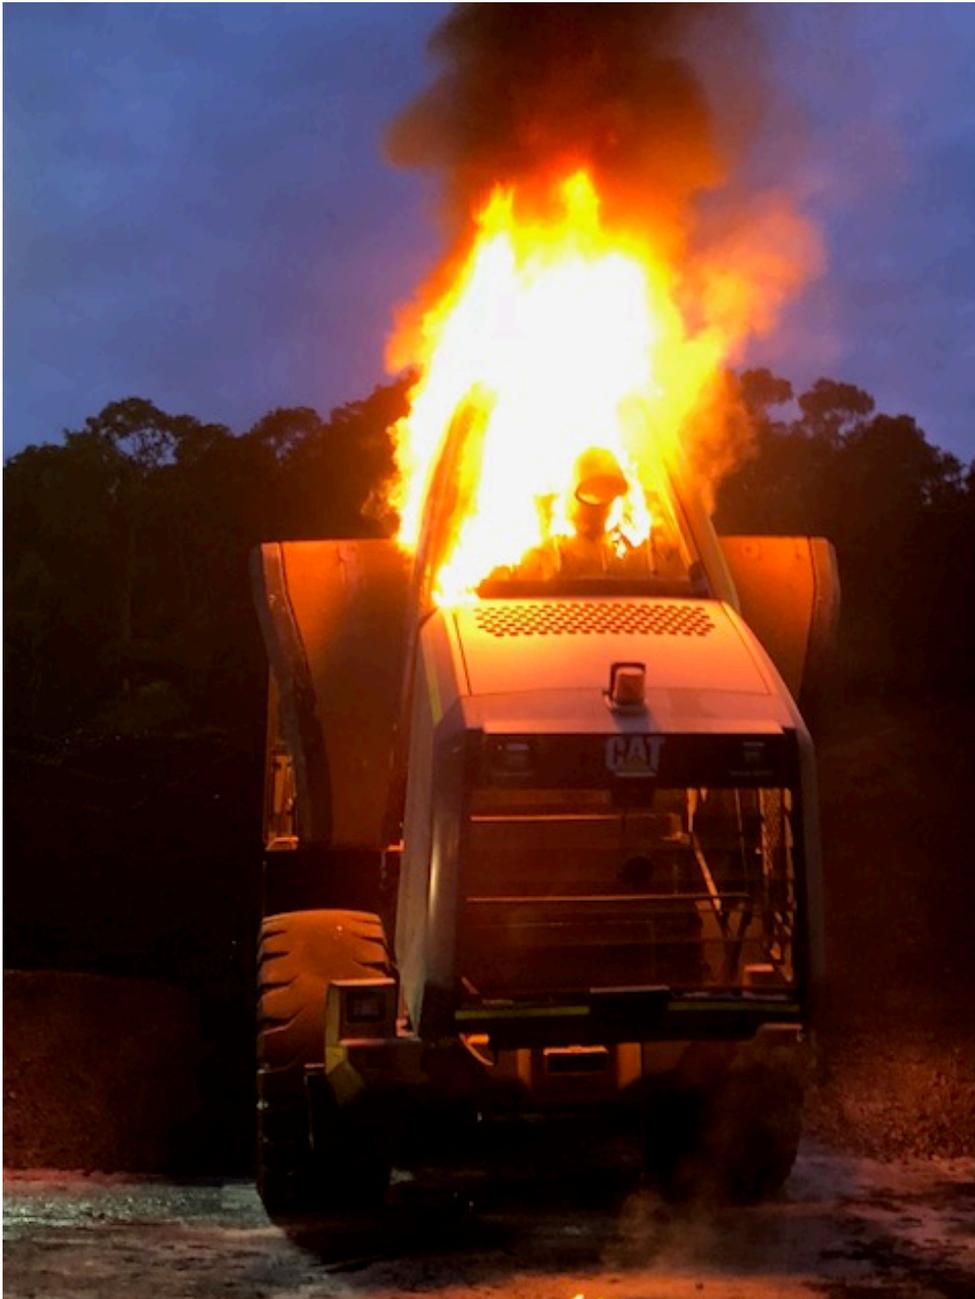
Figure 12 Newstan incident

January 2019 - Newstan IncNot0033664

The failure of a pilot fuel line to an after-treatment regeneration device (ARD) head resulted in atomised fuel being sprayed into the engine compartment. The fire was ignited by a heat source, most likely the exhaust system.

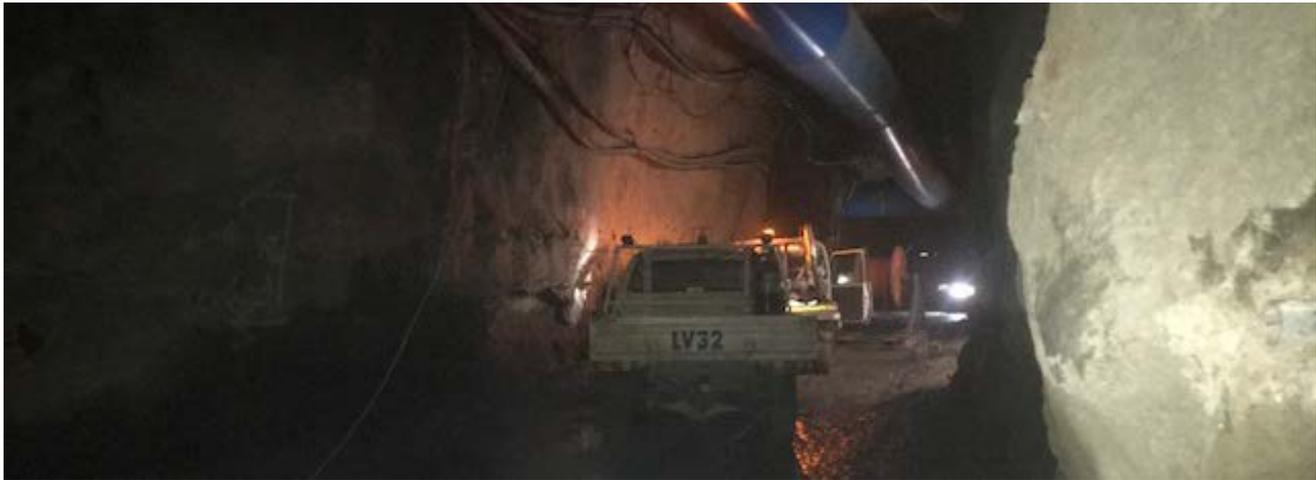
Figure 13 Rasp mine incident

January 2019 - Rasp Mine IncNot0033742

Wiring from an alternator shorted on the engine sump, which eventually burned a hole through the sump, caused a fire to start.

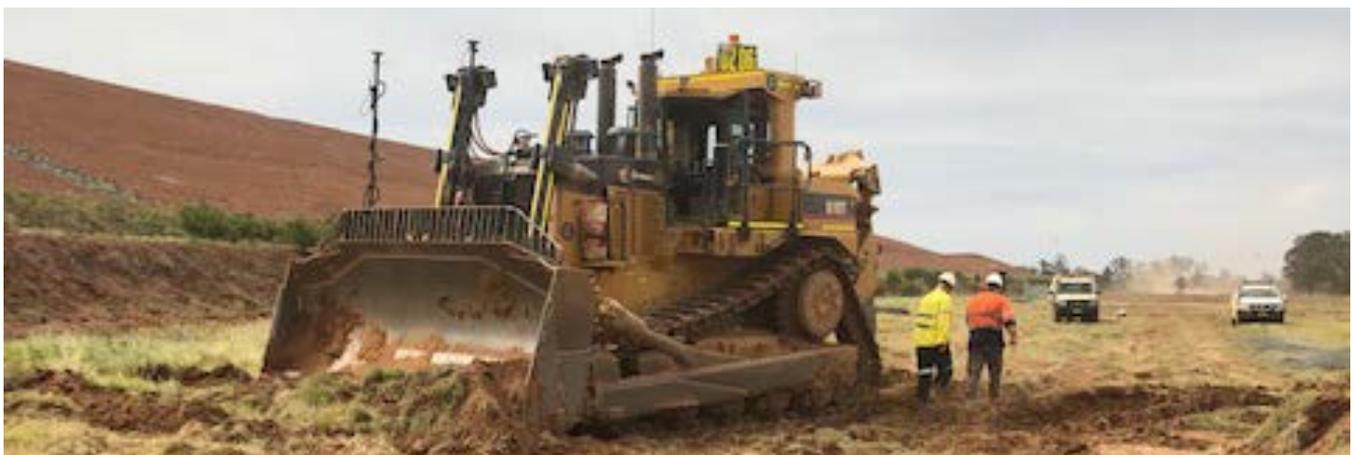
Figure 14 Tomingly incident

February 2019 - Tomingley Gold Mine IncNot0033802

Oil sprayed over hot engine components caused by a failed hydraulic hose O-ring for the ripper system.

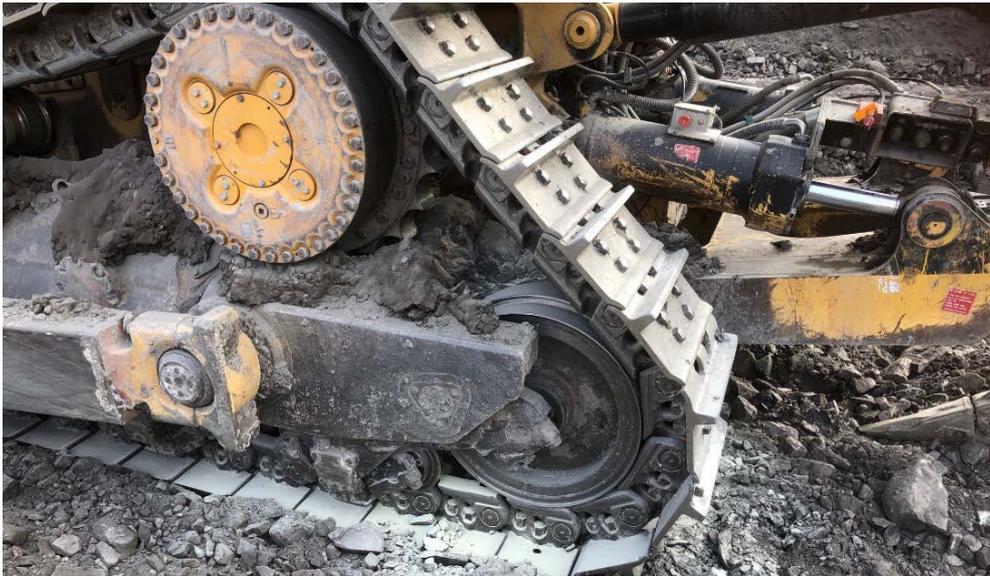
Figure 15 Moolarben incident

February 2019 - Moolarben open cut IncNot0033791

A dozer had a failed a left-hand rear idler bearing, which caused heating on the outside of the idler. The heat caused a small amount of grease on the outside of the idler to catch fire.

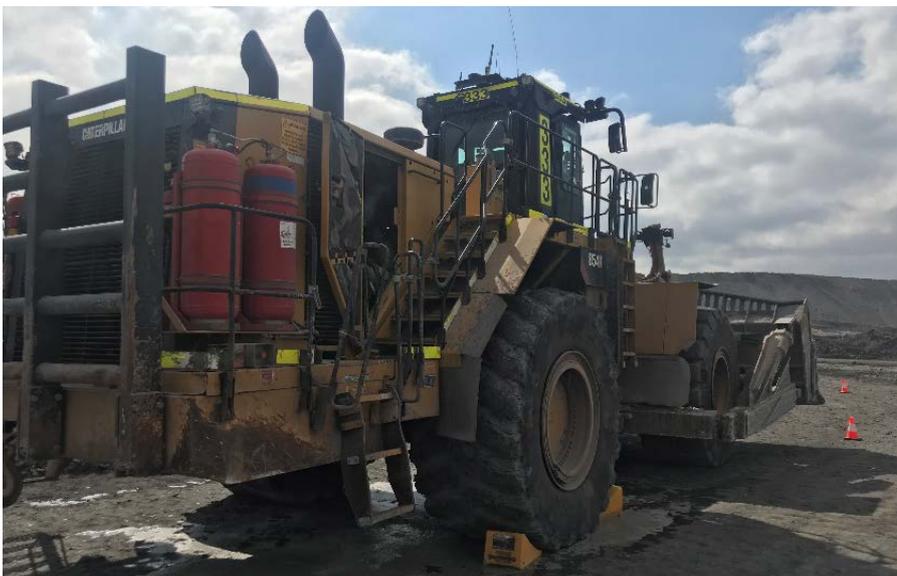
Figure 16 Mt Arthur North incident

February 2019 - Mt Arthur North IncNot0033822

A fuel hose rubbed through a rocker cover due to incorrect installation of the hose. Inspection of the condition of the fuel lines during the last service did not identify potential failure of the hose.

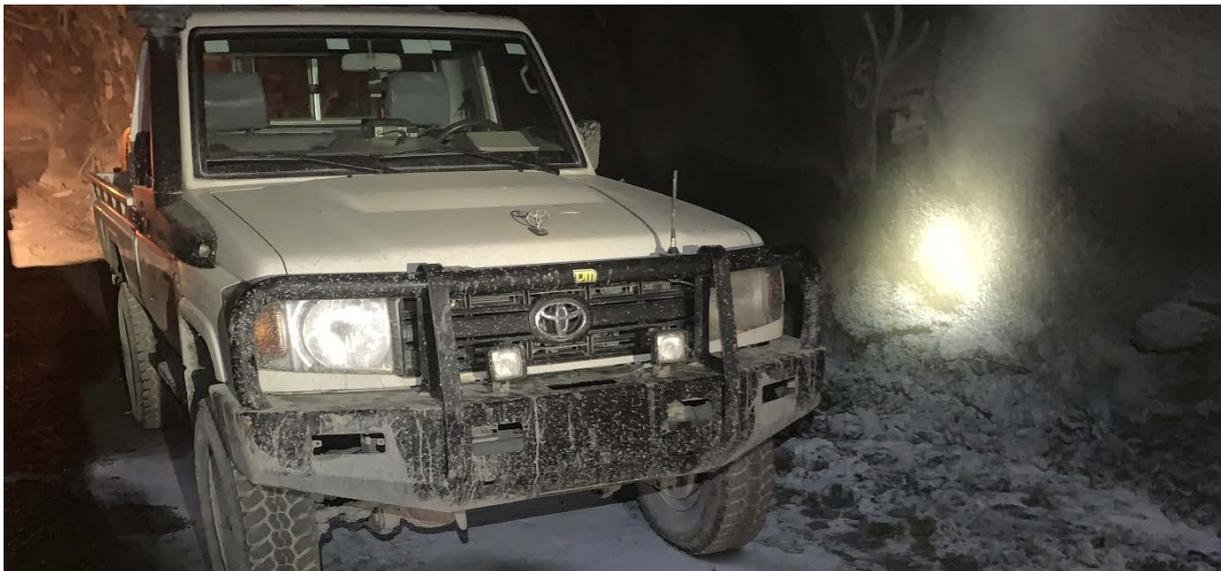
Figure 17 CSA mine incident

February 2019 - CSA Mine IncNot0033915

Park brake pads in contact with a brake disc on a heavy-duty park brake system. The park brake was left partially on while driving.

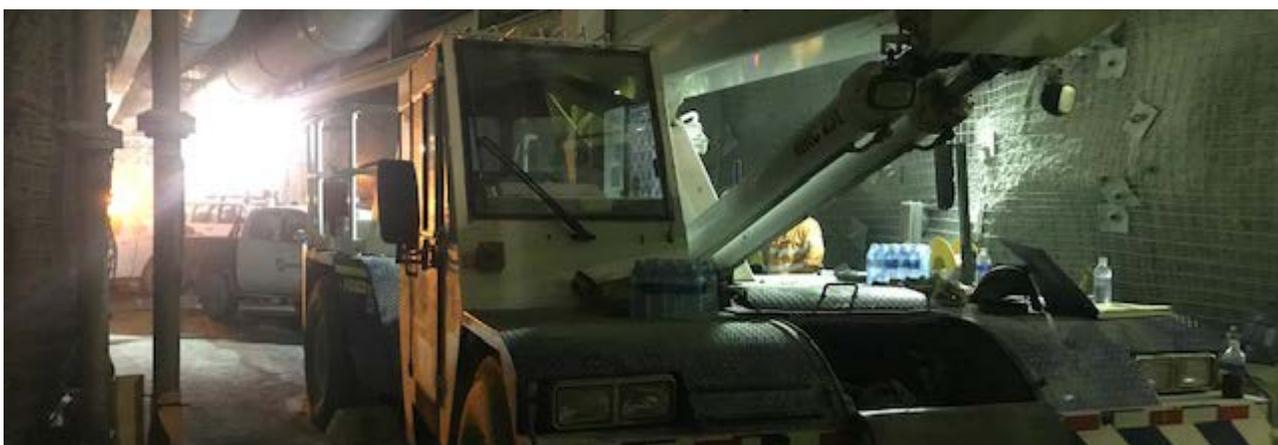
Figure 18 Cadia East incident

February 2019 - Cadia East IncNot0033951

Failure of the high current stud on the crane engine starter motor allowed a broken conductor to short to ground.

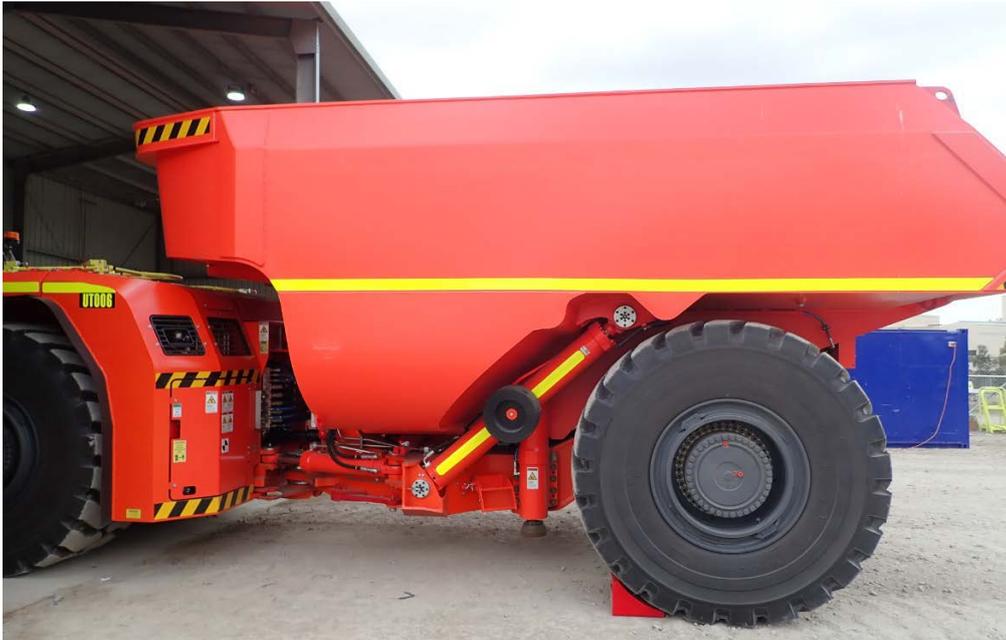
Figure 19 Cadia East ignition incident

February 2019 - Cadia East IncNot0033953

The bearing support block contact area deformed during fabrication, causing the bearing to become 'oval' when tightened down onto the support. This increased the bearing rolling torque and bearing operating temperature, to the point where the grease ignited.

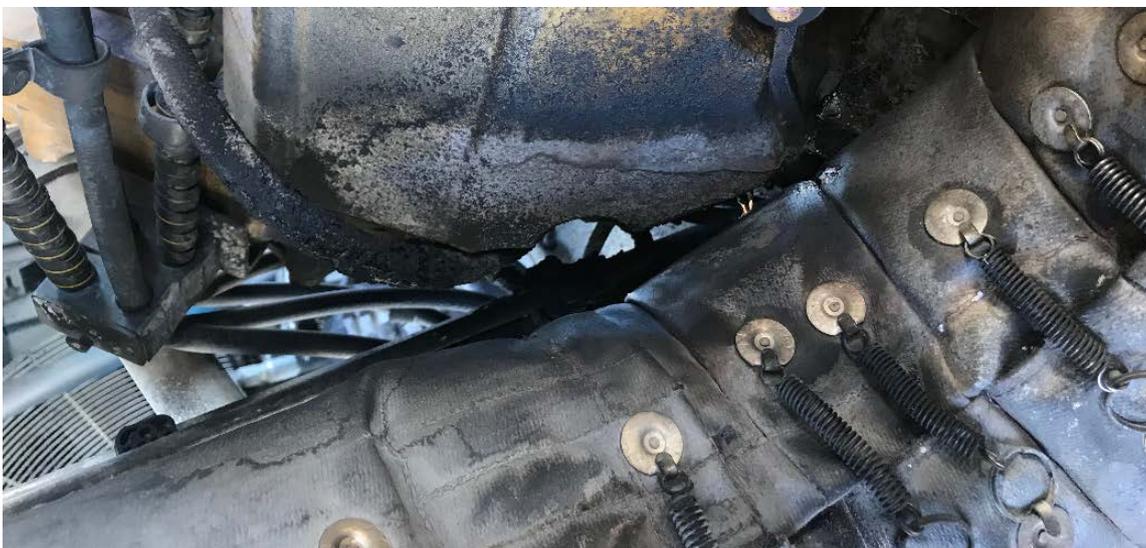
Figure 20 Mt Arthur North incident

February 2019 - Mt Arthur North IncNot0033998

A fuel return line on a Sandvik drill rubbed through, allowing diesel fuel to spray onto hot engine surfaces in the vicinity of the turbocharger. The return fuel line was inadequately supported or segregated and rubbed through on the engine rocker cover from normal machine vibration.

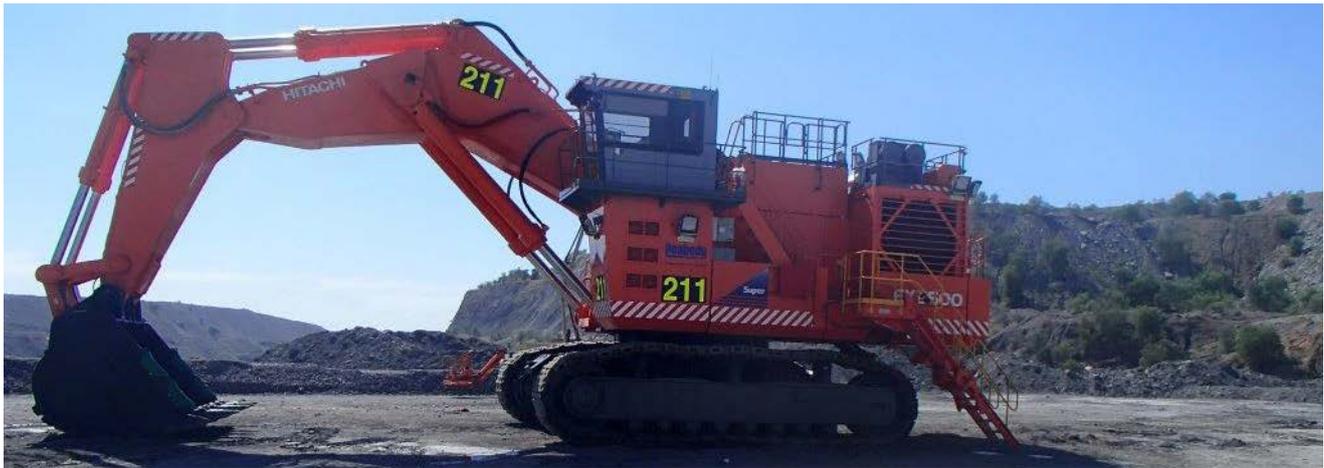
Figure 21 Wambo Open Cut incident

February 2019 - Wambo Open Cut IncNot00034127

The engine had recently been replaced on this machine. The turbo oil supply line had been incorrectly routed on the inside of the heat shielding blanket, directly against the turbo snail. This caused the hose to fail and engine oil to come into contact with the turbo.

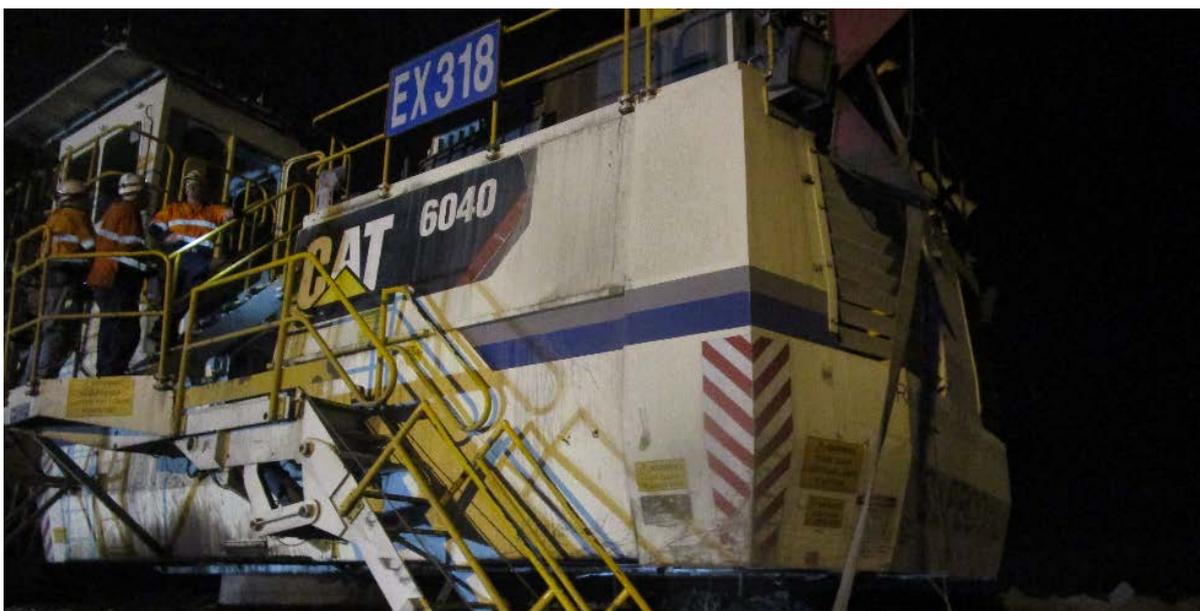
Figure 22 Ravensworth incident

March 2019 – Ravensworth IncNot0034078

There was a fire on a 6040 Caterpillar excavator in the right-hand side engine bay.

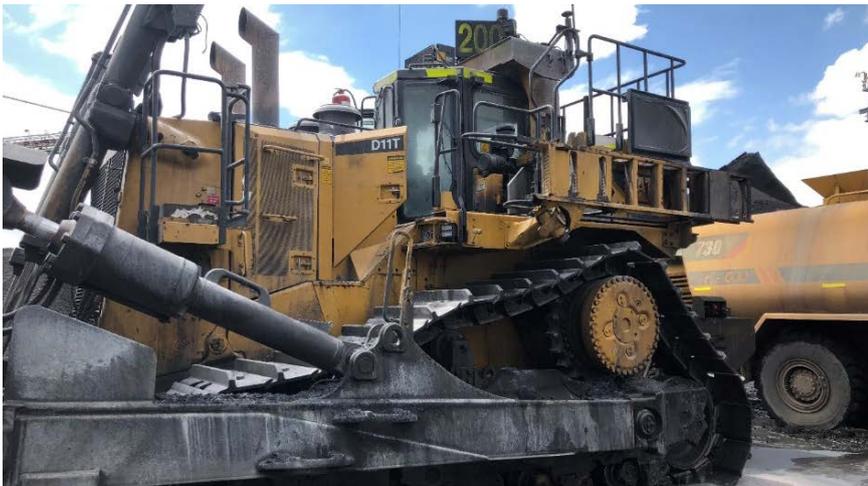
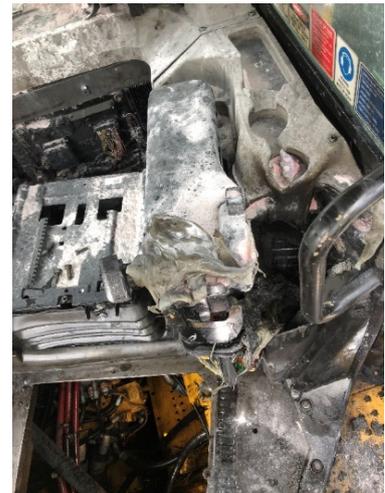
Figure 23 & 31 Wilpinjong incident

March 2019 - Wilpinjong IncNot0034097

A dozer cab filled with smoke and the operator picked up a self-rescuer. Another worker appeared on the right side of the cab and said there was no fire on that side. The cause was attributed to rubbing the air conditioning guard on the starter isolator cabling, resulting in a short circuit. The operator was sent for medical treatment regarding a hand injury that occurred while striking the fire suppression actuator.

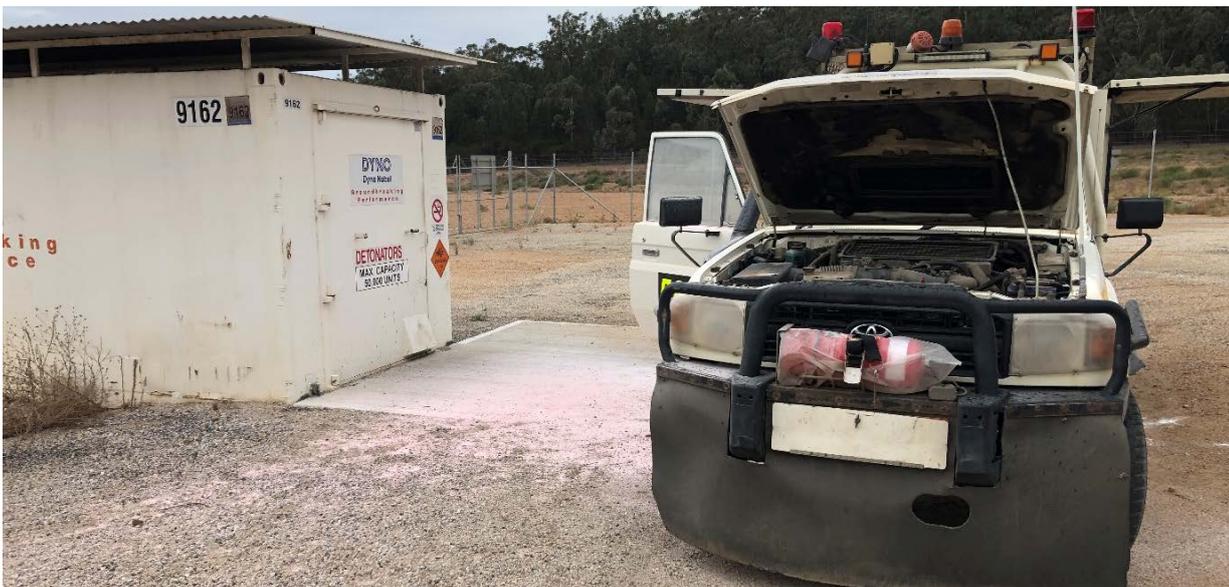
Figure 24 Wilpinjong vehicle incident

March 2019 - Wilpinjong IncNot0034114

A shotfirer's Toyota land cruiser 12-volt wiring loom rubbed through to the wiring above the battery box and caught fire while the workers were outside the explosives magazine. At the time of the incident, there were unused detonators remaining on board the vehicle.

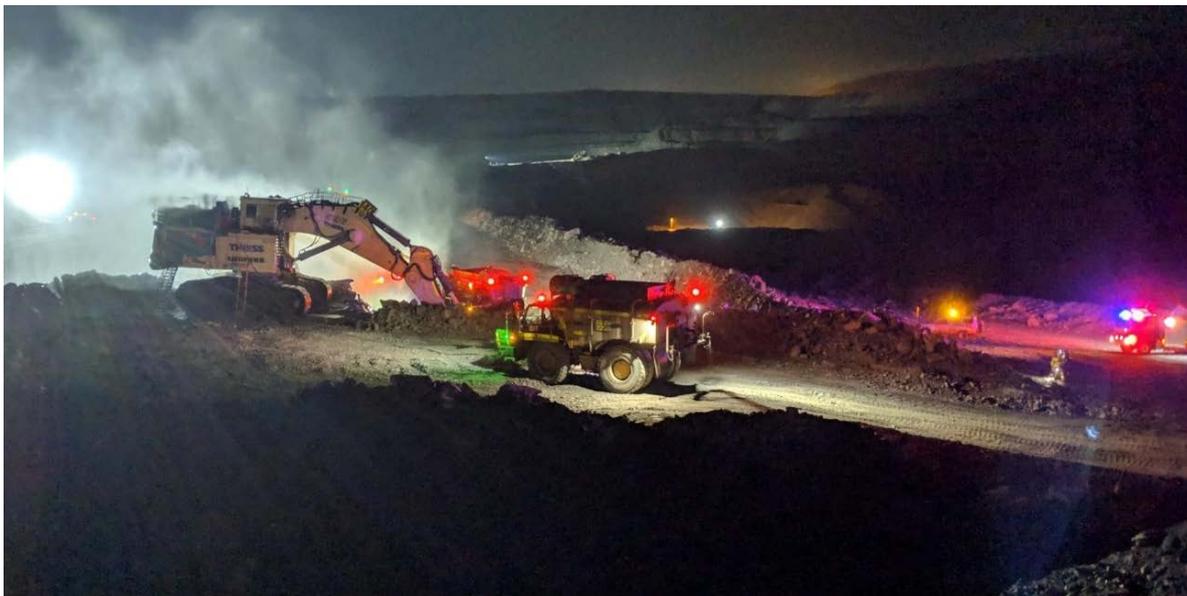
Figure 25 Mt Arthur excavator incident

March 2019 - Mt Arthur North IncNot0034122

A major oil fire occurred on a Liebherr 996 excavator. The machine had been back in service for one hour after maintenance. When the fire erupted, the suppression system was activated and four water carts were used to control the fire. Insufficient retention of a hydraulic fan motor hose caused a release of high pressure hydraulic oil. This oil sprayed under the scoop of the engine guard, igniting on the exhaust manifold.

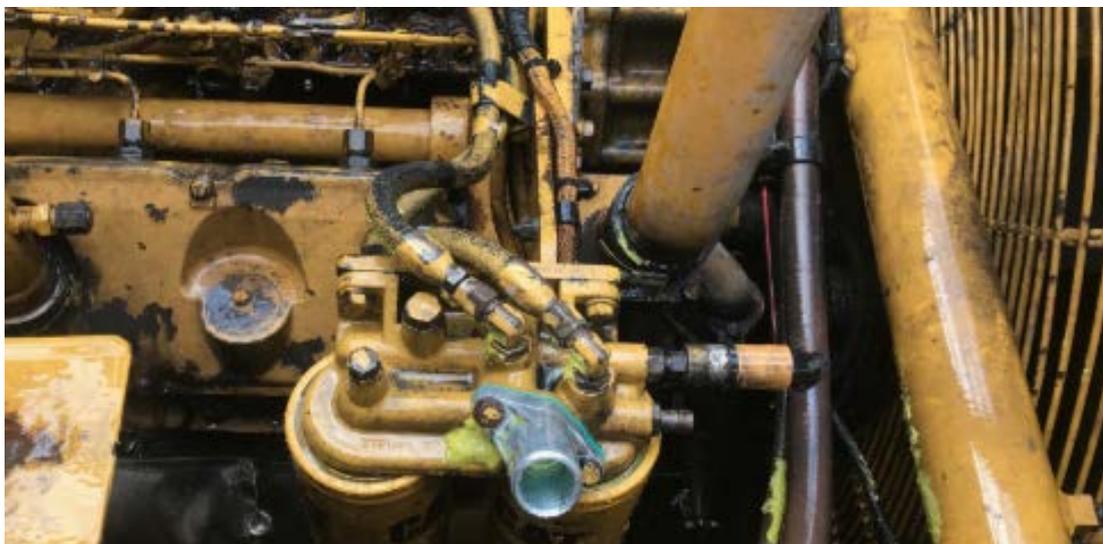
Figure 3426 Rix's Creek fire

March 2019 - Rix's Creek IncNot0034140

A manual fuel primer failed and came apart, spilling diesel on the motor of the service cart while it was operating, resulting in a fire.

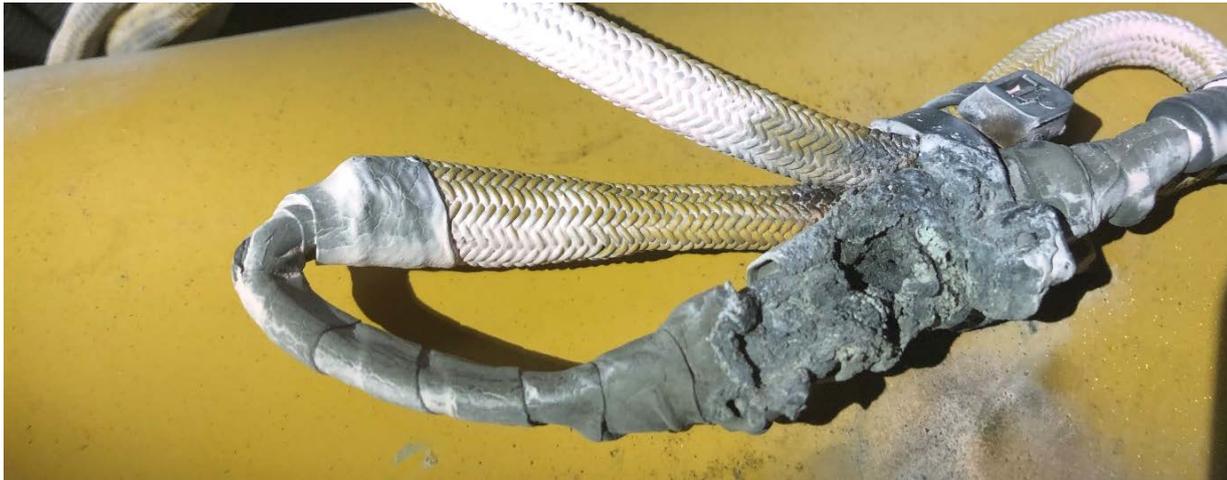
Figure 35 Wilpinjong incident

March 2019 - Wilpinjong IncNot0034210

A dozer related incident where a water/corrosion presence in an electrical connector was not identified during inspections.

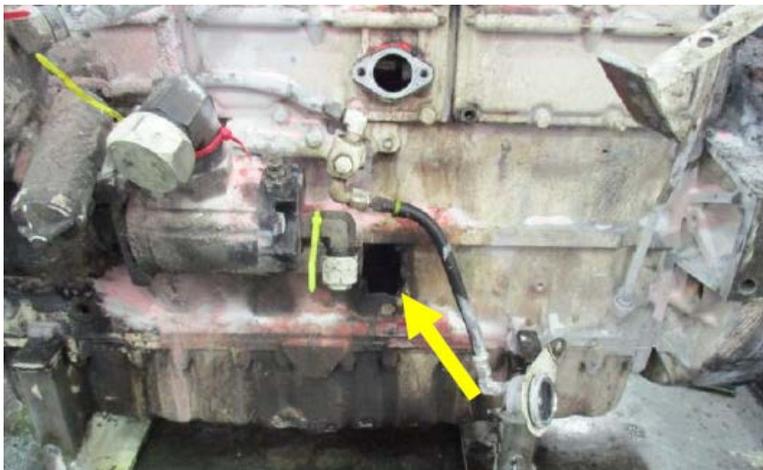
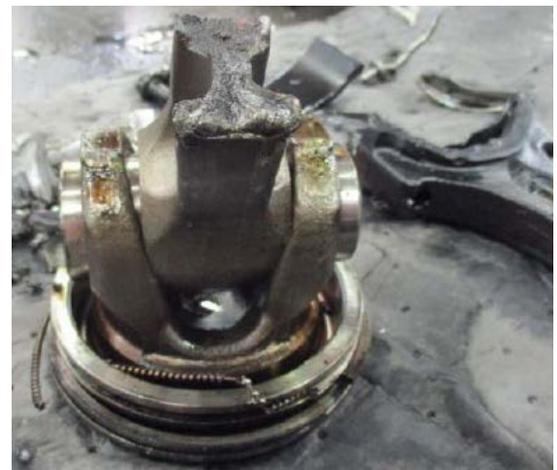
Figure 36 & 37 North Wambo incident

March 2019 - North Wambo IncNot0034184

There was a catastrophic engine failure, resulting in an oil fire at this underground coal mine.

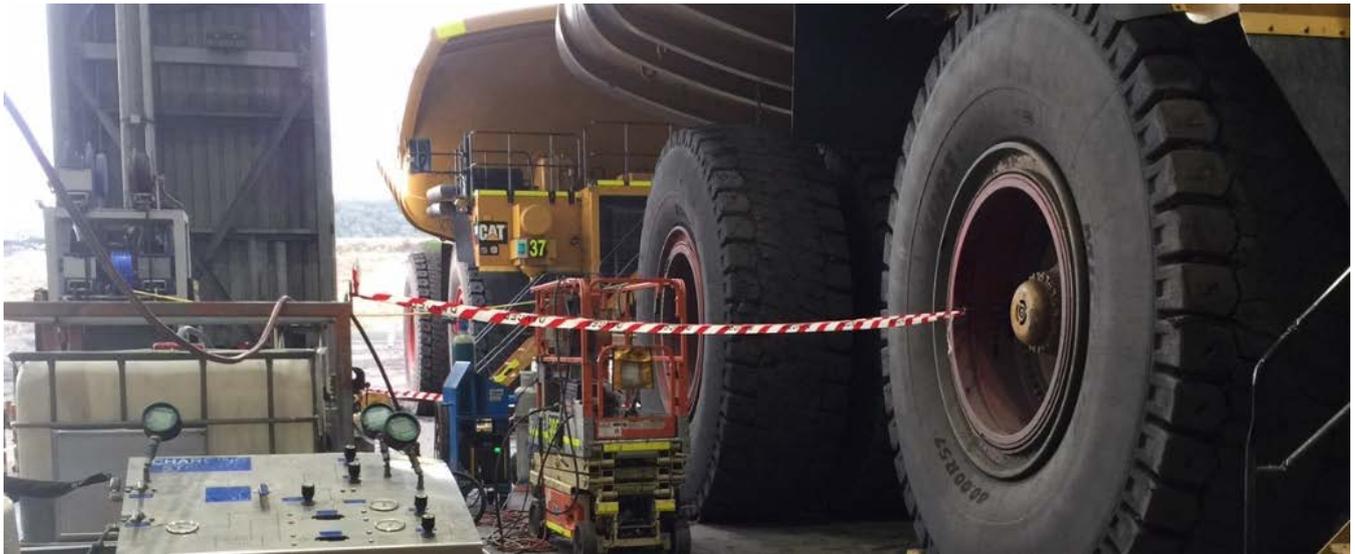
Figure 38 Wilpinjong incident

March 2019 - Wilpinjong IncNot0034233

Sparks from grinding work caused a damaged aerosol paint can to ignite. Flammable items had not been removed from the work area before undertaking the hot work.

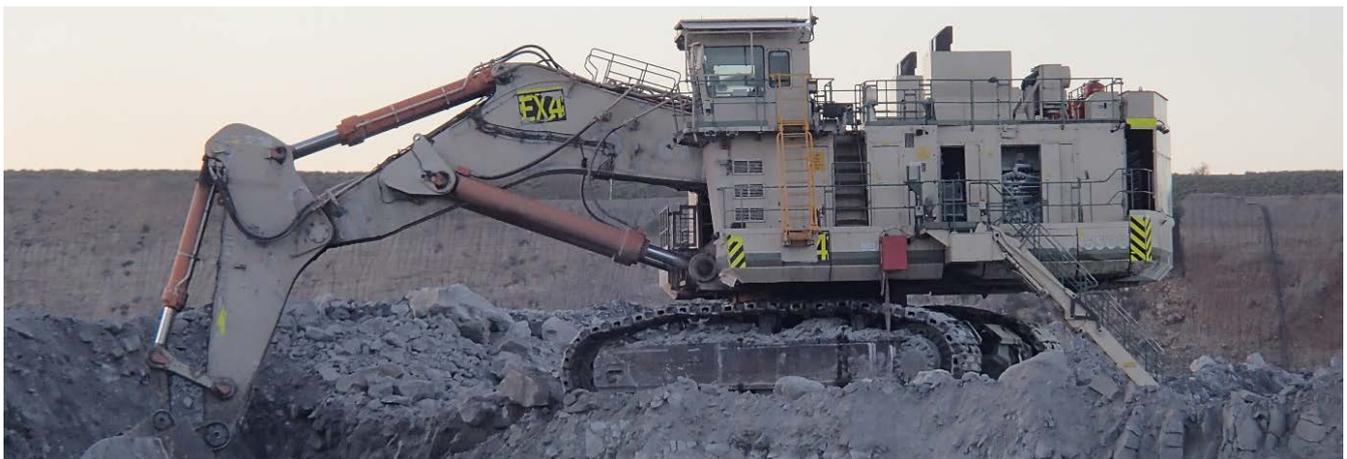
Figure 39 Bengalla incident

March 2019 - Bengalla IncNot0034268

An exhaust stack fire was caused by a bleed down manifold hose end failure. The hose was subject to mechanical strain and fatigue caused failure of fitting.

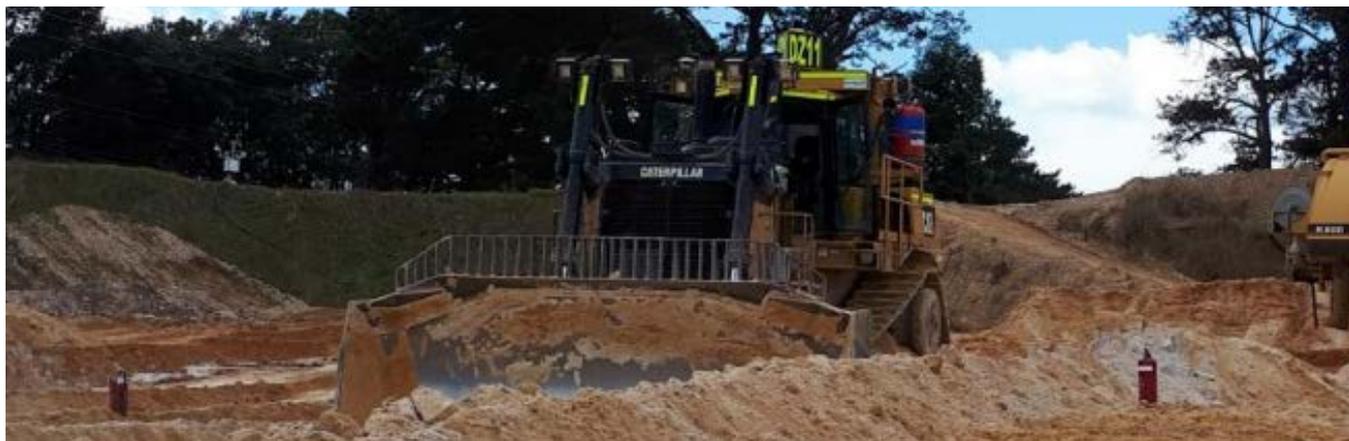
Figure 40 Central Coal Sands Quarry incident

March 2019 - Central Coast Sands Quarry IncNot0034272

A hydraulic fan pump hose rubbed through on the firewall of a dozer, causing hydraulic fluid to spray over the exhaust and turbo manifold.
