SAFETY ALERT

DATE: February 2020

Brake pad dislodged from calliper during winder testing

CM9 reference	DOC20/141098
Mine safety reference	SA20-01
Date published	28 February 2020
Authorised by	Chief Inspector Office of the Chief Inspector

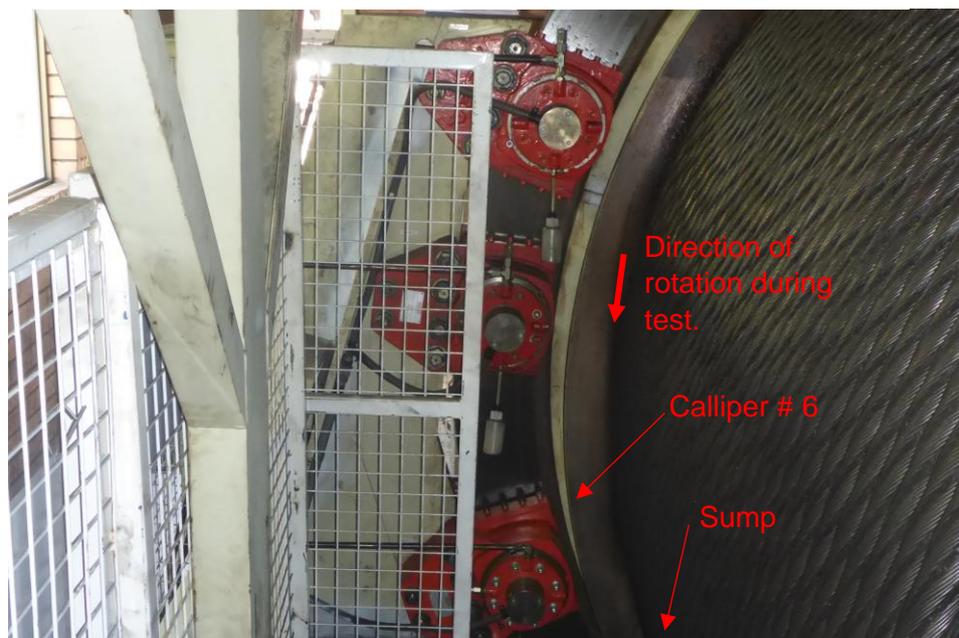
During an overspeed test of a drift winder, a brake pad dislodged from the brake calliper when the brakes were applied.

Two maintenance workers started the weekly electrical function testing. During the overspeed test, the winder registered a fault on the data log, as a failure to apply number 6 low speed brake calliper. This corresponded to a trip due to exceedance of the brake pad wear limit.

Upon initial investigation, workers found the brake friction pad, retaining plate and four of the five retaining plate bolts in the sump below the brake calliper. They also found the fifth bolt broken with part of the thread still engaged in the calliper.

Figure 1 - Showing winder drum and three of the ten Svendborg brake callipers

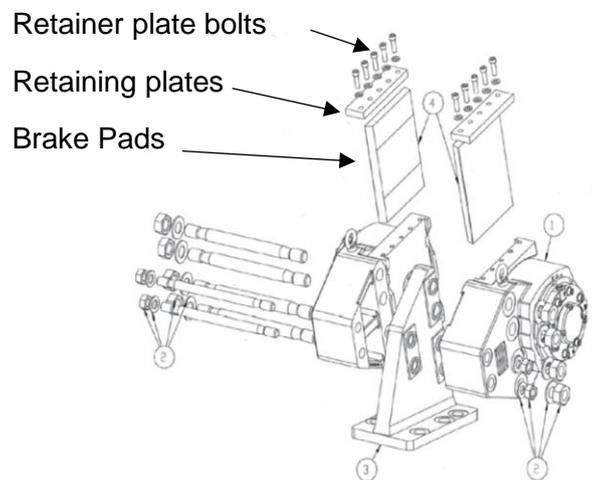
The failed bolt was determined to be the consequence of the force exerted by the brake pad on the retainer, which overloaded the bolt.

- The retainer plate bolts were M12 by 40 millimetres long class 12.9 socket head cap screws (bolts). The manufacturer specification is for class 8.8 bolts. Class 12.9 bolts had been supplied on overhauled callipers primarily because 8.8 class were special order and not readily available.

- Retainer plate bolts had been installed without the use of a torque wrench to the specified torque setting of 64Nm set by the manufacturer for class 8.8 bolts. Due to the bolts being class 12.9, a higher torque setting would have been needed to induce the required strain to prevent the bolt loosening over time.

- Thread wear or stretch was found in the tapped holes of the calliper. This presented as excessive axial play when inserting a new bolt into the thread.

- While no fasteners were found without washers fitted, it was noted that without the washer, the M12 by 40 millimetres long bolts could bottom out in the blind tapped hole with a slight gap underneath the head of the bolt (less than 1 millimetre). This highlighted the fitment and thickness of the washer critical to the assembly.

Figure 2 - The brake calliper assembly. Note the retaining plates are duplicated on the underside of the calliper.

- Conduct a review of winder brakes to ensure the correct grade of fastener, specified by the designer or manufacturer, is being used for the application.
- Review the details of work scopes and information provided to maintenance workers. These should include all necessary technical information (i.e. part re-order codes, fastener grade, length, material protection, lubrication, torque setting, application of thread locking compounds, washer details, fastener re-use or discard criteria).

- Identify instances of safety critical blind threaded holes. Undertake regular inspection and testing to ensure threaded holes remain within tolerances nominated by the manufacturer. A 'go/no-go' thread gauge or other techniques for this purpose may be suitable. Training and the competency of workers to perform the inspection and testing of threads should also be considered.

- Overhaul work scopes should include quality checks for fastener grades, torques, thread tolerance checks, components replaced when exceeding design life cycle, machining tolerances, surface finishes or other performance critical specifications.
